# INITIAL ENVIRONMENTAL EXAMINATION (IEE)

For Beach Nourishment

Soneva Gili Resort and Spa, North Malé Atoll

Proponent: Soneva Gili Resort and Spa

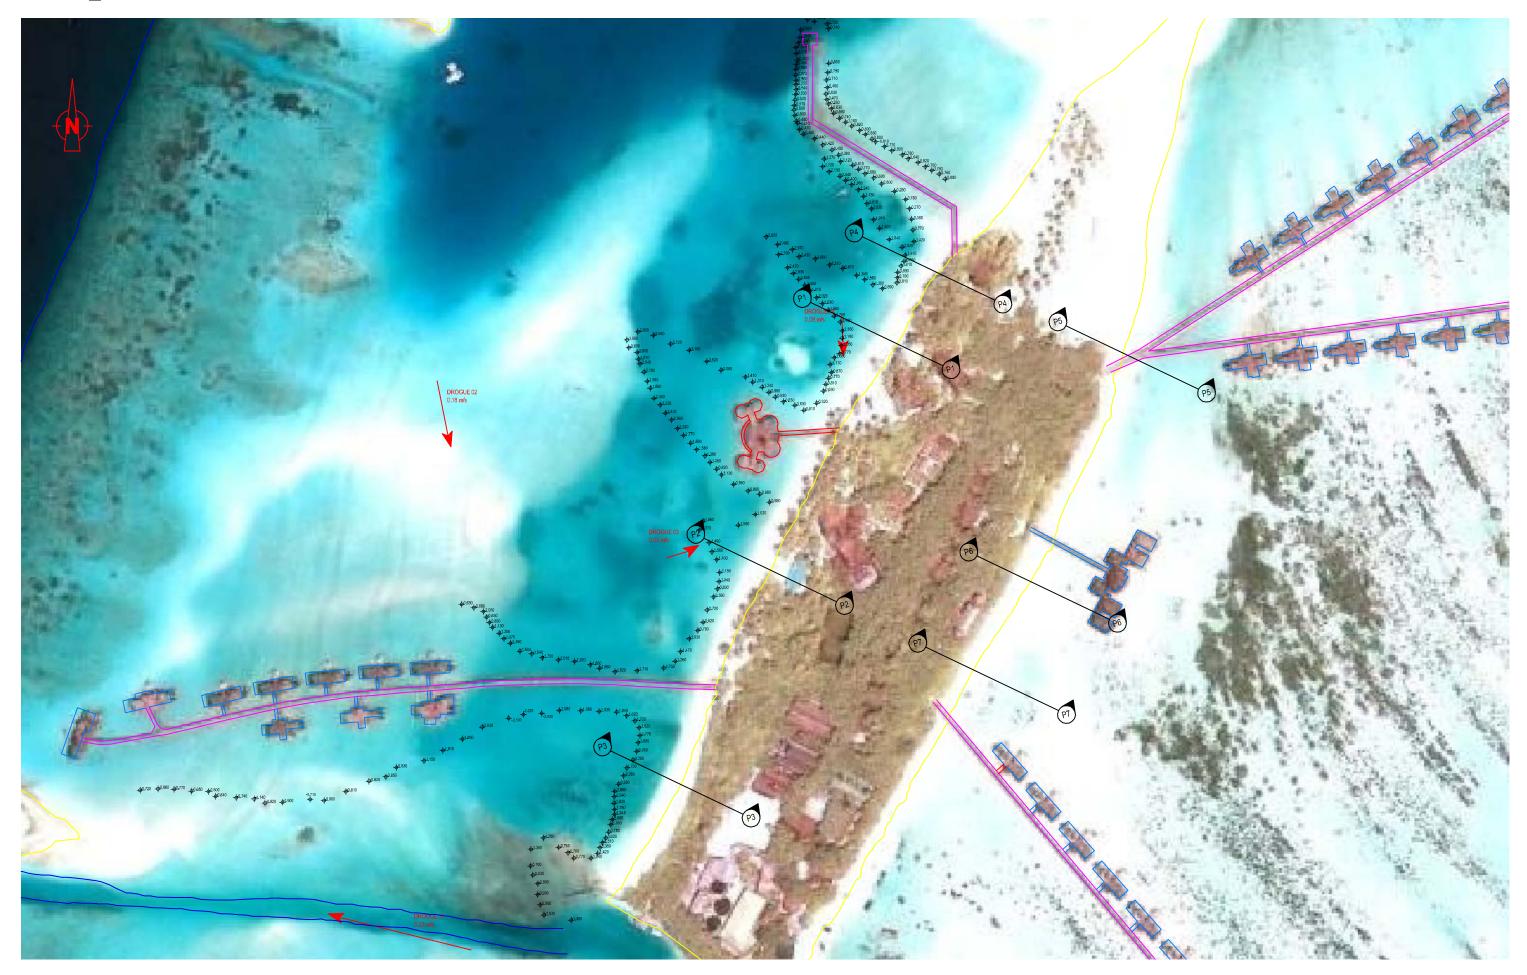
# Figure 3\_1: Survey Map, Soneva Gili

The entire island shoreline and survey locations (in the project boundary) were mapped using a differential GPS. Seven beach profiles P1-P7 as indicated in Figure 3-1 were taken around the island, of which four were taken on the western side and the remaining on eastern side of the island.

Marine water quality was tested on three locations W1, W2 and W3 within the lagoon system as in Table 4-2. There are low levels of turbidity in the different sample locations. The locations are shown in Figure 3-1

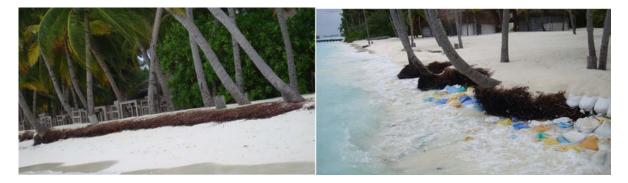
Figure 4-2: Beach line on the western side of Soneva Gili, September 2010

There is extensive erosion on the western side of the island as shown in Figure 4.2. Erosion has reached slightly beyond the vegetation line of the island. There is no beach on the western side except at low tide. More photos are shown in Figure 4-3.

The beach on the western side is subjected heavy erosion apparently due to combined effects of waves and tides during the southwest monsoon. Longshore currents are expected to bring in sediment to the western beaches during northeast monsoon, however, may not do so to combat the extent of erosion during southwest monsoon. Therefore, interventions such as continuous sand pumping would be necessary. The recent storm in July 2010 worsened the erosion leaving a completely eroded beach with damaged sand bags exposed along with roots of coconut palms on erosion scarps and beach berms. Continuous beach nourishment has been undertaken in the past as the preferred means of shore protection. However, this has been based on observations and experience of past erosion problems. Therefore, it is important to undertake detailed studies to assess the impacts of continuous, long term sand pumping activities in comparison with other shore protection alternatives. Therefore, EPA has recommended undertaking a detailed study and preparing an Environmental Impact Assessment report following this IEE as this IEE will establish baseline information and project details for provision of an urgent environmental clearance to undertake one-time sand pumping operation to nourish the western beaches.
