ENVIRONMENTAL IMPACT ASSESSMENT

For the Proposed Refurbishment of Adaaran Club
Rannaalhi, South Male' Atoll, Maldives

For Water Solutions Pvt. Ltd., Maldives

April 2008

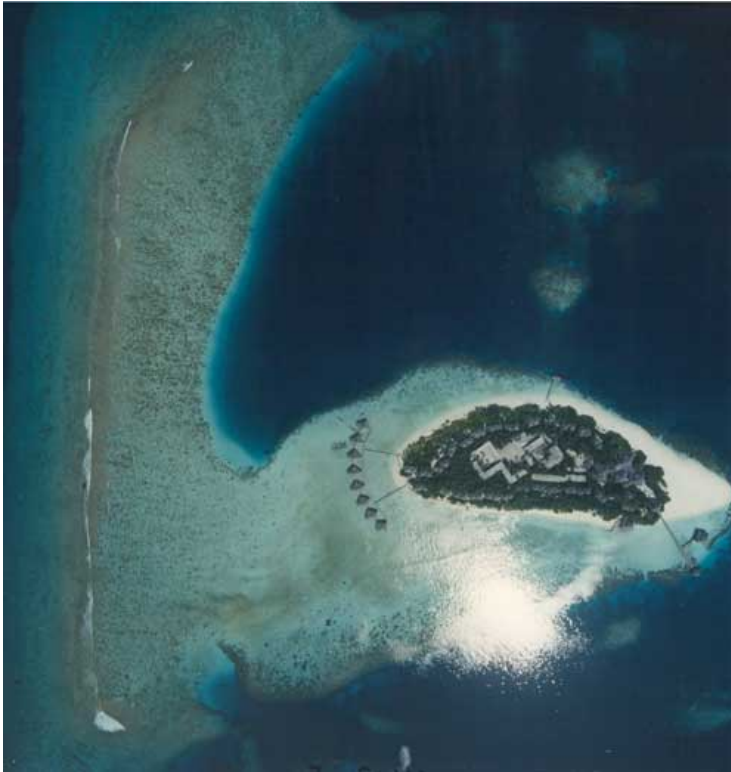
Figure 1: Aerial view of Rannaalhi and the reef system.

The island is roughly 45 m from the eastern rim of the reef system on which it is formed. Towards the east of the island is the atoll lagoon and towards the west of the island is the channel between Male atoll and Alif atoll. The southern shore line is approximately 150 m from the southern reef extent. The southern side of the island is prone to the effects of currents and oceanic wave activity during the south-west monsoon. As a result, coastal protection measures (groynes) have been constructed on this side for several years. The island is oriented towards east to west direction along its length. The reef on the western side is considerably larger than that on the eastern side (refer to figure 1).

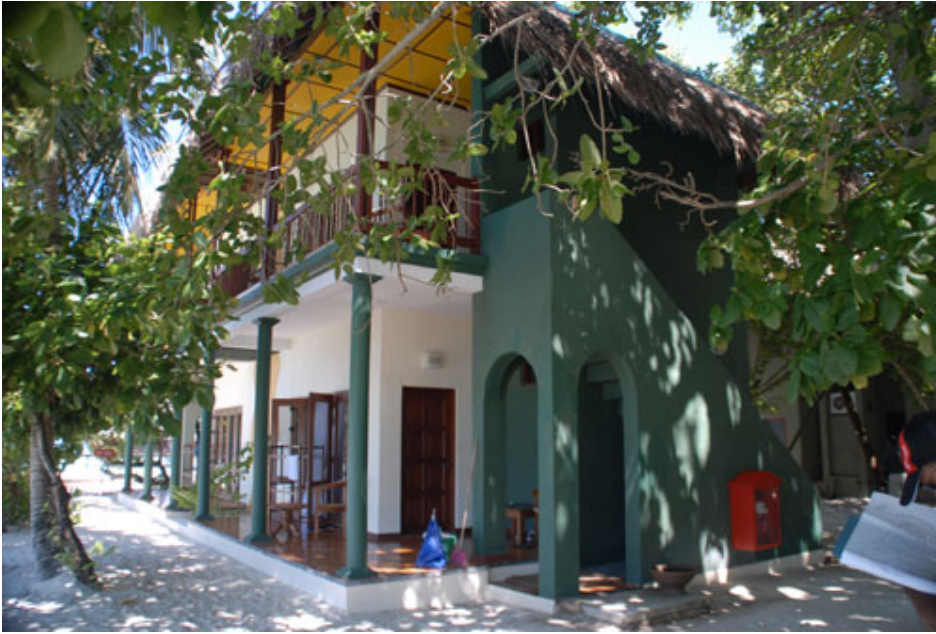
6.10.1 *Modification of 4 guest rooms (1 chalet)*

Refurbishment will include conversion of the chalet in to a bar and Spa. This component will not involve any demolition. The refurbishment will include mainly interior decoration and painting works. Please refer to the site plan attached as an annex. The photo below illustrates the existing chalet which will be modified. No trees will be cut for this component.

The new bar and spa will be developed by refurbishing the existing Chalet (4 rooms). Refer 6.10.1 and annex.

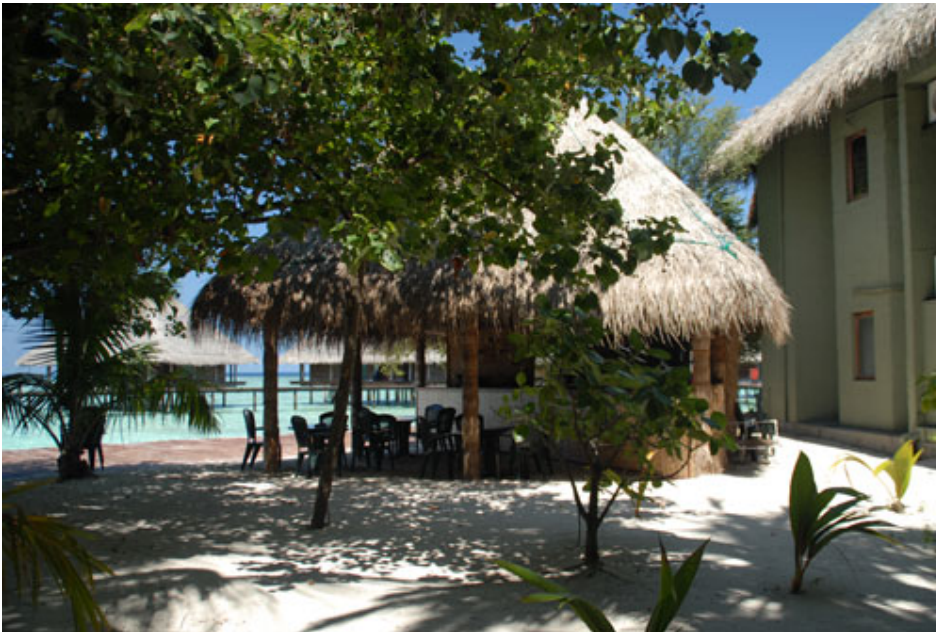
6.10.2 Demolition of existing beach bar

The beach bar on the western side of the island is made from coconut thatch roof and wood. Demolition will result in 20 m² of debris which will mainly be coconut thatch and wood. Please refer to the site plan attached as an annex. The photo below illustrates the existing beach bar which will be demolished. No trees will be cut for this component.

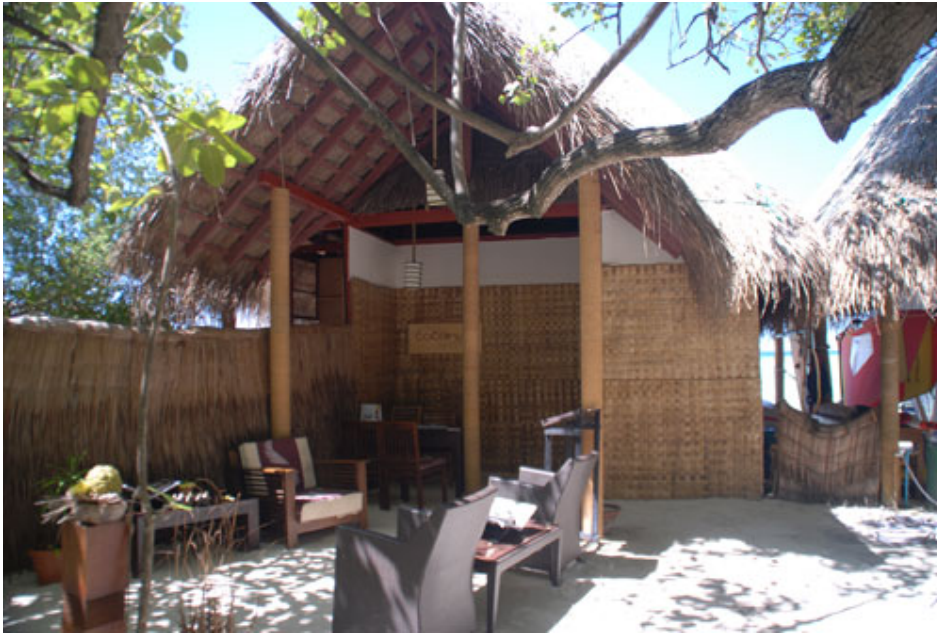
6.10.3 Demolition of existing Ayurveda

The existing Ayurveda spa is also made from wood and coconut thatch. Hence, this will also be demolished. The new spa will be developed after refurbishing the Chalet discussed earlier. Demolition will result in 20 m² of debris which will mainly be coconut thatch and wood. Please

refer to the site plan attached as an annex. The photo below illustrates the existing Ayurveda spa which will be demolished. No trees will be cut for this component.

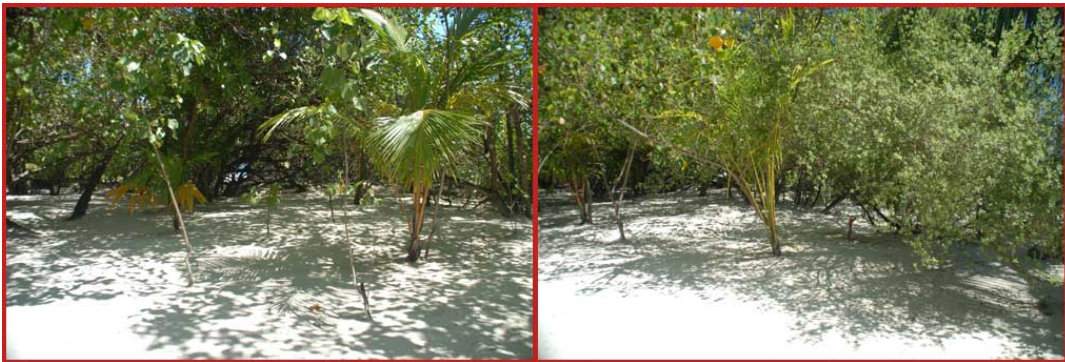
The location for the swimming pool is an empty area with limited young trees. The photo below illustrates the baseline condition of this area.

Figure 6: Floral landscape at the location for the swimming pool

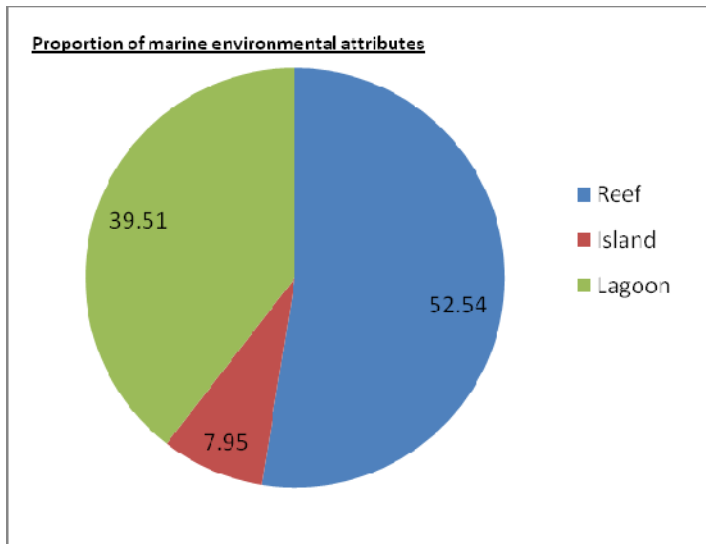
Figure 9: Proportion of marine environmental attributes of the island

reef flat was estimated as 328919 m². The following figure shows proportions of the environmental attributes of the island system in terms of area.

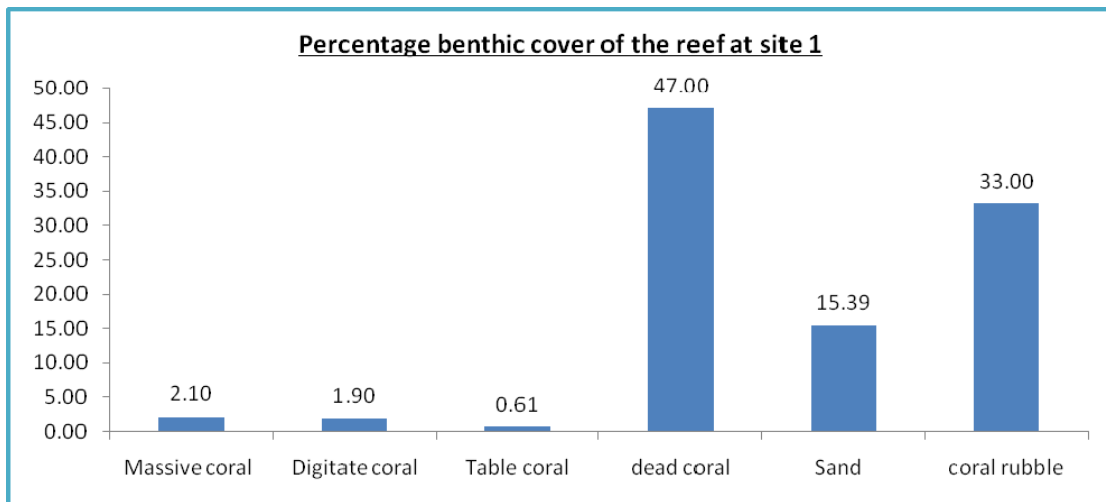
Figure 10 Percentage benthic cover of the reef at Site 1

The photo-quadrat reef survey and visual observations conducted showed that the coral reef at site 1 had 4.6% live coral cover consisting of corals mainly belonging to the *Acropora* group. The survey showed that site 1 consisted of 2.10 % massive corals, 1.9 % digitate coral and 0.61% table corals. This area is dominated by dead corals accounting for 47%, coral rubble accounting for 33% and 15% sand. Standard error for these estimates is within ±10%.

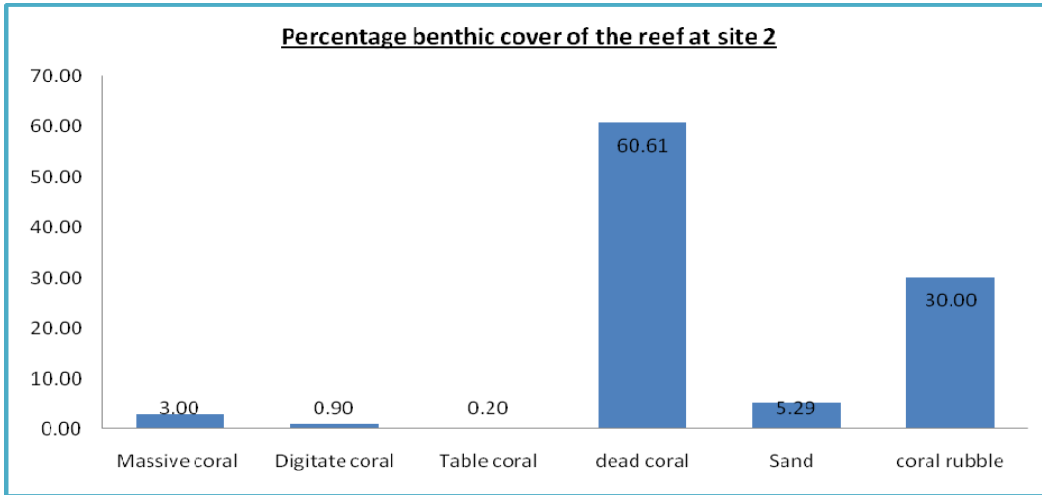
Figure 11: Benthic cover of the reef (site 2)

The photo-quadrat reef survey and visual observations conducted showed that the coral reef at site 2 had 4.10% live coral cover. The survey showed that site 2 consisted of 3 % massive corals, 0.9 % digitate coral and 0.20% table corals. This area is dominated by dead corals accounting for 60 %, coral rubble accounting for 30% and 5% sand. Standard error for these estimates is within $\pm 10\%$.

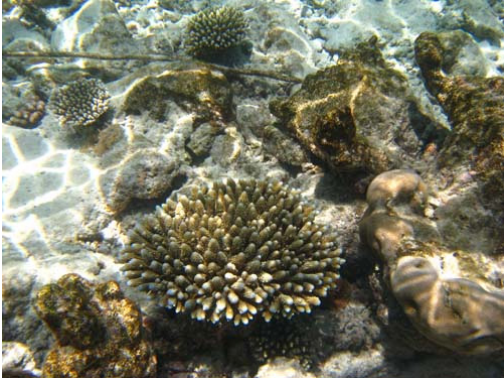
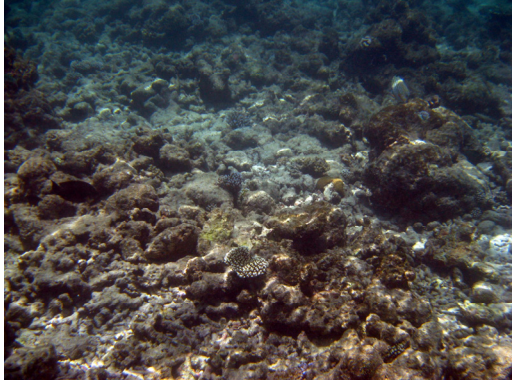
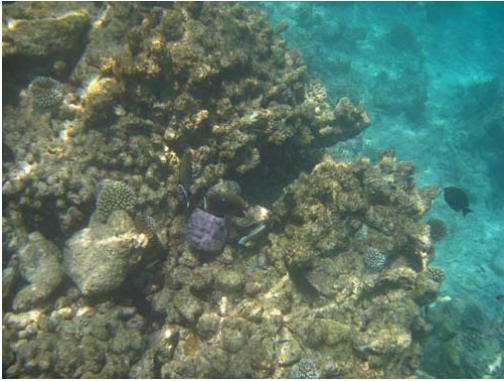
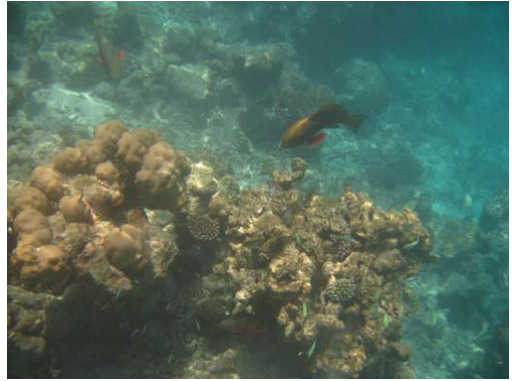
Figure 12: Photos from site (site 1)

<p>Isolated live coral at site 1 (<i>Acropora Digitate</i>)</p>	<p>Dead coral and coral rubble at side 1</p>

<p>Dead coral at site 2</p>	<p>Dead coral with some live coral massives</p>

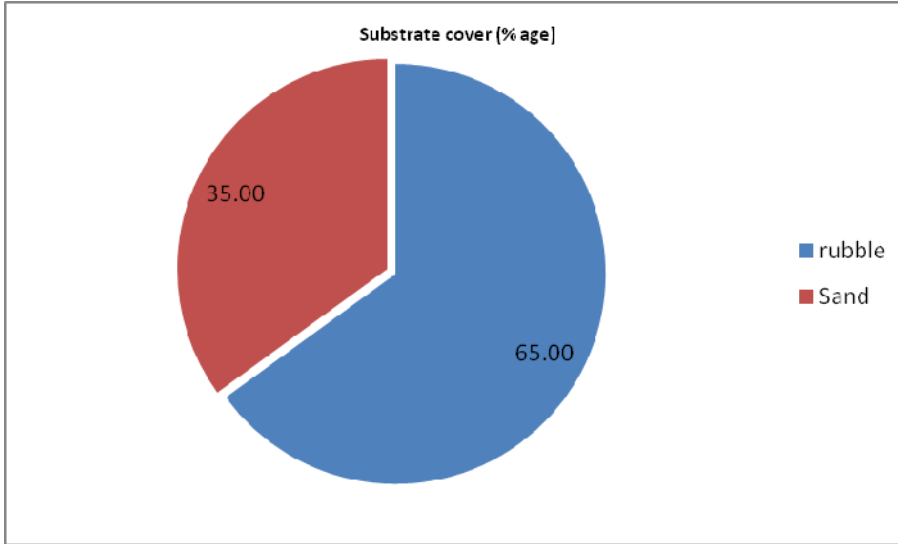
Figure 14: Substrate cover on the proposed site for water villas.

The lagoon survey was concentrated on the western side lagoon where impact of over-water villa construction is going to be the greatest. The lagoon survey showed that lagoon bottom consisted of mainly coral rubble and fine sand. The area had a high percentage of sand and rubble which combined with elevated levels of turbidity (3 NTU) makes the proposed site very unfavourable for coral recruitment as coral spat need a hard substrate to settle and grow. Absence of live corals along the transect line is a good indication of the absence of suitable substrate in this area. In this area, 65 % were rubble and 35% sand.
