Environmental Impact Assessment Notes for H.A. Uligamu Harbor Construction Project

Uligamu, Thiladhunmathee Uthuruburi, Maldives

January 2008

Environmental Impact Assessment Note for H.A. Uligamu Harbor Construction Project

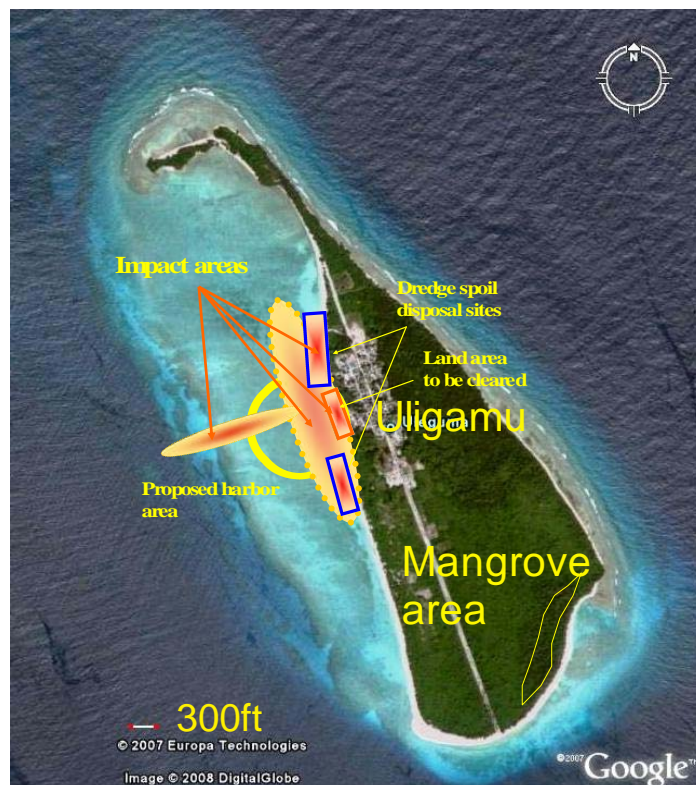
Figure 3: Project boundaries with possible direct and indirect impact areas. Dark red color represents direct impacts while the lighter color represents indirect impacts

The construction work will be carried mainly on the reef-flat of the island. The project site is rather un-altered. The dredging of the harbor will have a significant direct impact on the seabed and its associated flora and fauna. This direct impact area will be limited to the 300ft by 200ft harbor basin and 50ft by 1800ft entrance channel. The indirect impact area in relation to sedimentation will be felt all around the harbor area since the vast length of the entrance channel (see Figure 3).

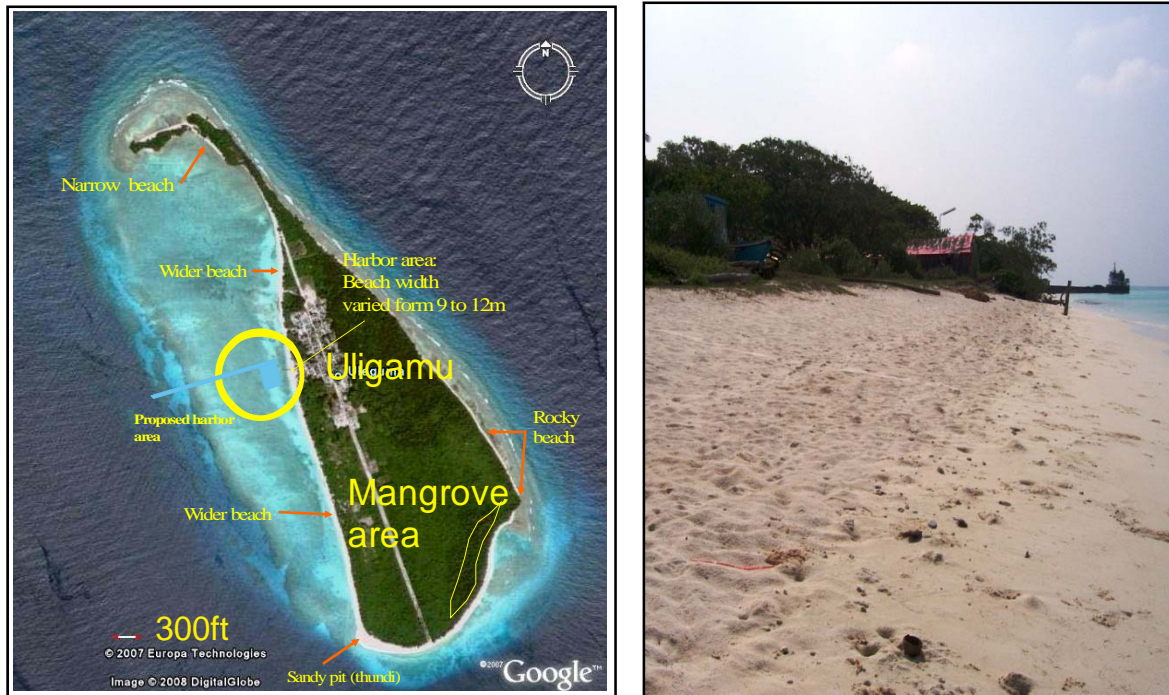
Figure 9: Beach widths of Uligamu (left). Wider beach was found at the southern side of harbor (right)

Beach is normally defined as the white sandy area between the vegetation line and the lowest astronomical tide. Width of the beach varies with the tidal fluctuations. The beach has a narrow width along much of the length of the north-east coast of Uligamu (see Figure 9). The west coast beach is relatively wider. A very large sand pit (*thundi*) was on the southern tip of the island.

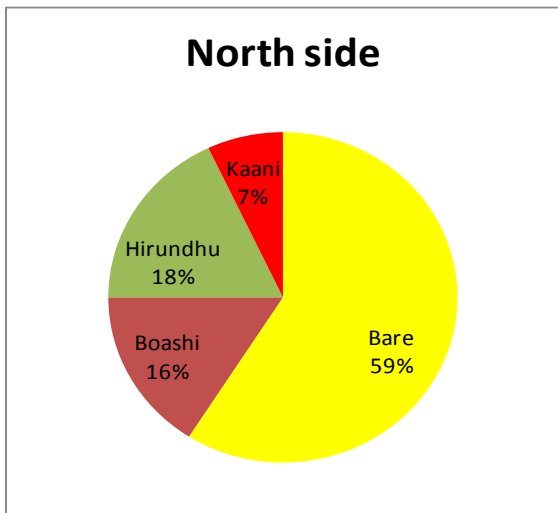
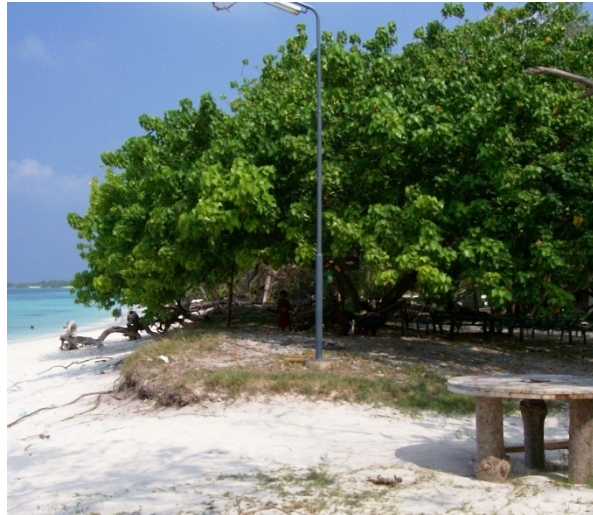
Figure 10: Coastal vegetation at northern side of the proposed harbor area (left), dominant vegetation was *hirundhu* at the site (right).

The results of the 2 transects (VT 1 and VT 2) carried out at the northern side of the harbour reveals that 18% of the beach vegetation cover was *hirundhu*. Other species encountered included *kaani* and *boashi*. About 60% of the surveyed area was observed to be bare since the *heylyhi* have been cleared off (see Figure 10).

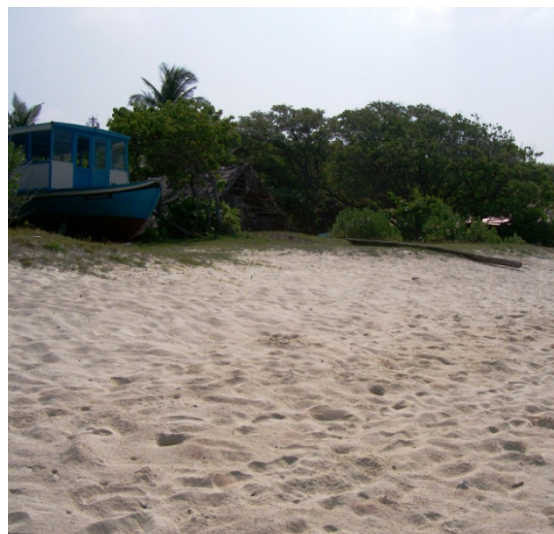
Figure 11: Coastal vegetation at southern side of the proposed harbor area (left), the area close to the jetty and boat hauling area has been cleared (right).

The vegetation cover at the southern side of the harbour (VT 3 and VT 4) shows that that 11% of the beach vegetation cover was *kaani* - the dominant. Other species encountered were *ruvaa*, *mirihi* and *magoo* (see Figure 11). About 80% was observed to be bare with no vegetation. This bare area corresponds existing jetty area and boat hauling area where the vegetation has been cleared.

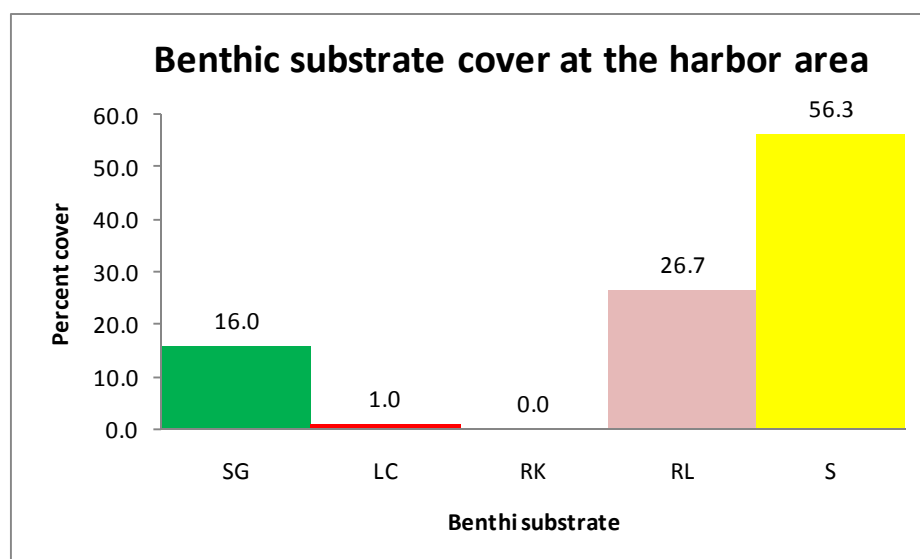
Figure 12: Percentage cover of benthic substrate present at the proposed harbor site's reef-flat. The dominant form of benthic cover is coral rubble. Massive forms of *Porites* spp. predominates the live benthic cover. Branching type corals namely *Acropora* spp. (staghorn), other massive types *Favites* spp., *Favia* sp. and encrusting types were also present. The benthic covers are given in percentages of the bottom area surveyed. SG = Seagrass, LC = live coral, RK = rock, RL = rubble, and S = sand.

The reef-flat around the proposed harbor area is not very poorly developed with about 1% live coral cover (see Figure 12). The bottom of the reef-flat was dominated by sand. Thinly grown seagrass were present at the area. The reef slope at this side forms a steep slope to the atoll basin. The reef condition here was better than the reef-flat in terms of coral cove, fish and other marine life.

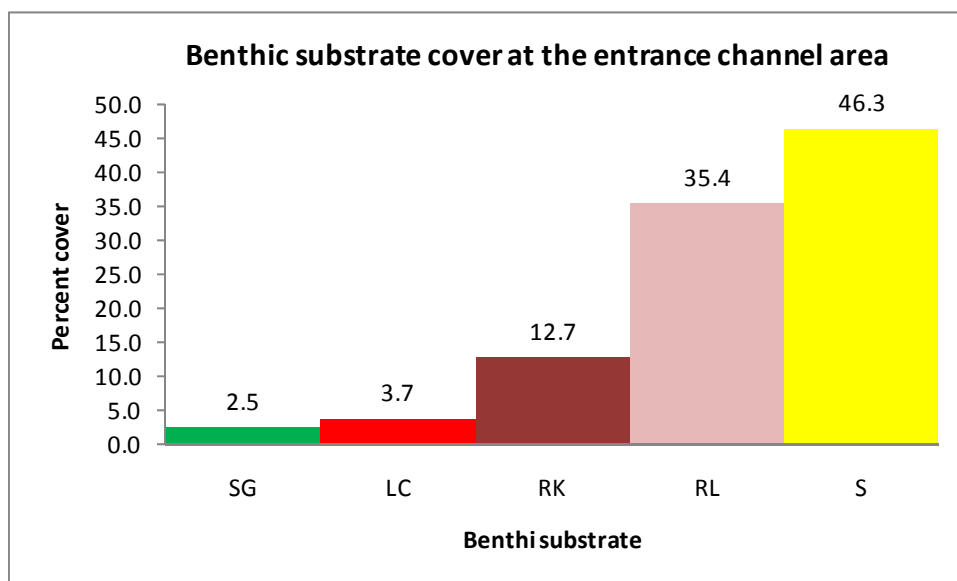
Figure 14: Percentage cover of benthic substrate at the proposed channel area. Codes have been explained in Figure 12.

The live coral cover was higher at the reef edge and near the mid of the entrance channel. Seagrass cover was lower here. Fine sand dominated here too (Figure 14).

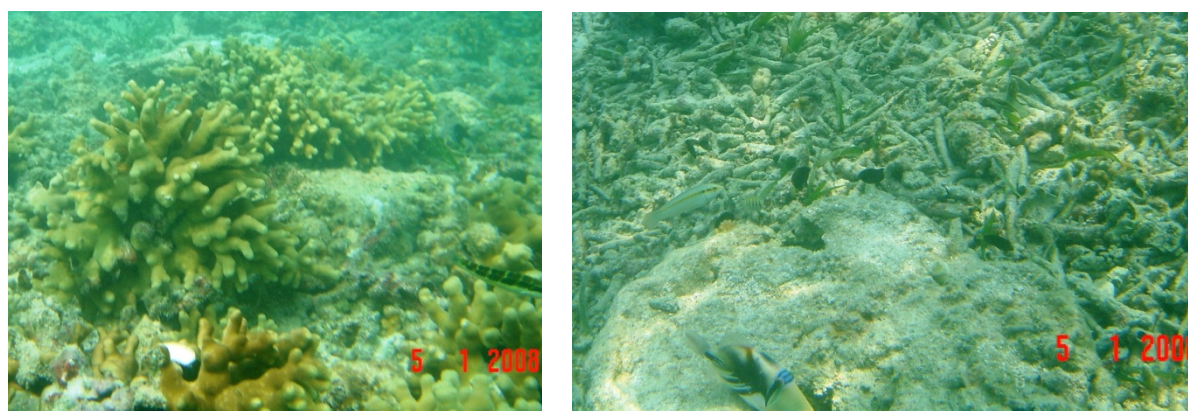
Figure 15: Benthic cover at entrance channel area. Branching Porites (left); Rock and rubble (right).

More hard substrate is seen here. The fish life is also richer here. The depth remained rather similar with 1 to 1.5m at MSL. The benthic substrate at the entrance channel area is presented below (Figure 15).
