# environmental impact assessment report

december, 2007

ga.funadhoo island for agricultural development  
north huvadhoo atoll  
republic of maldives

E-CAD ASSOCIATES PVT LTD  
TOTAL + BUILDING + SOLUTIONS

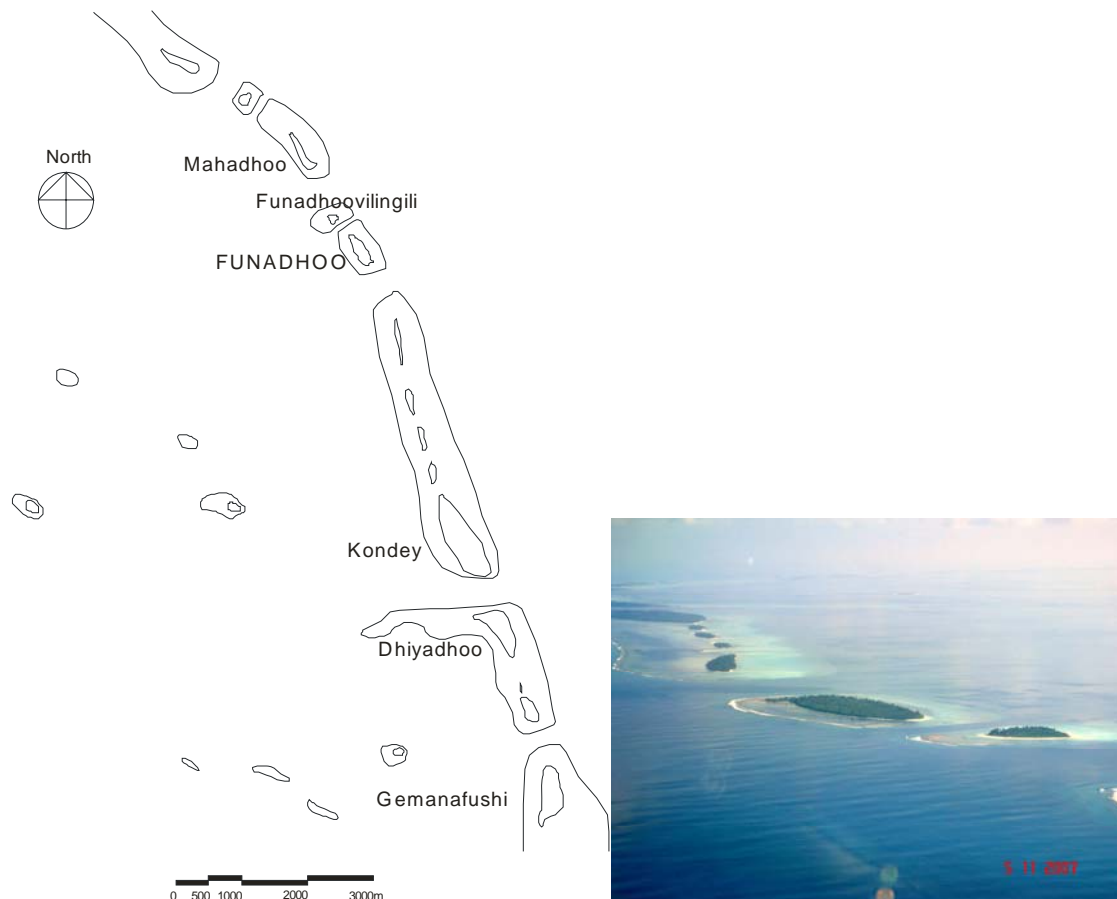
Figure 1 location of the project

The closest island to the project location is a very small uninhabited island named Funadhoo vilingili less than 1km north. The closest inhabited islands to the project location are Kondey (population 383) 7km, Dhiyadhoo (population 229) 9km and Gemanafushi (population 1110) 13km south of the project location and Dhaandhoo (population 1563) 9km and Nilandhoo (population 847) 11km north of the project location. The closest resort island which is under development is Hadaha 10km southwest of the project location.

The project location, Funadhoo island is located on eastern rim of Huvadho Atoll within a separate coral reef system (within a separate Falhu). Any part of Funadhoo island or reef is not included in the list of sites requiring special protection.

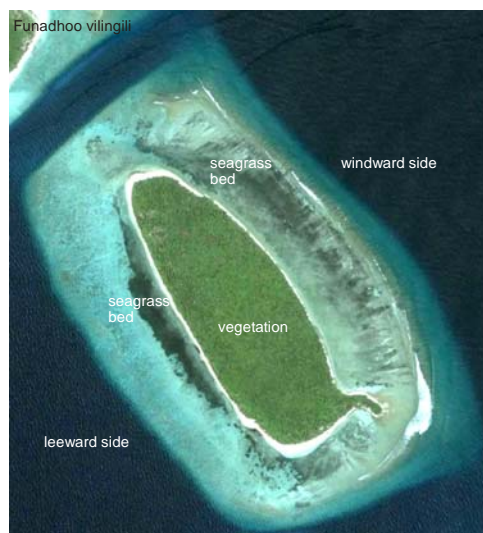
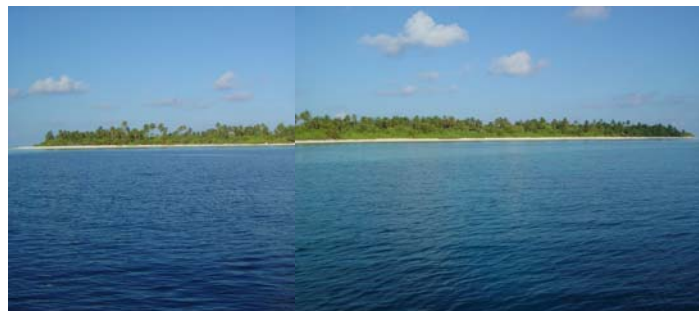
Plate 1 aerial photo (left) and side elevation (right)

The vegetated area of the island is approximately 22 hectares (200,000m<sup>2</sup>). The island is elongated oval shape and found to be stable in terms of erosion and accretion. The total area of coral reef system is approximately 106 hectares. The shallow lagoon area surrounding the island is approximately 27 hectares.

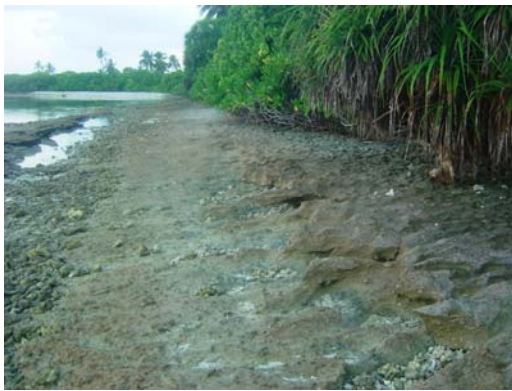
Plate 2 eastern side coastal vegetation

The coastal vegetation is thick and intact and consisted of mostly sea lettuce on eastern side and sea lettuce and screw pine on eastern side. The inside vegetation consists of mostly Sea hibiscus, screw pine and coconut palms in southern areas of the island. There are approximately 500 coconut palms in the island. The vegetation of the island can be said not matured as there are no large trees found except a few including Barringtonia. Less than 1% of the island is covered with mature tree. Although the vegetation is young the entire island is cover by vegetation. Tsunami impact to the island was found to be minimal as the shallow lagoon areas of the island are not extensive and the island has higher than average elevation.

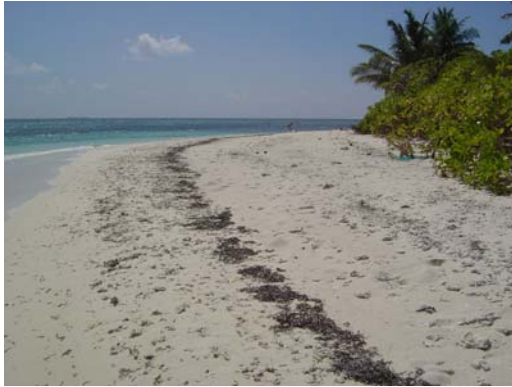
Plate 4 western side beach

A considerably large beach is found on entire western side of the island whereas, the eastern side consisted of mostly beach rock, boulders, pebbles and rubble. Approximately 50% of the perimeter of the island consisted of sandy beach. The beach on northwestern side is the most dynamic beach area. Seasonal beach erosion is found around the southwestern side of the island.

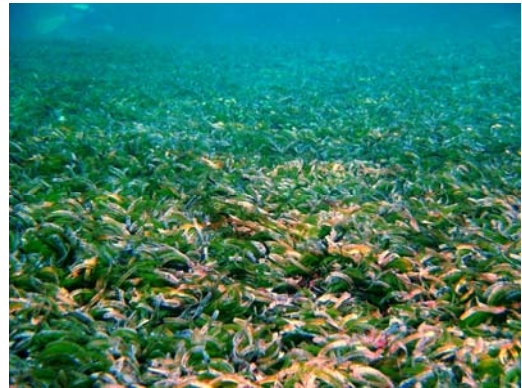
Plate 5 western side seagrass bed

Seagrass beds are found in the lagoon on both western and eastern sides of the island. These seagrass beds cover approximately 5 hectares (18%) of the lagoon area around the island. The growth of seagrass bed in the lagoon western side of the island is more and at a better status compared to eastern side. However, seagrass growing around the island can be said as poor in general.

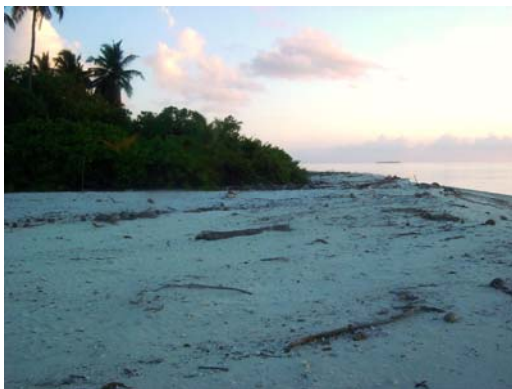
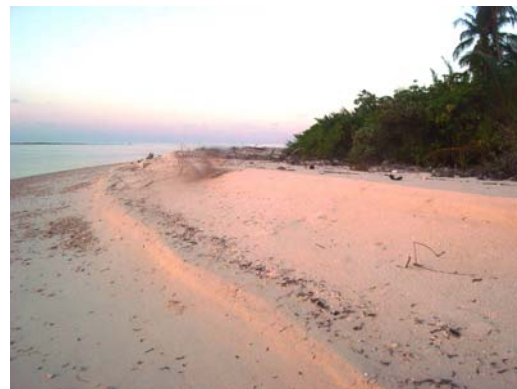
Plate 6 Beach Section A

Section A is the northern sand-spit of the island and consisted of fine sediments forming a significantly large beach area. The northern sand-spit has an area of approximately 1.7 hectares. This sand-spit swings from northwestern side to northeastern side in southwest

monsoon and back to northwestern side in northeast monsoon. The observations showed that beach sediment in this area is confined within section A as observed in many other similar islands. There is no permanent beach erosion in this section of the beach.

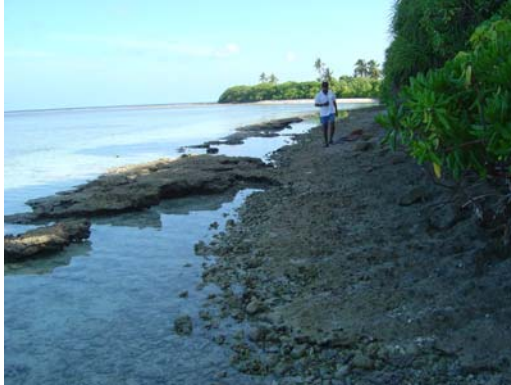
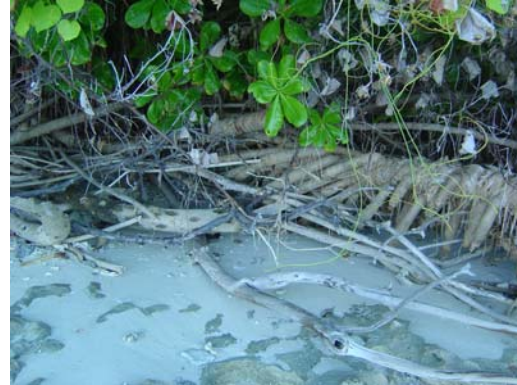
Plate 7 Beach Section B

Section B is the eastern side of the island, which is the windward side. This section of the beach consisted of mostly beach rock especially the mid area as seen in the picture above left. The northern areas of section B consisted of some sandy areas with the sand spilling over from the section A during southwest monsoon. The southern areas of section B consisted of mostly pebble and boulders and rubble, pebble being most dominant and rubble being least but significant amounts. Due to the nature of larger size beach materials, dynamics of beach materials is less and occurs during stormy conditions of the monsoon system which occurs annually. Serious beach erosion was found in southern areas of section B as seen in the picture above right.

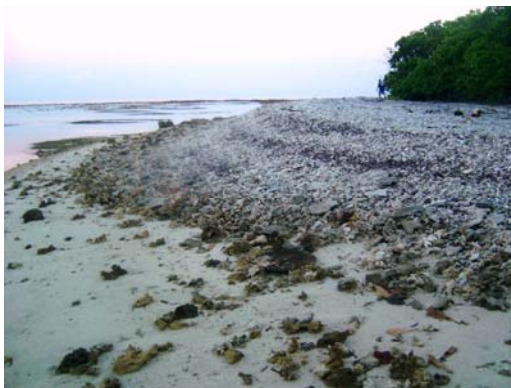
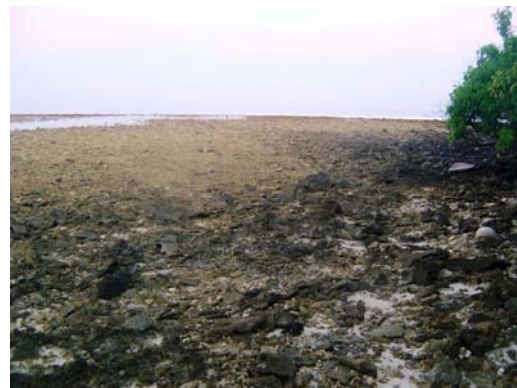
Plate 8 Beach Section C

Section C is the southeastern side of the island where a narrow extension of the island is formed. This section's beach materials are mostly rubble and some sandy areas at the base of the rubble mount as seen in the picture above left. Central area close to the island of this section consisted of rubble pile of size approximately half a hectare. This area was found to be a

collection point for rubble. Further south of this section consisted of an extensive area of cobble and rubble which get exposed during the low tides as seen in the picture above right. Dynamics of beach material in this section is also observed to be less frequent than in western areas of the island beach. However, serious beach erosion was found in northern areas of section C.

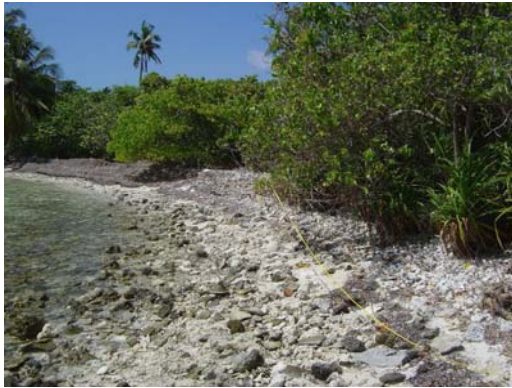
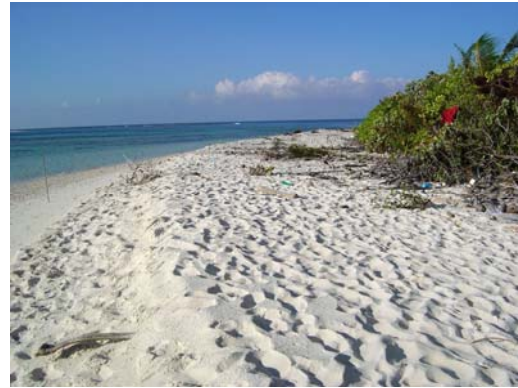
Plate 9 Beach Section D

Section D is the southern side of the island where high energy of dissipating waves is found. Beach materials in this section of the beach consisted of mostly pebble and rubble and some sand as seen in the picture above left. Western side of this section of the beach is the southern sand-spit of the island where the beach consisted of fine sand as seen in the picture above right. This sand-spit is a very dynamic beach area where the beach sand moves from west to east during southwest monsoon and the opposite direction during northeast monsoon. Serious beach erosion is found in northwestern and southeastern area of this section of the beach.

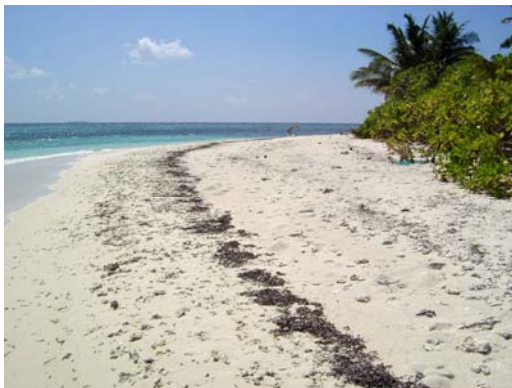
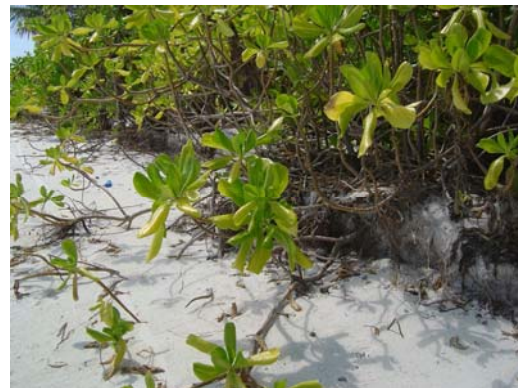
Plate 10 Beach Section E

Section E is the central area of the beach in western side of the island where the most stable sandy beach is found as seen in the picture above left. The beach in this section of the island is very long and narrow having a length and a width of approximately 200m and 16m respectively.

Slight seasonal beach erosion is found in southern areas of this section of the beach as seen in the picture above right.

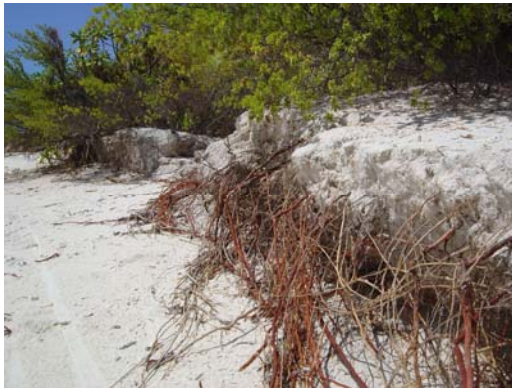
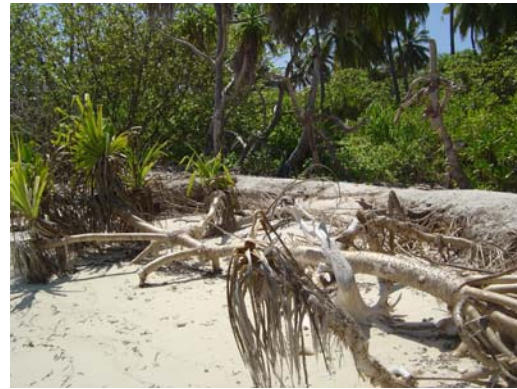
Plate 11 seasonal beach erosion in SWP

Seasonal beach erosion was observed to be severe and serious in the western side of the island, especially in southern areas on western and northern areas in western side of the island. Permanent and serious beach erosion is found in southern areas in eastern side of the island. Serious seasonal beach erosion in southwestern side of the island has caused loss of some coastal vegetation including screw pines and a few coconut palms. Permanent beach erosion in southern side of the island has caused loss of larger trees of the coastal vegetation including screw pines and nit pitcha. Permanent beach erosion in southeastern side of the island is causing loss of coconut palms and other large trees in addition busy vegetation consisting of screw pines, sea lettuce and ironwood.

Serious seasonal beach erosion in SW side of the island is causing loss of coastal vegetation.

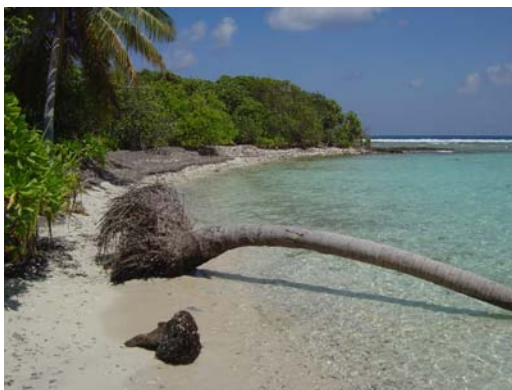
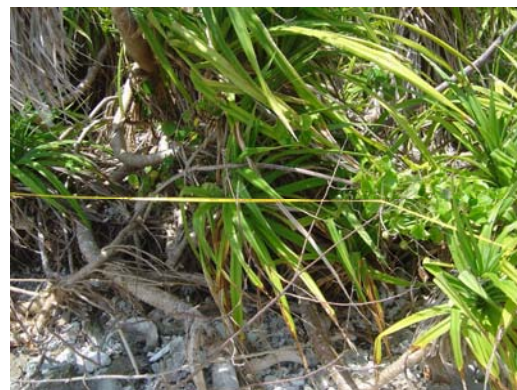
Plate 12 seasonal beach erosion in S. of the island

Serious seasonal beach erosion in southern side of the island is causing loss of coastal vegetation consisting of coconut palms other large trees in addition to screw pines.

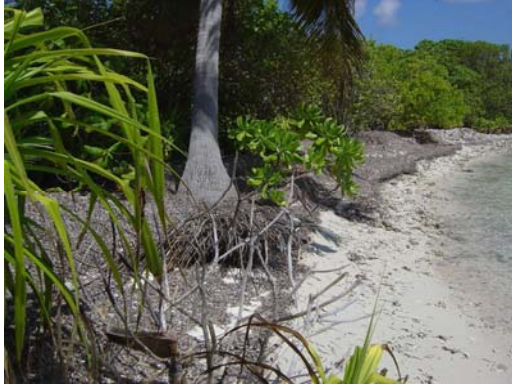
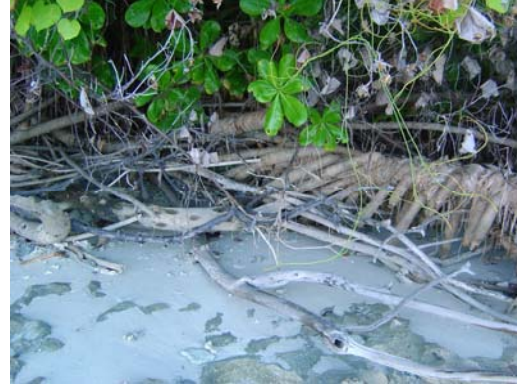
Plate 13 permanent beach erosion in S. side

Permanent beach erosion in southeastern side is causing loss of coastal vegetation including coconut palms, screw pines, sea lettuce and risking loss of other larger coastal vegetation including barrintonia and sea hibiscus trees.

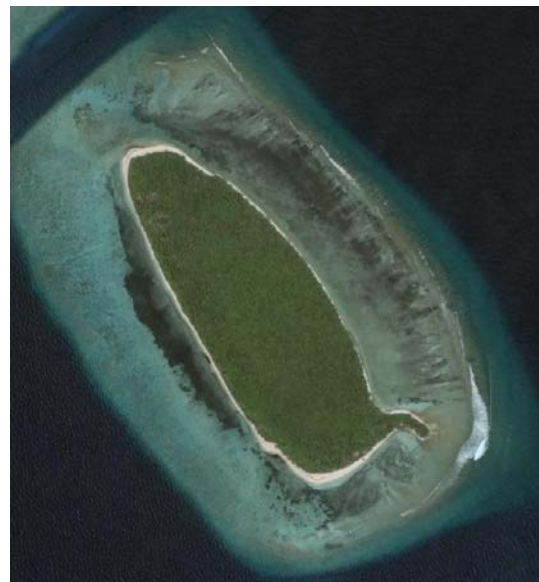
Plate 14 aerial photos of Ga. Funadhoo – 1969 (left) 2005 (right)

Previous beach erosion observed by comparing the aerial photos taken in 1969 (below left) and satellite photos below right) show that there has been significant beach erosion within the last 35 years especially in southern and southeastern areas of the island. The photos below show that a large area from south of the island has been lost due to the erosion of beach and the coastal vegetation. Field observation and analysis of historical aerial photos show that the size of the beach around the island has been significantly reduced due to beach erosion.

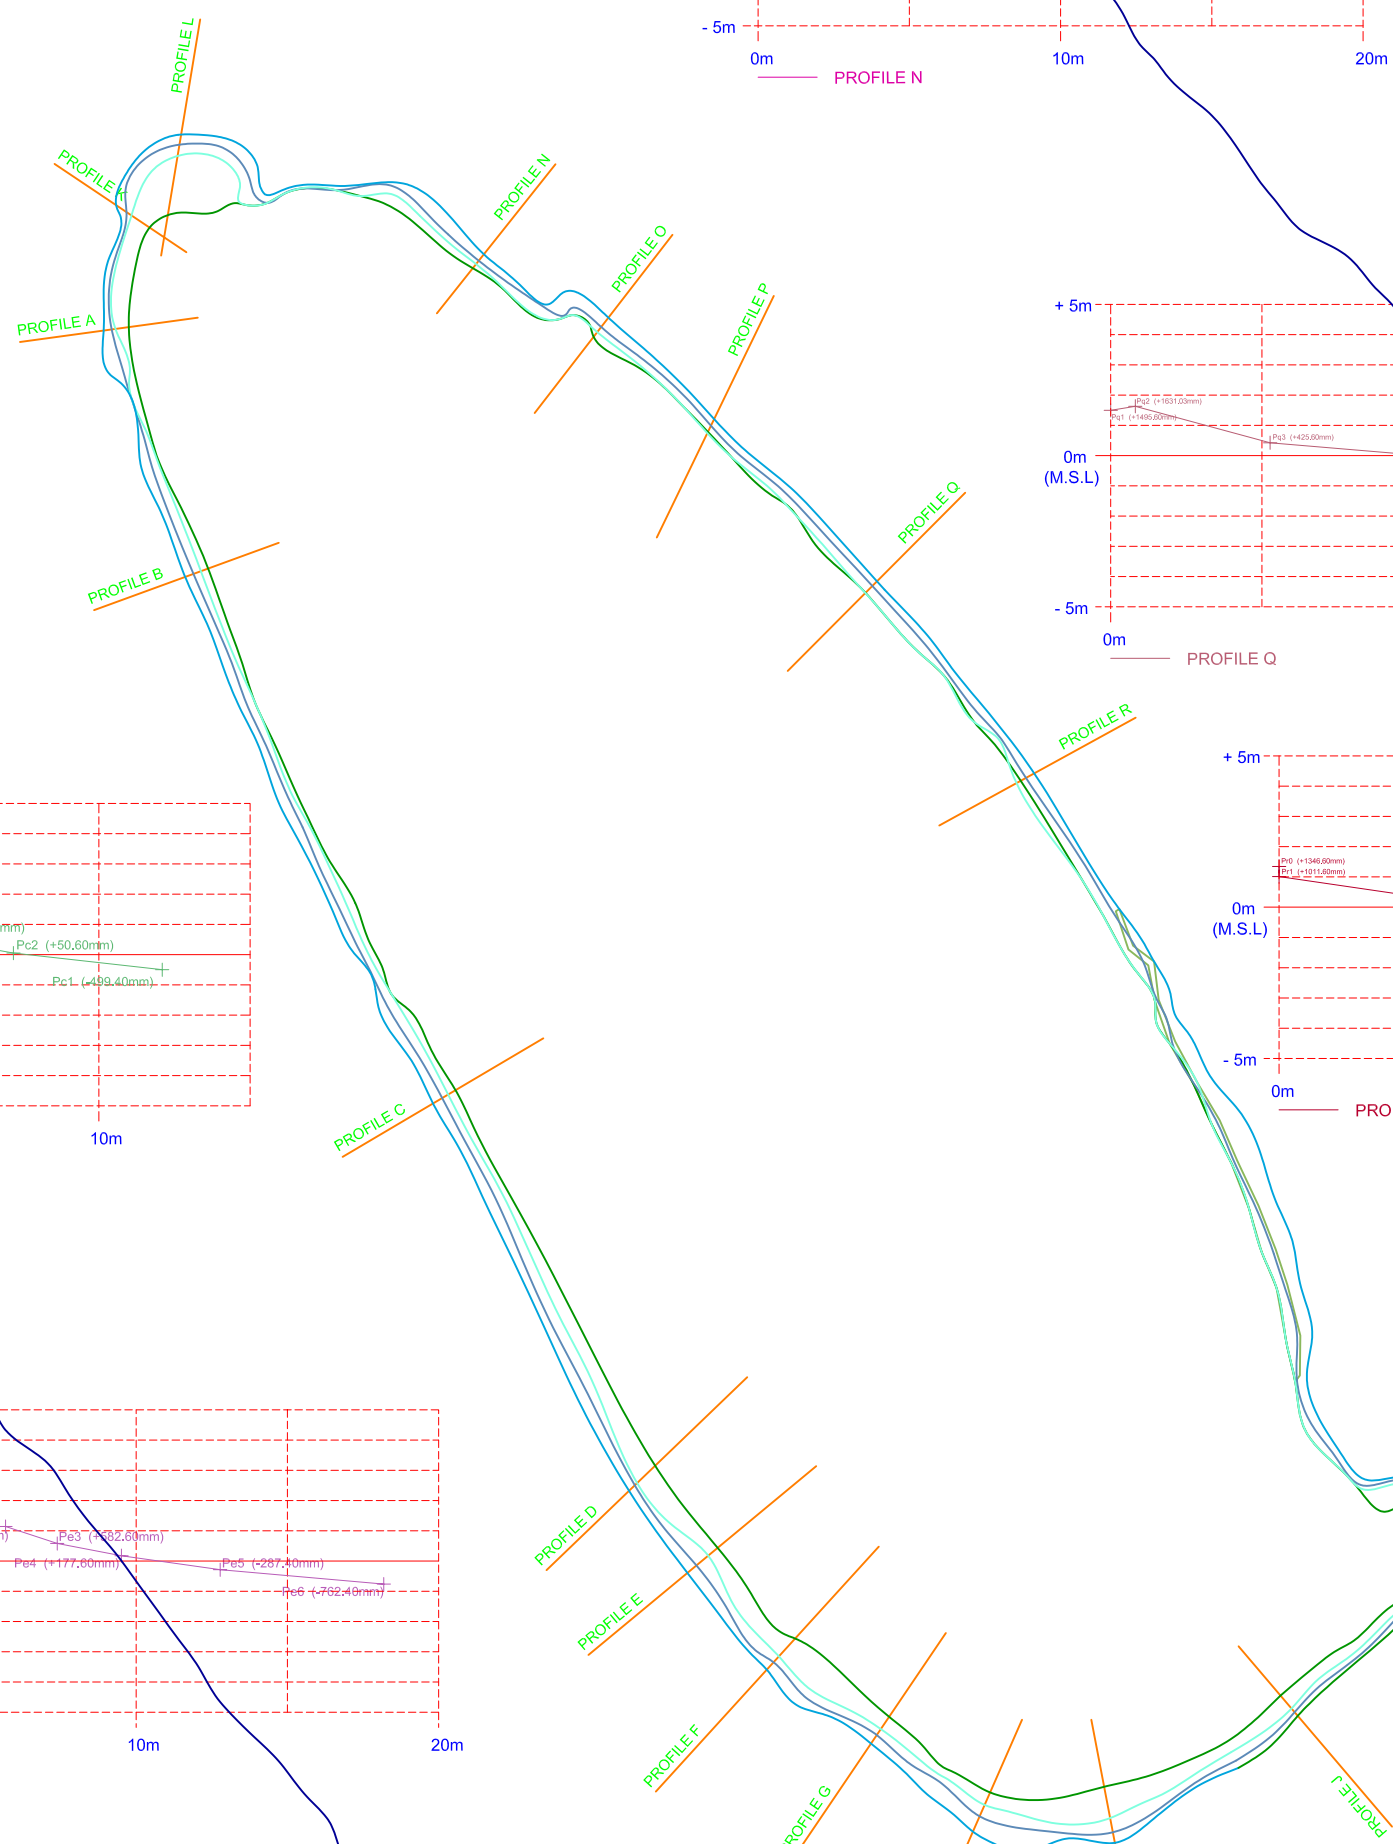
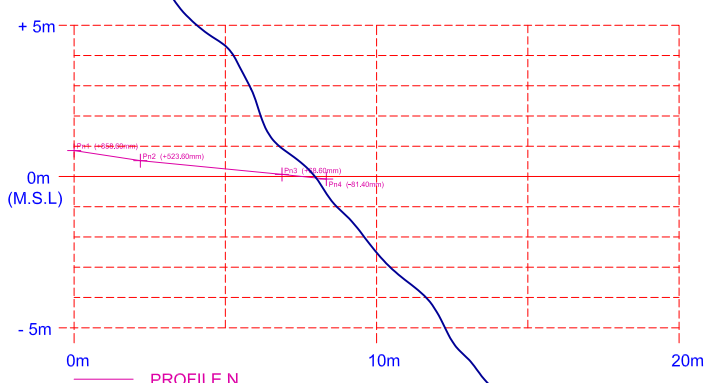
**Figure 4**  
**BEACH PROFILE MAP**  
N.T.S

Funadhoo is an elongated on eastern rim of the atoll, therefore eastern side of the island is very exposed to the wind generated waves. Western side of the island is also very exposed as the atoll is one of the largest atolls. Due north-south orientation and elongated shape of the island, beach dynamics around the island is confined to mostly north and south of the island where sand accumulation is also found. Sand from northwestern area of the island moves north and northwest during SW monsoon and likewise in the southern areas of the island the sand moves from southwestern area to southeastern areas in SW monsoon. This movement of the sand reverses during NE monsoon and a uniform pattern of beach dynamics is found in northern and southern ends of the island. Beach profiles were taken in various locations marked as shown in figure x. to assess the beach dynamics around the island on a long-term basis.

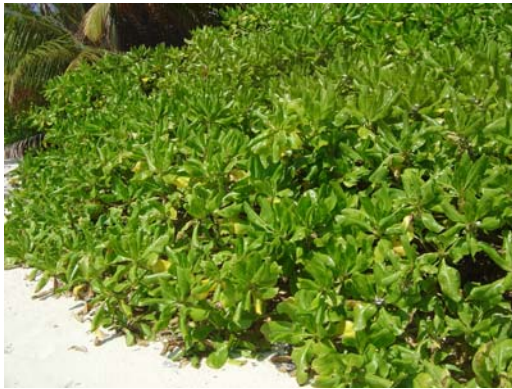
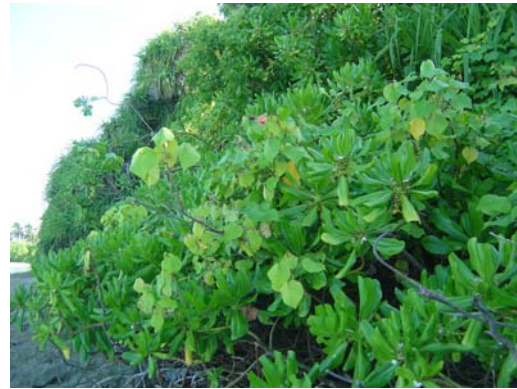
Plate 15 eastern side coastal vegetation

Eastern side coastal vegetation (left) consisted of more Sea lettuce and the eastern side coastal vegetation (right) consisted of more varies species however, dominated by Sea lettuce.

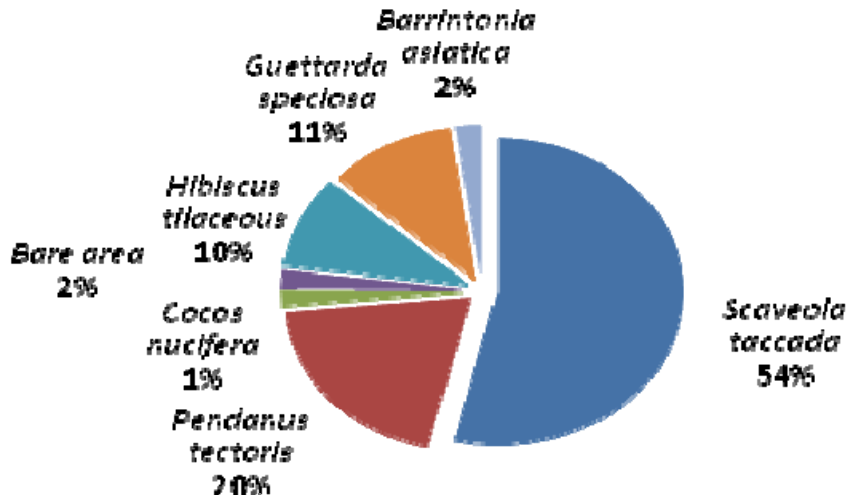
Figure 5 eastern side coastal vegetation cover

The transects taken at northern side of the island showed that the coastal vegetation is dominated by Sea lettuce (*Scaveola taccada*) consisting of 54%. Screw pine (*Pendanus tectoris*) is the next most dominant species found in this area consisting of 20% of the coastal vegetation. Nit pitcha (*Guettarda speciosa*) and Sea hibiscus (*Hibiscus tilaceous*) each species accounted about 10% of the coastal vegetation on eastern side of the island. Coconut palms accounted 1% and Barrintonia accounted 2% of the coastal vegetation by area. 2% of the coastal perimeter were also found to be bare without any bush or plants. Therefore, approximately 98% of the island's coastal vegetation belt is covered with bushes and plants.

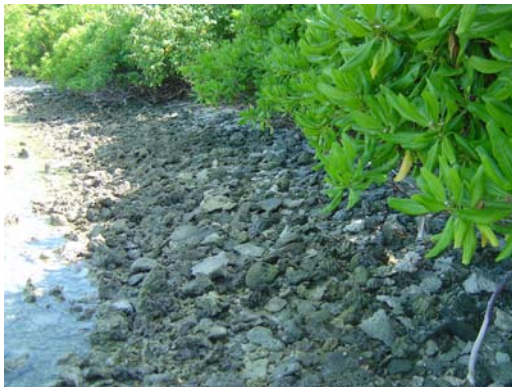
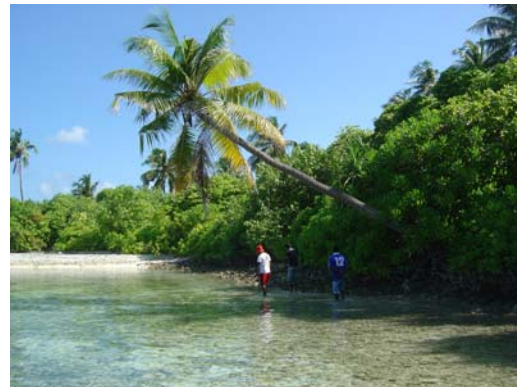
Plate 16 western side coastal vegetation

Western side coastal vegetation is dominated by sea lettuce however, has a more varied species composition in comparison with western side.

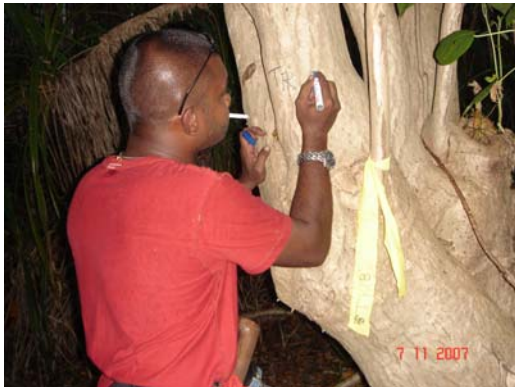
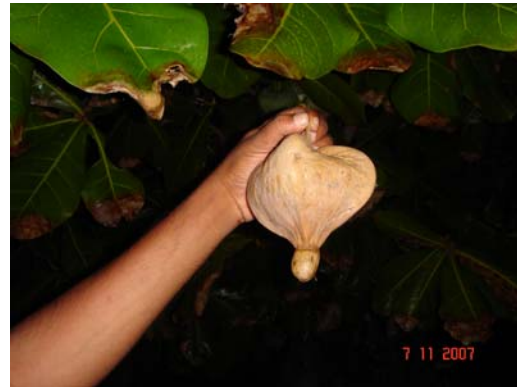
Plate 18 inner vegetation

Locating and marking large trees

Inner vegetation – Sea putat (*Barrintonia*)

Inner vegetation survey included larger trees that significant in terms of species, canopy size and age. Significant large trees were located using total station surveying equipment and shown in figure x. Significant large tree inside the island included Alexander laurel wood tree (*Calophyllum inophyllum*), Nit pitcha (*Guettarda speciosa*), Sea putat (*Barrintonia asiatica*), Tree heliotrope (*Tournefortia argentea*) and most significantly Coconut palms (*Cocos nucifera*)

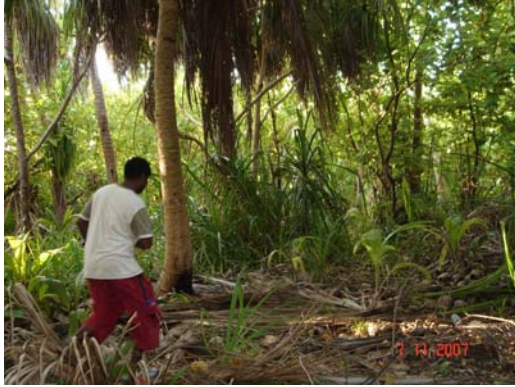
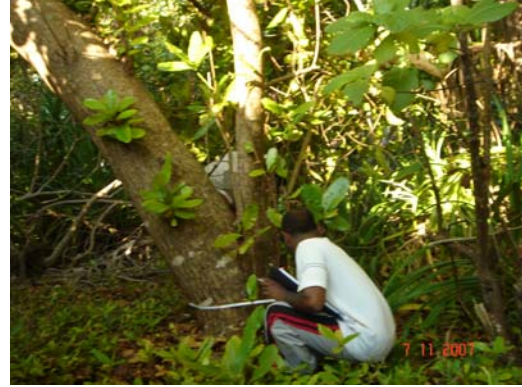
Plate 19 coconut palms inside the island (left) beauty leaf (right)

Significant inner vegetation – Coconut palms

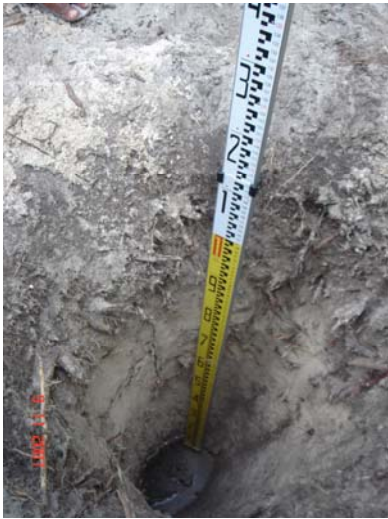
Profile 1

Funadhoo is a relatively large and matured island in terms of geology and vegetation. The soil profiles taken from various locations of the island showed that the contents of the soil had a high percentage of humus and a relatively thick layer of dark soil below the humus layer. The following photos show the soil profiles taken from four locations inside and on periphery of the island

Plate 20 soil profiles taken at various locations in central and periphery of the island

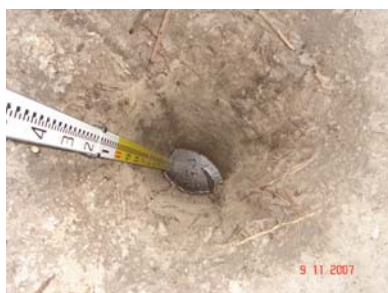
Plate 21 depth of groundwater

As the island is uninhabited the groundwater of the island has not been used for any purpose therefore at natural status. The depth of the groundwater lens is 1.5m during high tide as shown in their picture below The high salinity of the samples is due to the samples taken from periphery of the island rather than in central area of the island. Central area of the island was not accessible to take water samples due to the thick vegetation in the central area of the island.

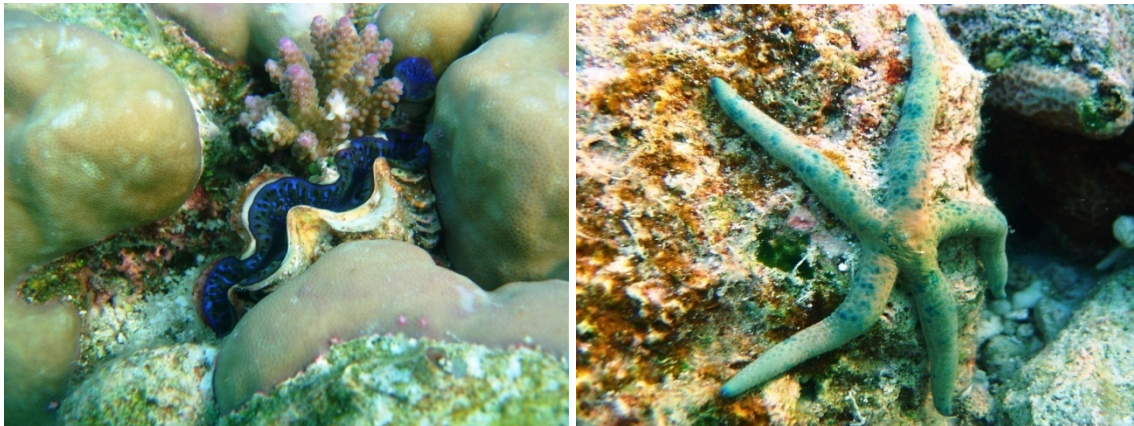
Plate 28 invertebrates in site 1, 3 and 4

Only a few species of mollusks and echinoderms were encountered in these 3 sites (see Plate 28). This may be due to the nocturnal nature of mollusks and echinoderms. What was observed during the timed swims is presented in the table below.

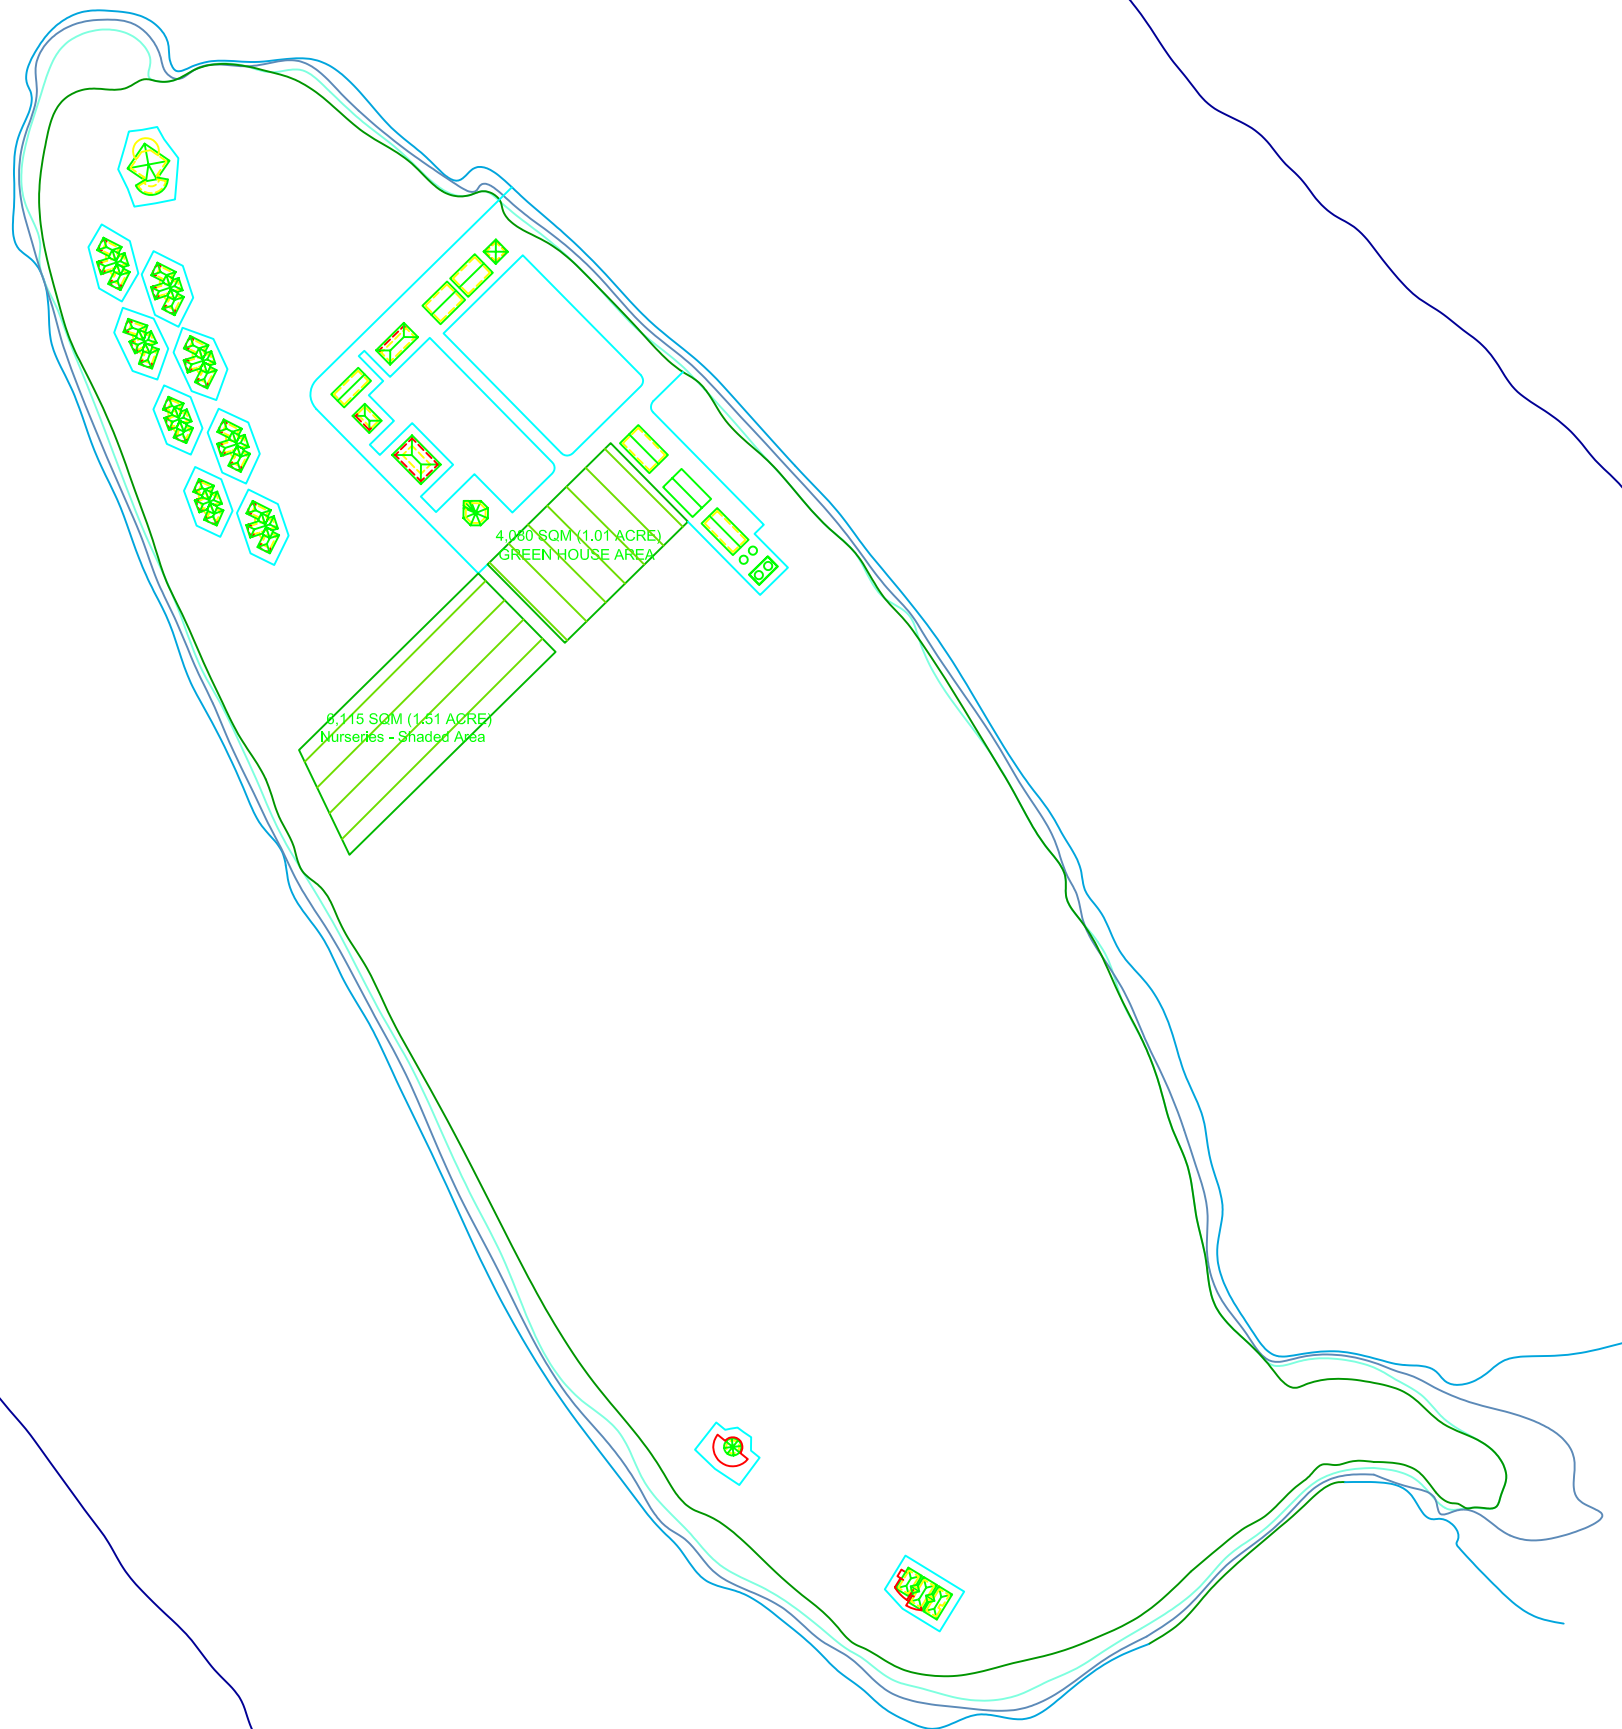
TOTAL VEGETATION CLEARING AREA (BUILDINGS): 15,999.81 SQM  
 TOTAL VEGETATION CLEARING AREA (AGRICULTURAL): 10,195 SQM  
 TOTAL VEGETATION CLEARING AREA : 26,194.81 SQM  
 CLEARED AREA ( % ) : 12.15 %
