ENVIRONMENTAL IMPACT ASSESSMENT
For Development of a
Slipway at Raa. Vandhoo

By Miruza Mohamed
2011

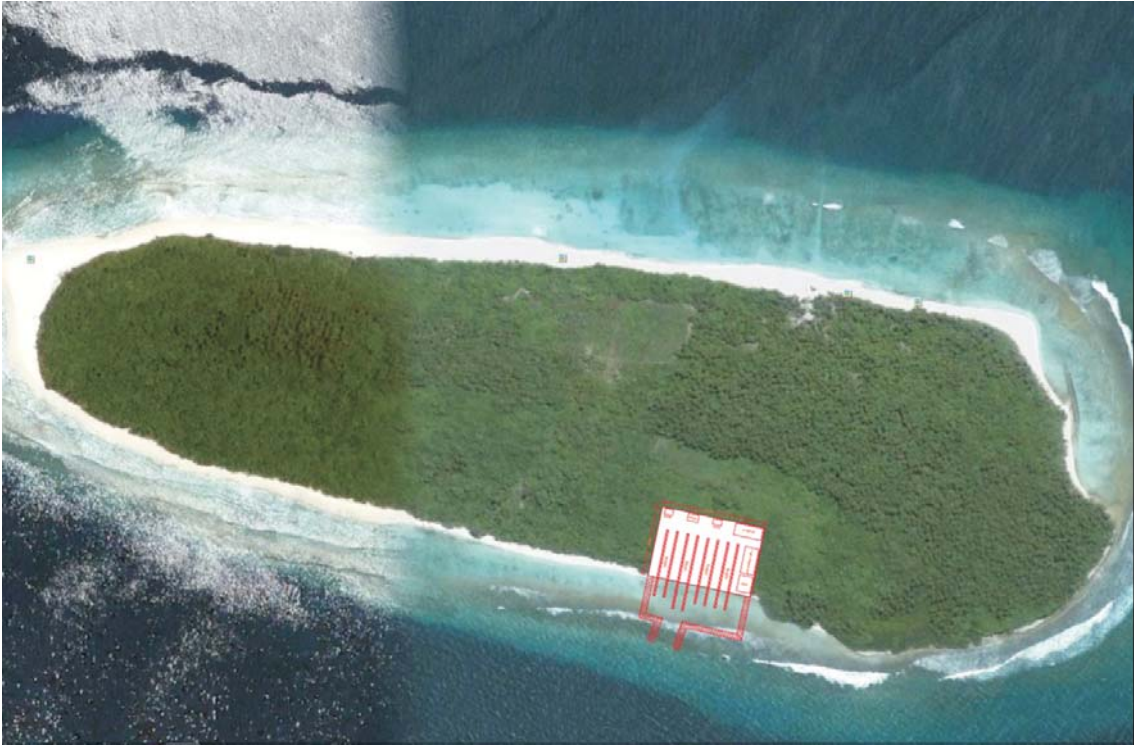
Figure 1: Location of the Slipway.

The proposed development project is located in the island of Vandhoo in North Maalhosmadulu (Raa) Atoll at 05° 32' 07" N and 73° 02' 30" E. The closest islands to the project location are inhabited islands of Innamaadhoo approximately 1.5km and Rasmaadhoo about 3km north, and Iguraidhoo approximately 4.5km south of Vandhoo. The allocated area is on the southeastern side of the island Figure 1Error! Reference source not found..

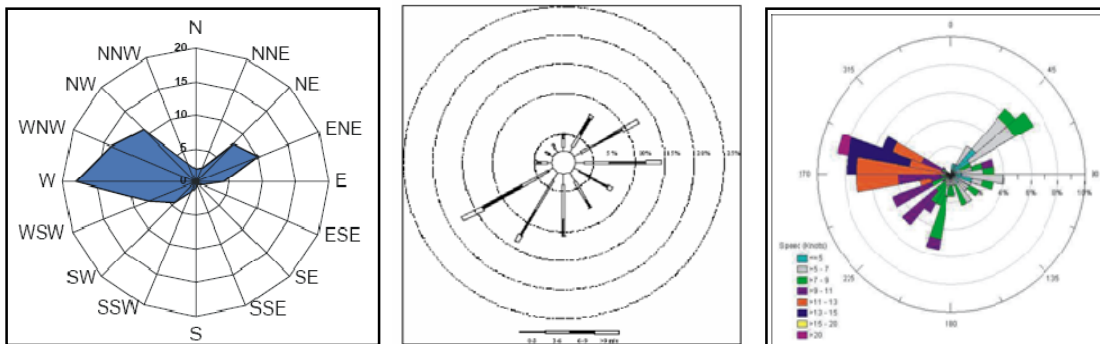
In Figure 4 the right-hand side diagram is general wind rose for the Maldives (Environment 2005), central diagram is seasonally adjusted wind rose for B. Dharavandhoo (G.H Consultants 2006) and left is monthly average wind for HDh. Hanimaadhoo (DoM).

Figure 4: Wind characteristics

General wind characteristics for the Maldives and H.Dh. Hanimaadhoo shows that frequency of wind coming directly from the south is relatively less and the speed is low too. This suggests that the location of the Vandhoo slipway at the southern side of the island is appropriate since the slipway and the channel will be calmer most part of the year.

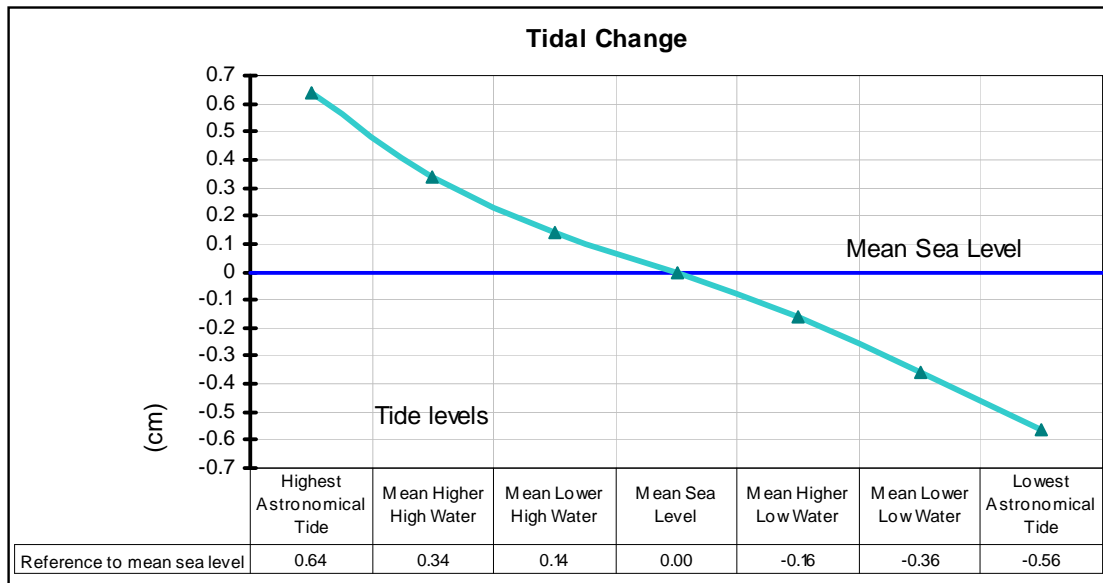
Maldives experiences mixed semi-diurnal and diurnal tides with a strong diurnal inequality. Tide records at K. Hulhule, and HDh. Hanimaadhoo which can be applied for estimating tide levels at Vandhoo with reasonable accuracy. A tidal analysis (see Figure 5) shows that, the maximum tidal range to be about 1.20m. The highest astronomical tide level is +0.64m (Mean Sea Level) and the lowest astronomical tide level is -0.56m (MSL).

Figure 5: Astronomical tidal variation in Maldives, (Environment Maldives - SoE Maldives 2002)

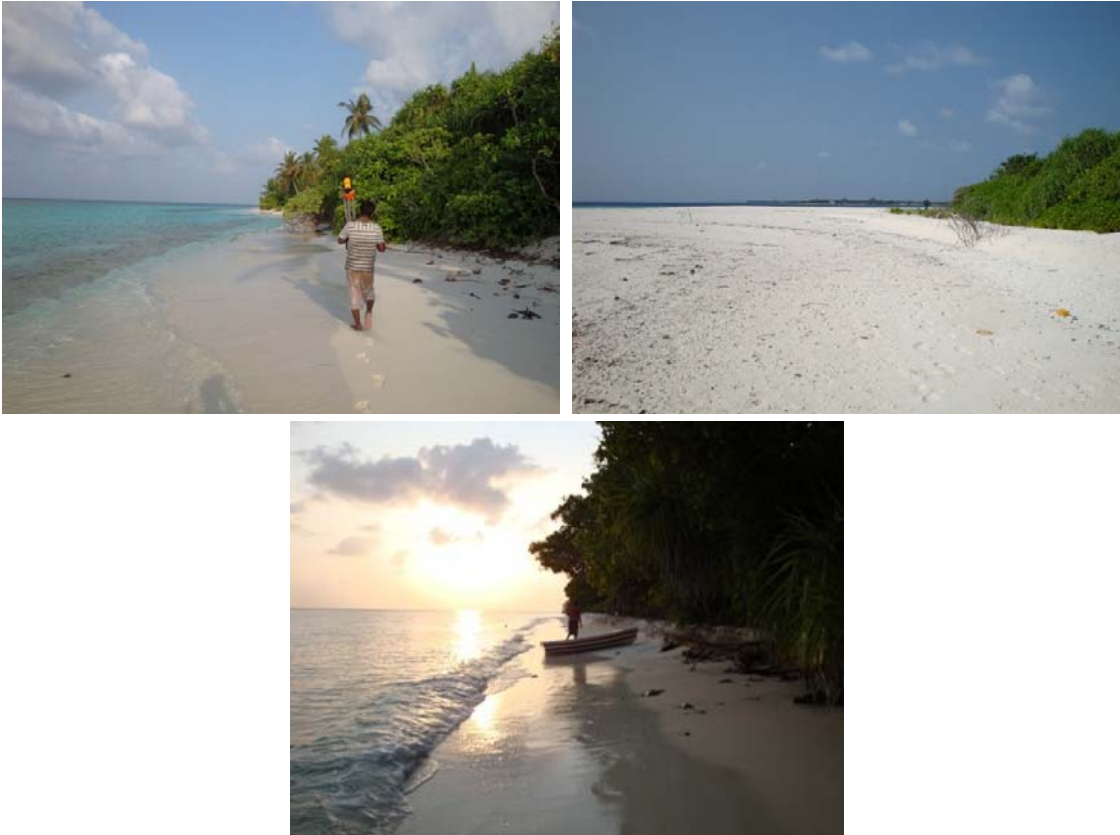
The beach area on the northern side of the island is larger compared to that on the southern side. Figure 7 shows a comparison of the beach area found on the northern and southern part of the island.

Figure 7: a) and b) showing the northern side beaches which are wider compared to the beach area found on the southern side.

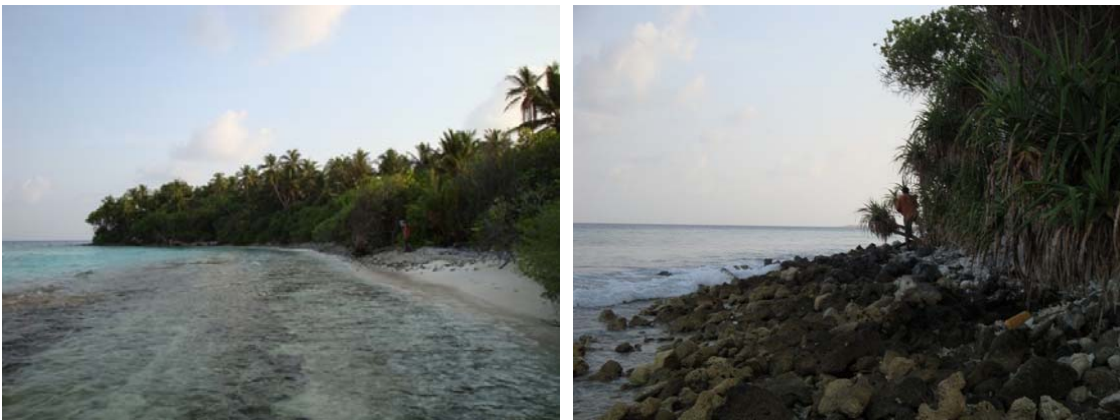
Figure 8: a) beach around the project site and b) beach on the eastern side

Figure 8 shows the beach near the proposed project site and the beach on the eastern side. There is no significant beach area found on the project development site and the foreshore is dominated by beach rock. Due to wave action and erosion, there is beach found on the eastern side while it is dominated by rubbles. A large sand pit (*thundi*) was found on the

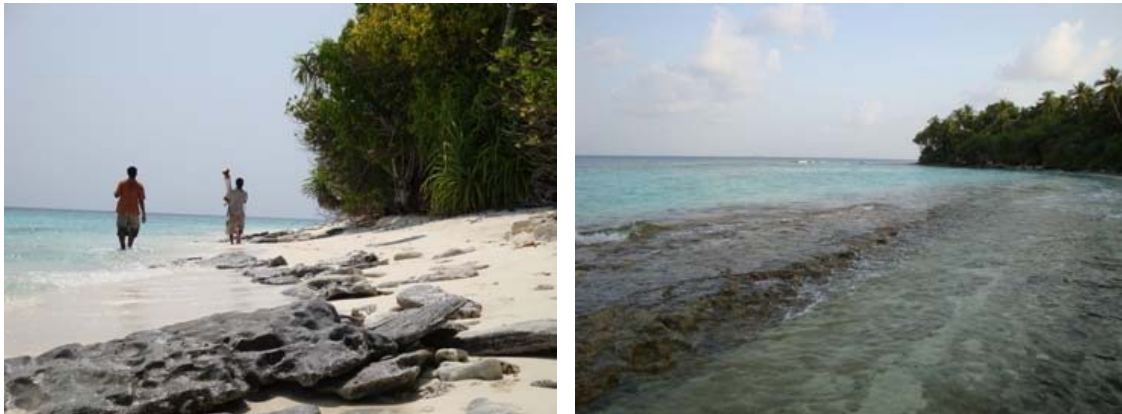
Southern side of the island consisted exposed thin stretches of beach rock. This stretch of beach rock is approximately 100m long and 3m wide in average. The beach rock on south eastern side is approximately 100m long and 2m wide and less compacted than the beach rock on south eastern side. The rocky nature of the beach on the southern side is depicted in Figure 9.

Figure 9: Beach rock formations around the island

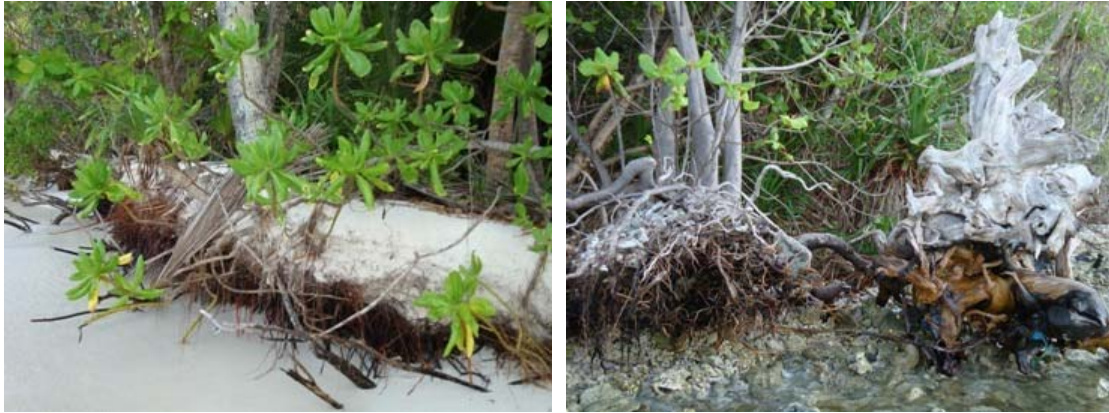
In general continuous natural beach erosion of Vandhoo is considered slow however, the field surveys suggest that erosion in eastern side of the island is a serious issue.

Figure 10: Beach erosion on eastern side of the island

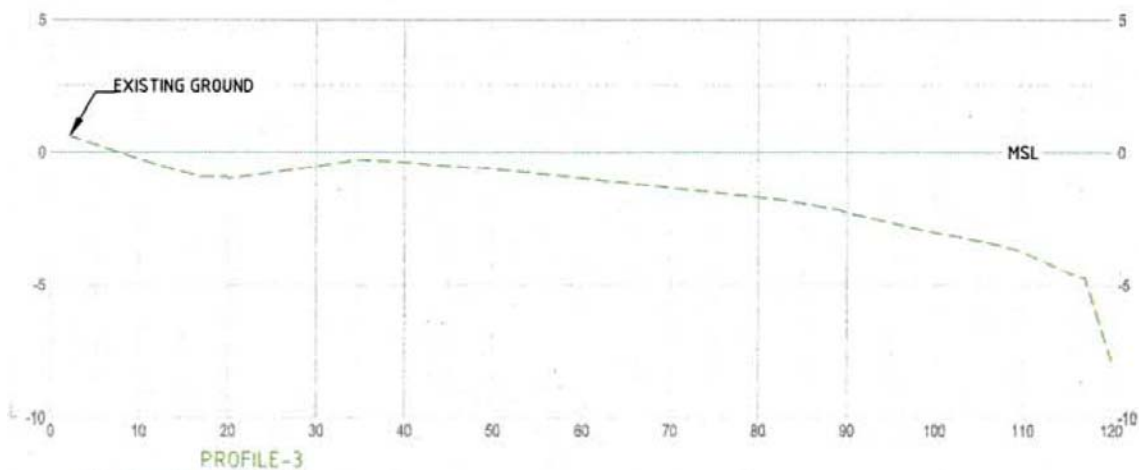
Figure 11 and Figure 12 shows the beach profiles obtained on the western side of the slip way and that obtained on the north eastern side of the island respectively. The profiles too indicate that the beach area near the project location is virtually non-existent and a wider beach is seen on the north eastern side of the island. Rest of the beach profiles are found in Appendix F.

Figure 11: Beach profile 3 obtained on the western side of the slipway.

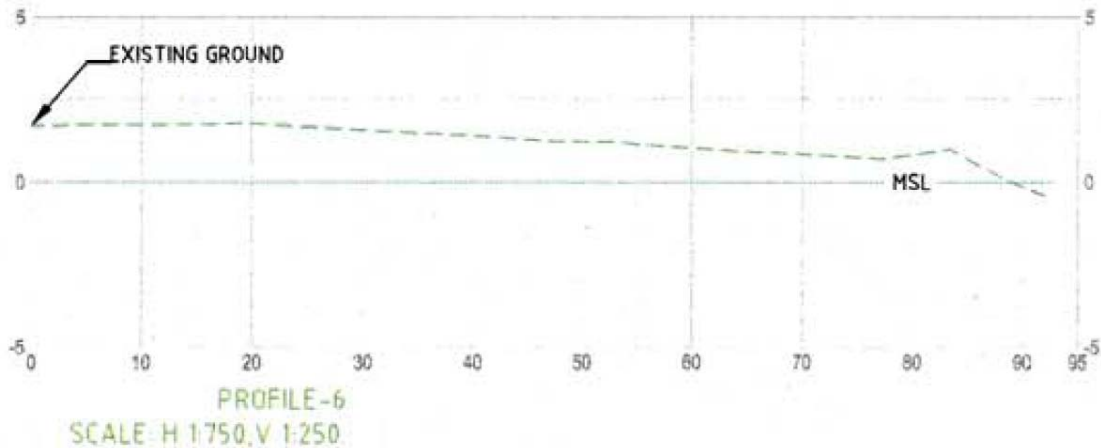
Figure 12: Beach profile 6 obtained on the north eastern corner of the island.

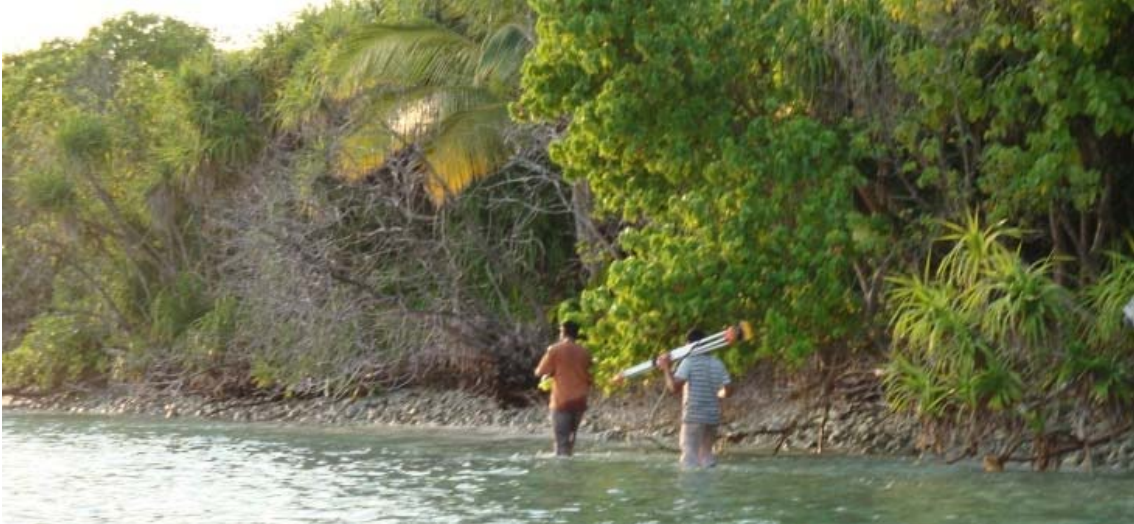
Figure 13: Coastal vegetation at the slipway area

Vegetation of the island can be categorized into two different main types; they are the coastal or the peripheral vegetation and the inner vegetation or the vegetation inside the island. The vegetation inside the island can be divided into thickly vegetated area at the central portions of the island, and sparse vegetation in other areas. Coastal vegetation is a belt of vegetation around the island that consists of more salt tolerant and bushy plants that are more adapted to coastal environment and plays an important role in protecting the island from beach and soil erosion. The inside vegetation consisted of larger and older trees that are less tolerant to salty water. The non-vegetated area is approximately 4.7 hectares which is 4% of the land area. The total vegetated area of the island is approximately 30 hectares. Figure 13 shows vegetation found near the existing jetty which is the proposed slipway area.

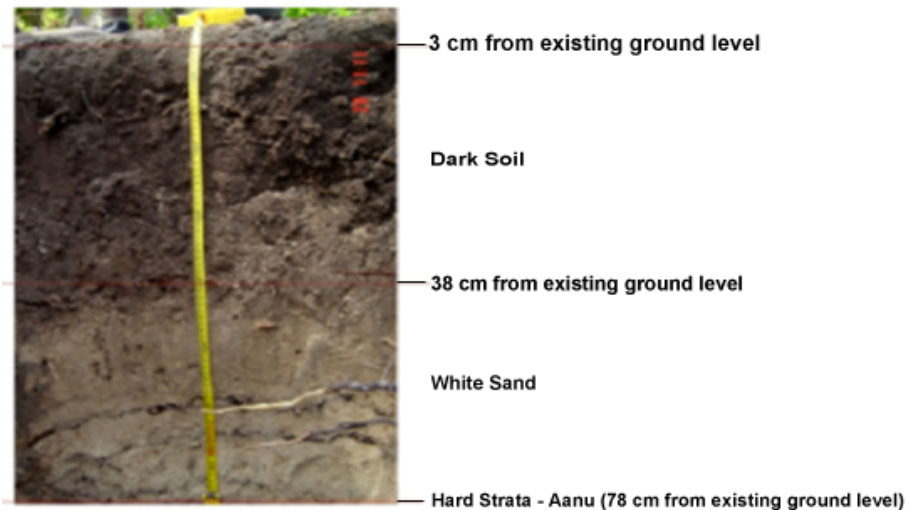
Soil profiles taken at the project location (Figure 17 and Figure 18) showed that soil was stratified into three main parts. They are dark soil containing the humus made of vegetation decay on the top, white a layer of coarse white sand below the dark soil without humus content and compacted sand forming the bedrock. Water was found below this bedrock. Dark soil was found to an average depth of 50 cm ground water level was found at a depth of 100 cm to 115 cm during the mean tide level. Soil profile taken lengthwise showed that soil with humus content and the ground water level are very uniform throughout the island. The soil surveys carried out showed that the island is comparatively fertile despite the small size of the island. Soil profiles taken from four locations of the island showed that soil of the island was relative fertile compared to small size of the islands. Humus layer and nutrient contents of the soil was found to be comparable to some of the larger islands in the country. Lush and thick vegetation of the island also showed that the soil is fertile and enables growth of vegetation.

Figure 17: Schematics of the soil profile.

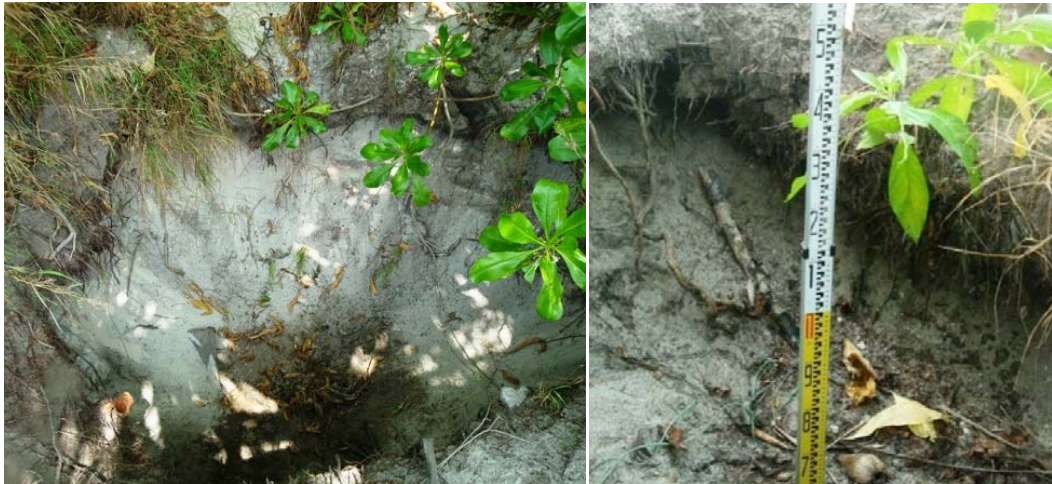
Figure 18: Soil stratification profile onsite.

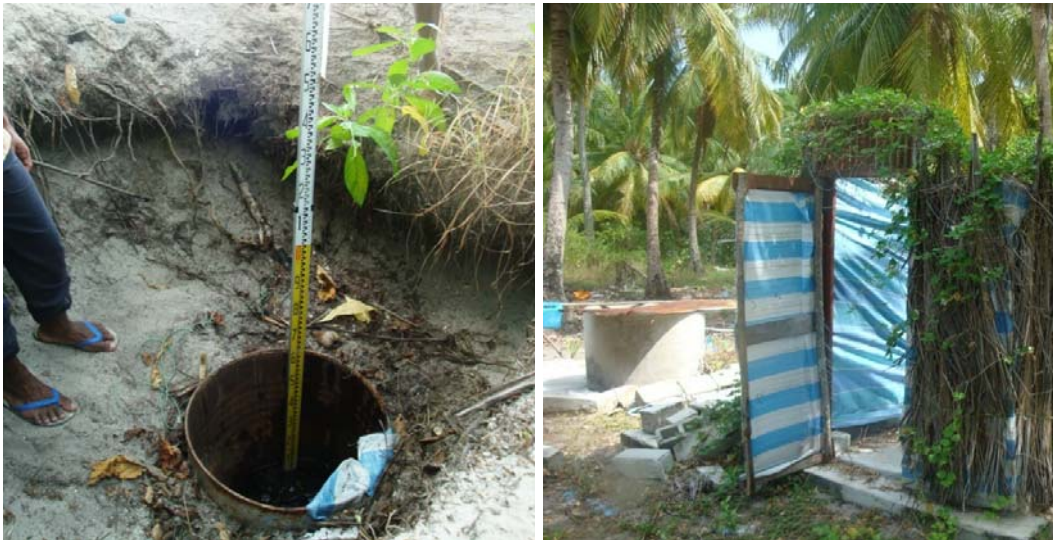
Groundwater lens of the island was found to be shallow at an average depth of 1m to 1.2m at mean tide. Figure 19 shows some of the groundwater wells that were used in the island. Ground water sample was obtained from the location S3 and S4 shown in Figure 28.

Figure 19: Some of the groundwater wells found in the island and survey sites.

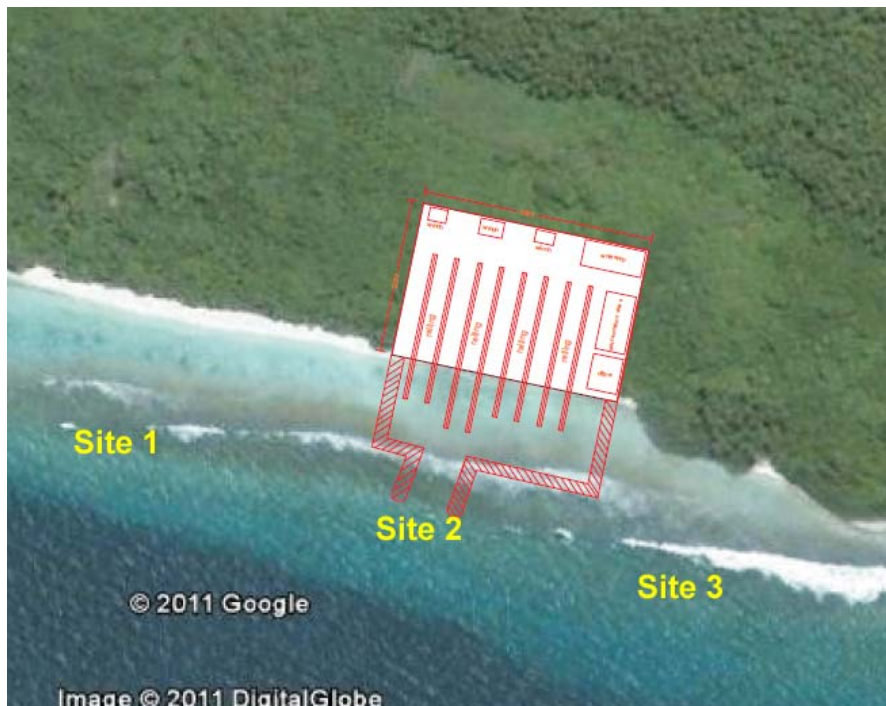
The coral reef system of Vandhoo was quantitatively, semi-quantitatively and qualitatively surveyed using standard marine environmental survey methodologies. Reef-slope was surveyed using manta tow technique. Quadrat surveys were conducted on 3 areas that were selected on the reef-flat for assessing benthic substrate cover. The surveyed sites are shown in Figure 20.

Figure 20: Location of the marine survey sites.

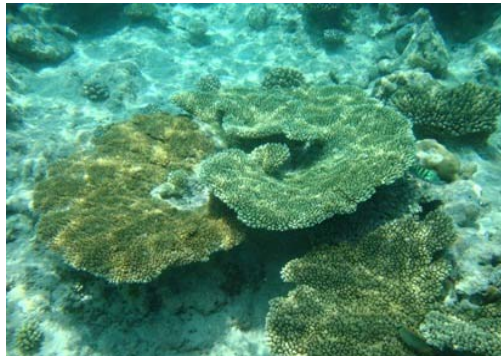
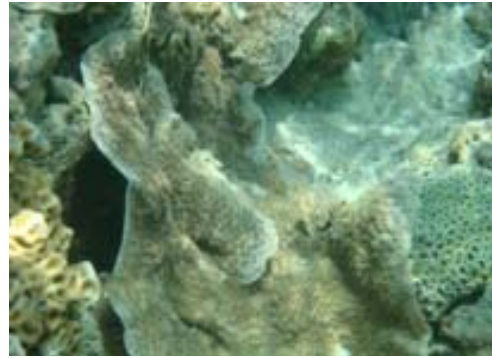
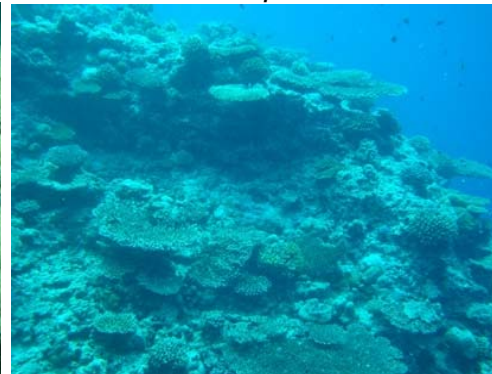
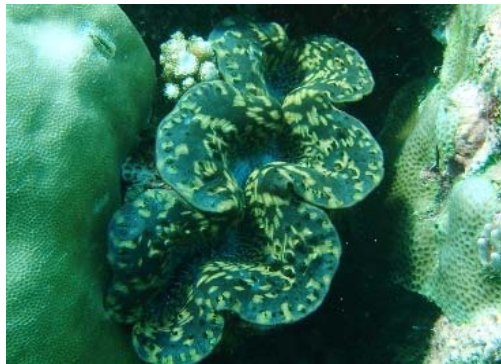
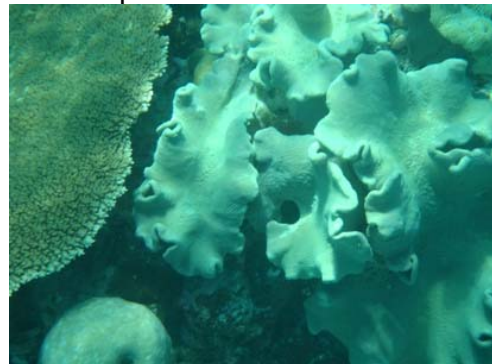
Figure 21: Benthic substrates encountered at the reef-slope.

Live coral cover was dominated by small individual colonies of *Porites* spp and *Acropora* spp. Other coral genera documented included the laminar coral *Echinopaora*, branching forms of *Acropora*, *Pocillopora* and *Porites*. Massive types such as *Favia*, *Favites*, *Montastrea* and *Goniastrea*. *Fungia*, *Pavona* and *Galexea* are also seen. The figure below shows the benthic substrate cover at the northern reef-slope area.

Tabulate *Acropora*

Favites and *Echinopora*

Reef slope

A Giant clam

Soft coral and Table coral

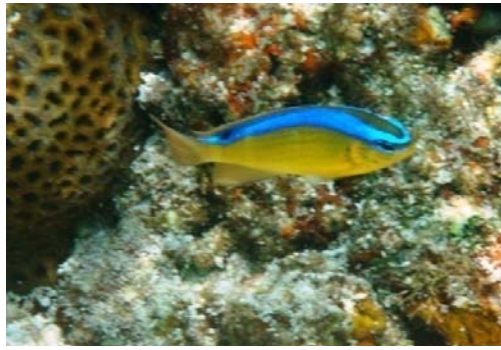
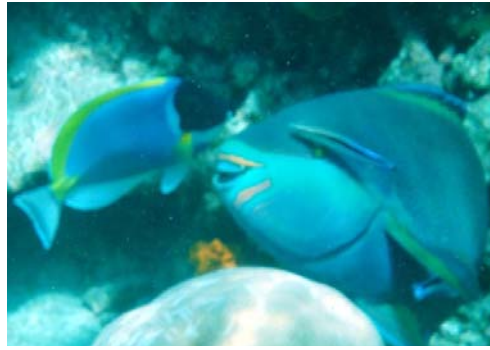
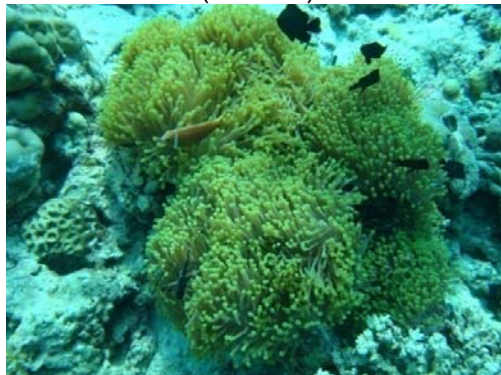
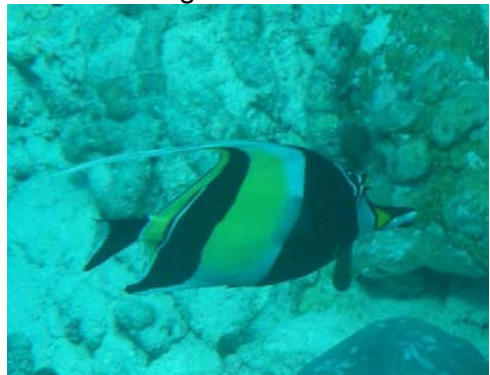
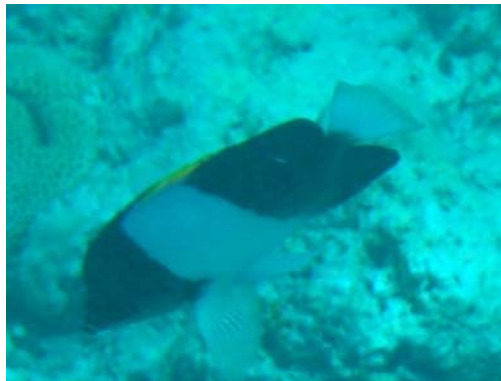
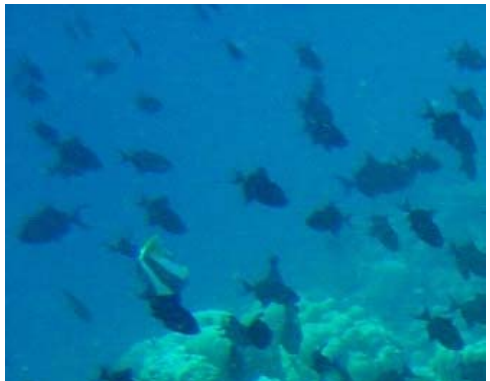
Figure 22: Some of the fishes observed at the reef-slope.

Commercial fish species such as serranids and lethrinids were documented during the manta tow. The parentheses next to the commercial species represent the number of individuals encountered in each of the given family. The dominant fish species *O. niger* was ubiquitous. Several other species of reef fish were also seen. Among these are schools of *H. zoster* are worth noting due to their abundance. Some of the fishes encountered at the reef slope are shown below.

A Pomacentrid (damselfish)

An assemblage of fish

A. nigripes on *H. magnifaca*

Z. cornutus

H. zoster

O. niger (trigger)

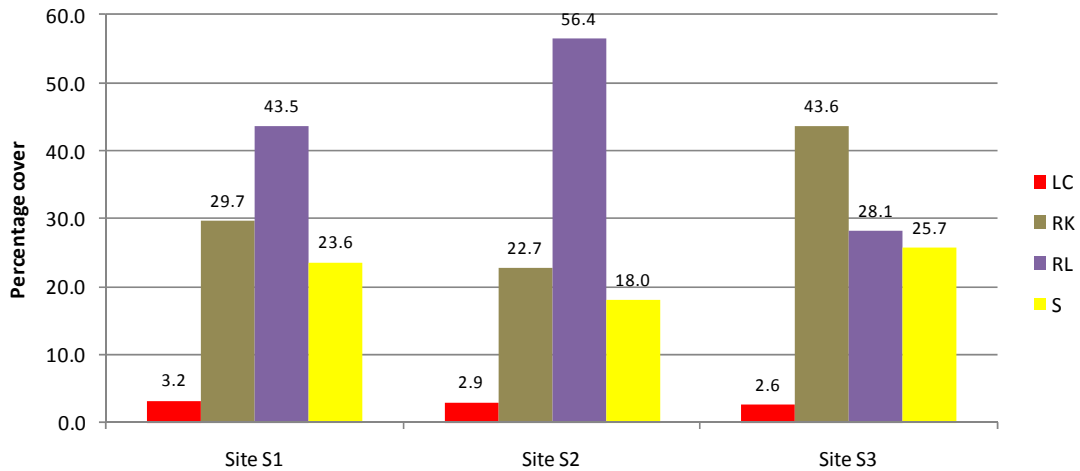
Most of the area close to the proposed slipway area was covered with rubble and rock. Percentage of rock was highest at the Site 2. The percentage of live coral was highest, i.e. 3.2% in Site 1.

Branching forms of *Acropora* spp. and *Porites* spp. and other genus like *Pocillopora*, *Pavona*, *Favia*, *Goniastrea*, *Laptoria*, *Heliopora* and *Montipora* were encountered at the survey sites. Massive type corals namely *Porites* were encountered.

Figure 23: Benthic substrate cover on southern side.

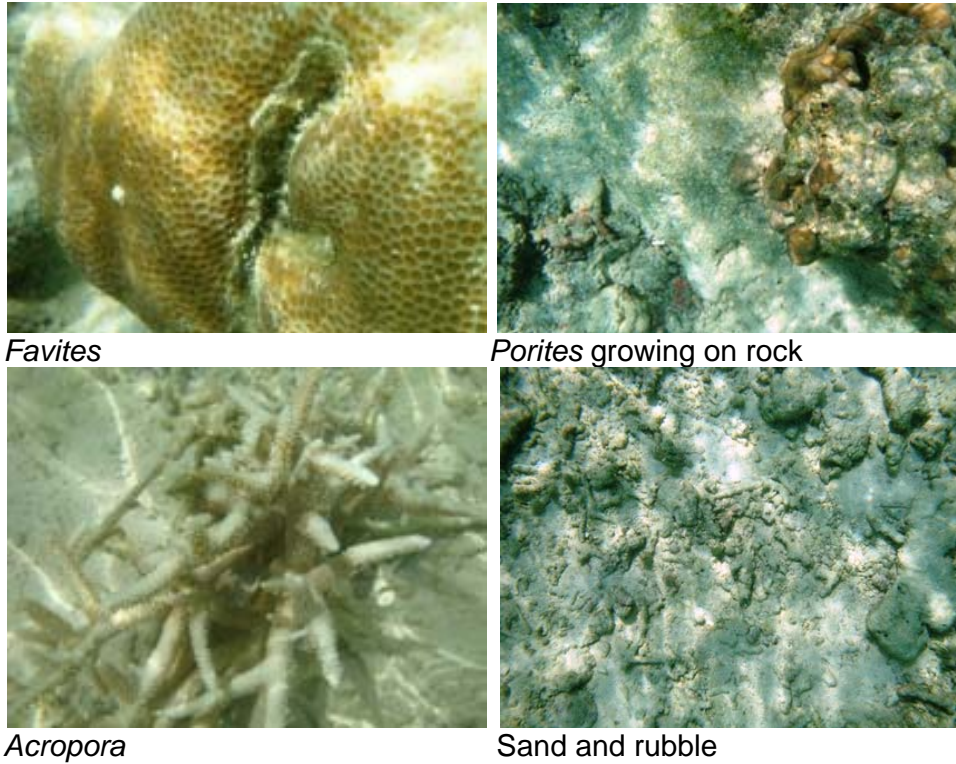
Based on the survey data of the 3 reef-flat sites, rubble, rock and sand were found to be dominant on the proposed slipway region. The photographs below provide an idea of benthic cover present at the survey sites.

Figure 24: Benthic substrate present at the reef-flat sites

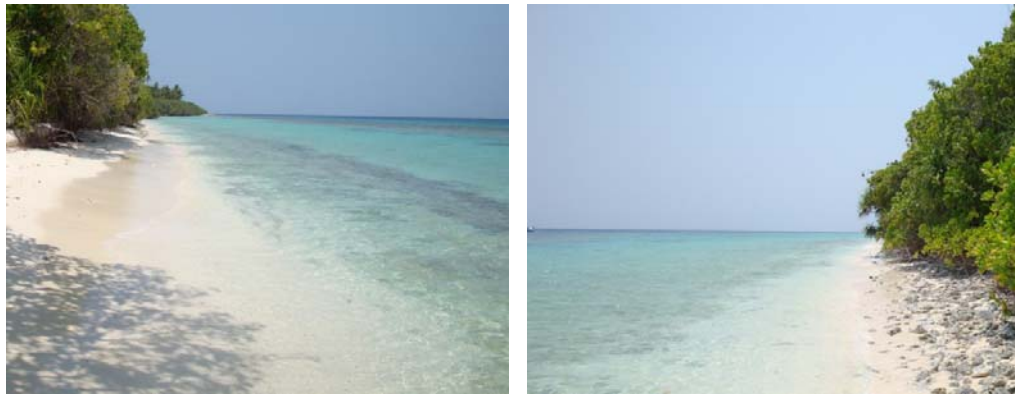
Figure 27: Lagoons around the island

The shallow lagoon area around the island was calculated as approximately 29 hectares. The lagoon on the on all sides of the island are shallow (see Figure 27).

The average depth of the lagoon on northern side of the island is deeper than on other sides. Lagoon bottom consisted of mostly sand, rubble. Waves in the western and northwestern sides of lagoon are higher as the wind waves generated by the southwest monsoon directly reaches the lagoon on this side.

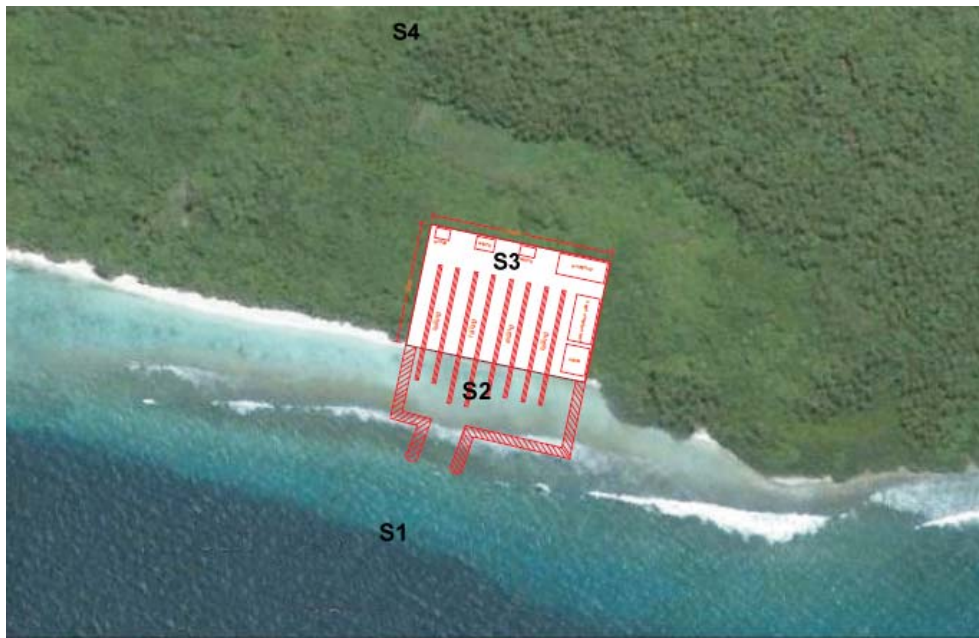
S4 – ground water sample (lat 5° 31' 54.83", lon 73° 02' 33.24")

Figure 28: Water sampling locations.
