ENVIRONMENTAL IMPACT ASSESSMENT FOR THE PROPOSED ARTIFICIAL BEACH IN GA VILLINGILI, NORTH HUVADHU ATOLL

PREPARED FOR
GA. Villingili
Council

Prepared by :
MAHMOOD RIYAZ (PHD) (EIA03/07)
M. S. ADAM (PHD) (EIA 01/07)

November 2016

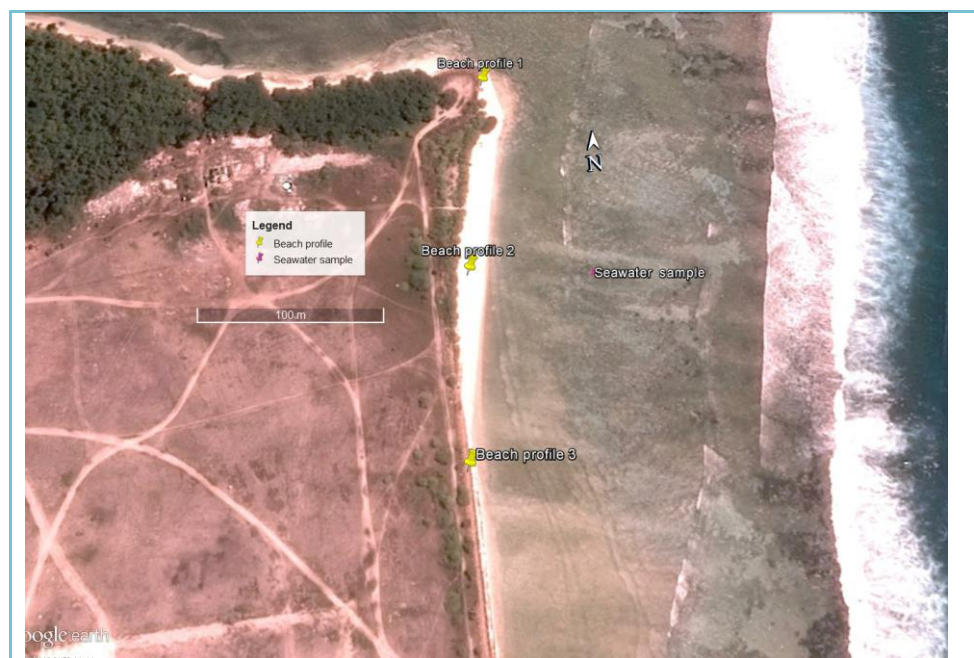
Figure 4: Map showing sampling and beach profile locations

The area proposed for the development was mapped and various location and areas of interest are marked by using a handheld GPS. These data collection points include low water mark, high water mark, and vegetation line and sea water sampling locations. Figure 4 shows the water sampling locations, vegetation transact, and beach profile lines.

Lagoon seawater sample was taken and water quality was assessed at the Male’ Water and Sewerage Company’s laboratory using standard methodologies. Sampling locations are shown in Figure 4. The results are given in Table 5 and the original tests results are given in Annex 5. It is recommended to use the monitoring data during the project implementation against the baseline information in assessing the environmental impacts

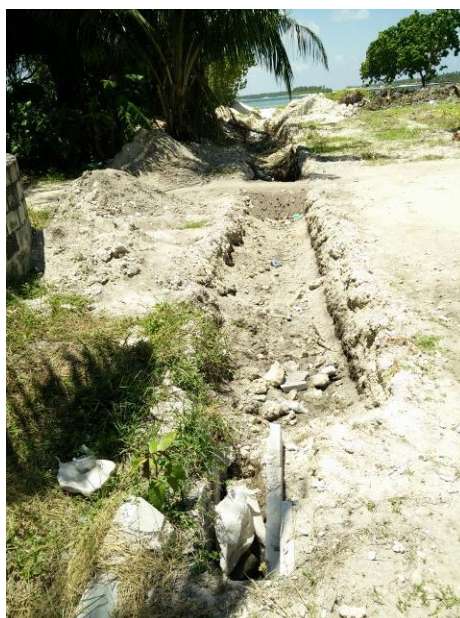
Figure 6: tranches made to drain flood water

Available severe weather event records shows that GDh Kaadedhoo received a maximum precipitation of 219.8 mm for a 24 hour period on 10th July 2002, the highest recorded anywhere in Maldives since recording began. This event caused widespread damage or disruption to personal property, road infrastructure, sewerage infrastructure, backyard crops, harbour quay wall, school operation and businesses in GA Villingili Island ~~located~~. Flood depths in the southern part of GA Villingili were reported at 0.3-0.4 m. During the flooding events of November 2003, the recoded rainfall in GDh Kaadedhoo for the 24 hour period was 64.4 mm. A month later, rainfall up to 60.3 mm was observed. Two similar events ~~were~~ occurred in 2016 in which part of the island was flooded from torrential rain and associated *Udha* (storm surges). *Udha* was initiated from southern end of the island and extensively flooded large part of the island. *Figure 6* shows the tranches made to release the floodwater into the sea. Extreme weather related events cause disruption to businesses, school and minor damage to household goods in GA Villingili Island. Flooding events experienced in GA Villingili Island are believed to be due to combination of high intensity-~~of~~ rainfall in the region in combination with substantial changes brought to the physical environment of the island and poor drainage.

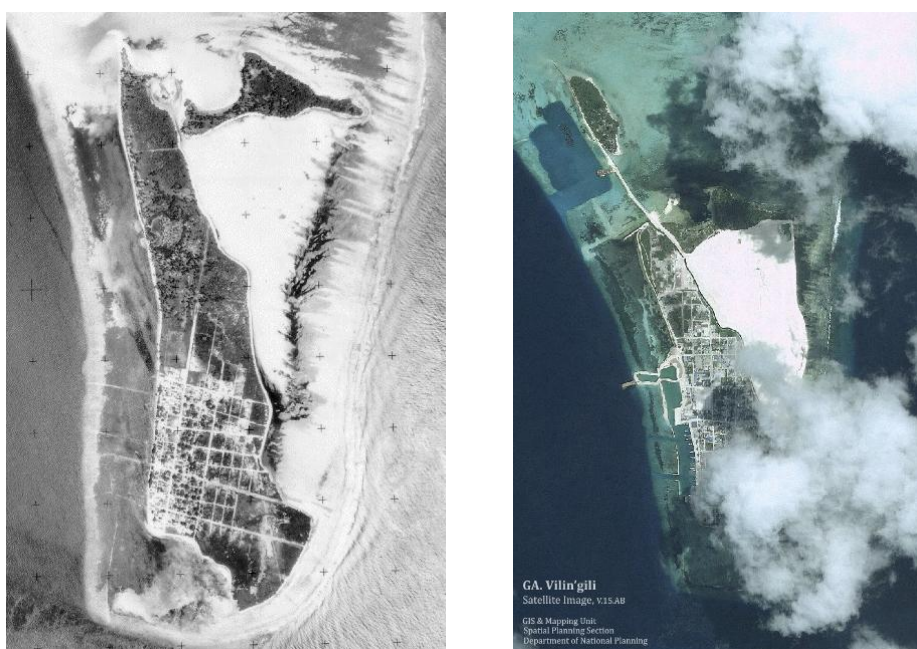
Figure 7: Ariel photgrpahs of GA Villingili, 1969 (left) and 1994 (right showing changes in landuse and land cover

The coastal environment of GA Villingili has been extensively modified, particularly the eastern and western sides of the island. Over 40 hectares of land has been reclaimed from the eastern side under the land reclamation project (Figure 7). Comparison of 1969 and 2009 with the recent images of the island shows complete transformation of the island. The 1969 image also shows fairly large enclosed water bodies' marshy lands (*Kulhi*) on the northern and southern ends of the islands. With extensive reclamation and expansion of the urbanisation the two marshy lands has significantly decreased in size and the natural environment has been altered ~~has altered~~.

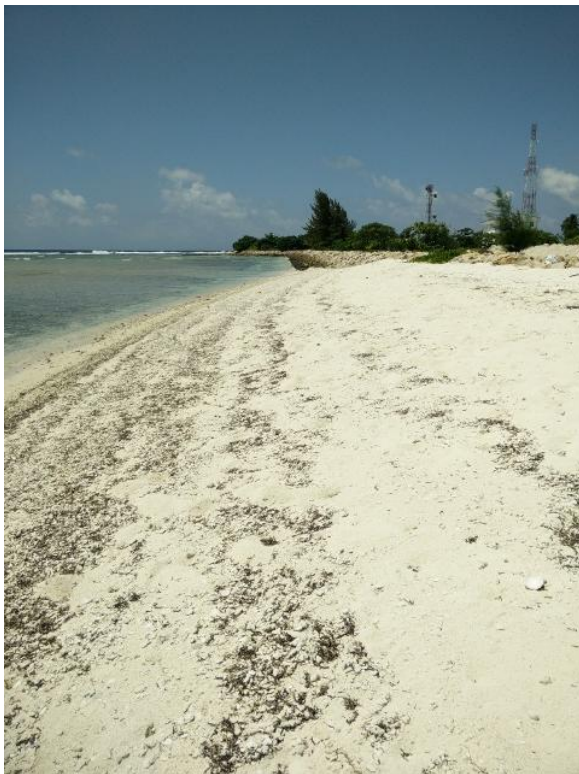
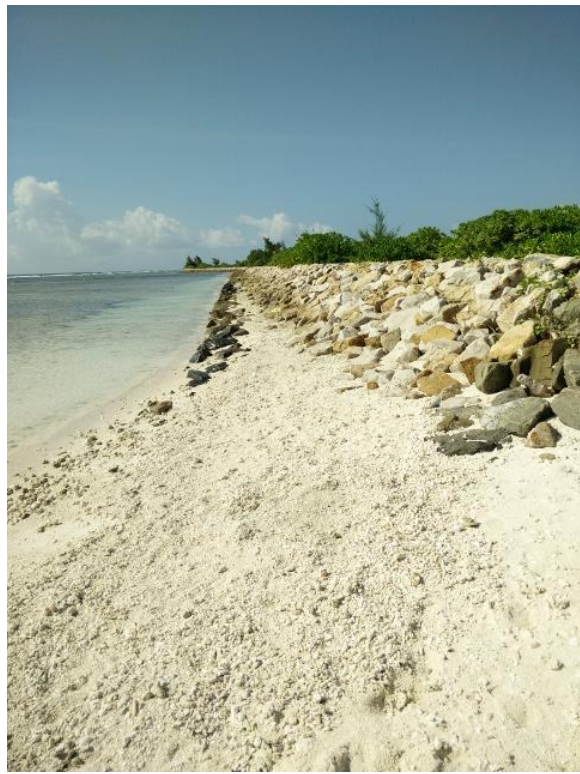
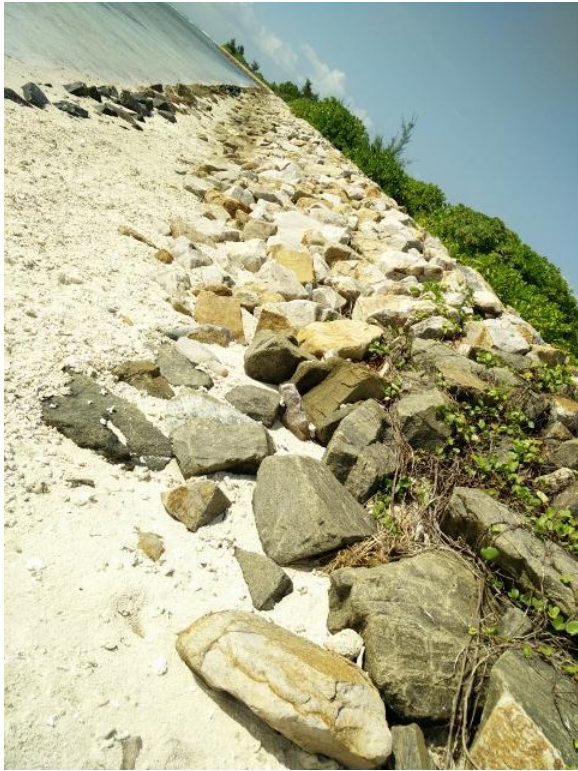
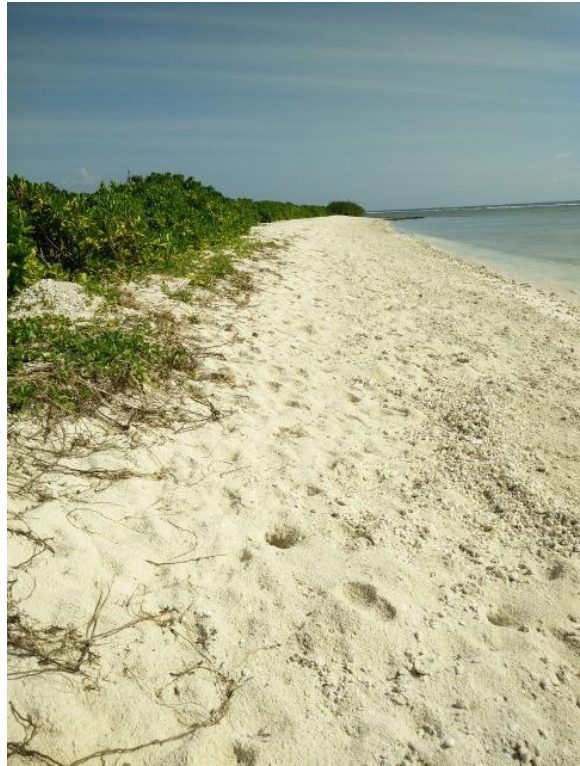
Figure 8: existing beach and rock boulder revetment on the eastern side of Villingili

The eastern shoreline has been protected by a rock boulder revetment. Two harbours are developed on the western side of the island. The harbours are protected with a rock boulder breakwater and a quay

The proposed development is take place on the north eastern end of the island. The area is reclaimed and a rock boulder revetment has been constructed along the eastern coastline (Figure 8). Pocket beaches (white sandy beaches) are developed along the eastern shoreline. The north western corner has a fairly wide; 3-5m wide sandy beach developed by accretion of sand. The northern end of the beach has large number of fairly wide beach rock series. Beach composition on the eastern side consists of medium grained coral sand and coral rubble 1-4 inch long dead branching coral and pebbles. Coral rubble is extensively used in the island to cover the black sand in the houses. Manually coral rubble is mined from the area. Evidence of mining was observed during the field visit Figure 9.

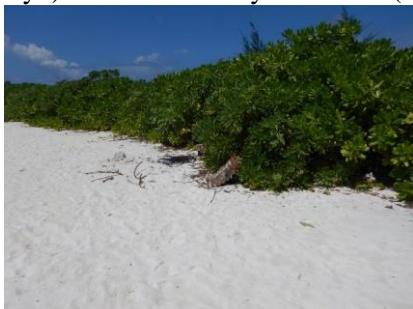
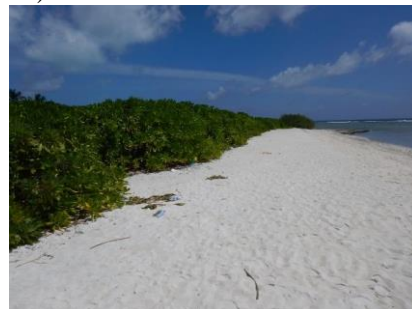
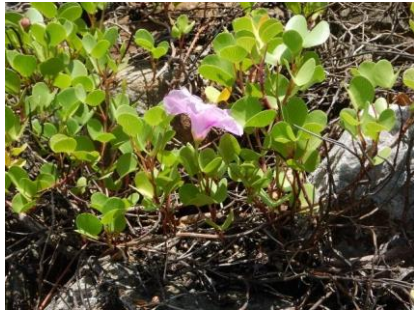
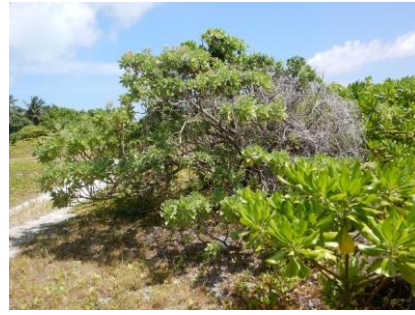
Part of the existing revetment is covered with coastal vegetation and extends few meters seaward. Coastal vegetation cover in the area consists of a mix of shrubs dominated by *Scavola taccada* (Magoo) and *Tournefortia argentic* (Boashi). The tropical coastline creeper *Ipomoea pre-caprae* (Bodu veli veyo) covers the sandy seashores (Figure 10).

Figure 10: Coastal vegetation on the north eastern corner of the island

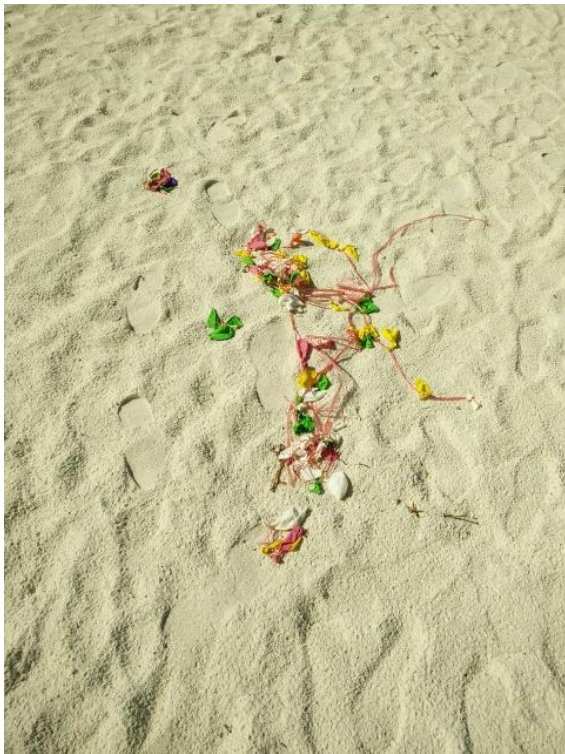
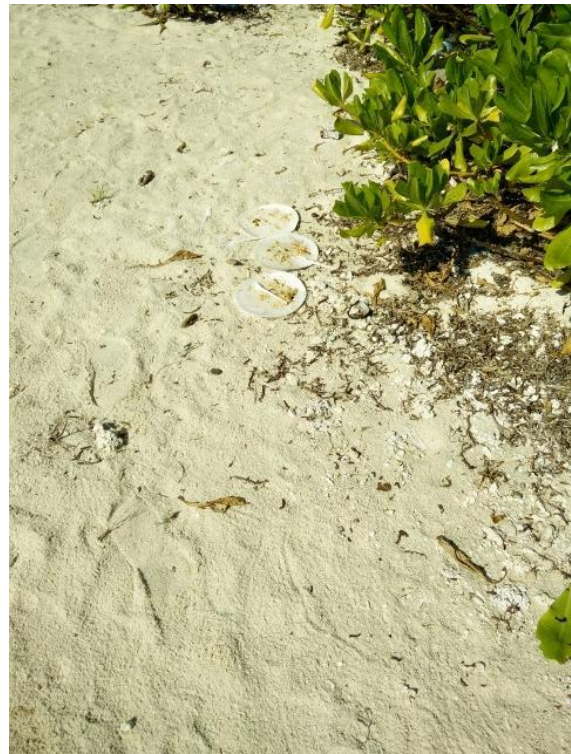
The beach is currently used by local picnickers goes particularly the youth for romantic beach settings and parties. Left over material from beach parties and picnics were found on the beach (Figure 11)

Figure 11: Leftover material from picnic NE, end of GA Villingili

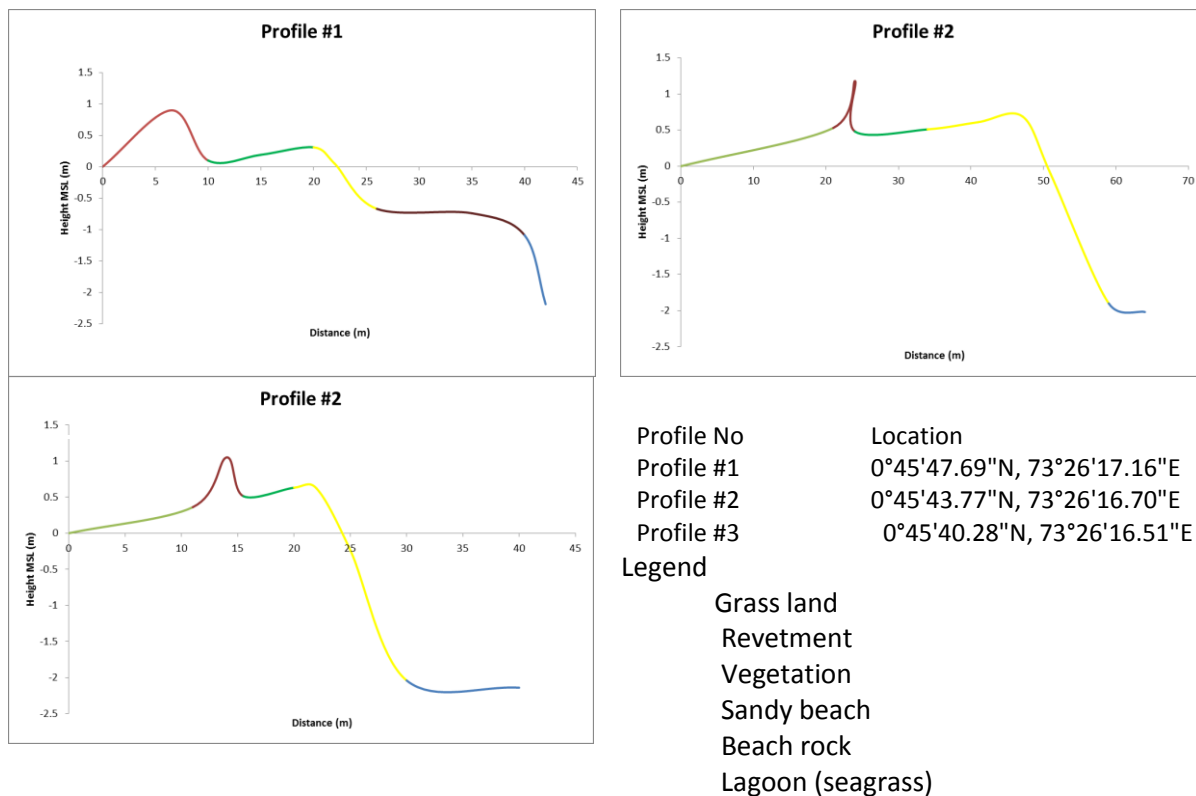
Figure 12: Beach profiles taken from area proposed for the development of artificial beach at GA Villingili.

Three beach profiles are taken across the north eastern section of the eastern beach. The beach profiles start from the landward side and run across the existing revetment, vegetation, sandy beach and into the shallow lagoon perpendicular to the beach. Location of beach profiles are shown in Figure 12 Profile #1 taken from the north eastern tip of the beach shows fairly stable but meandering beach slope with relatively high rises and steep dips. Fourteen meter wide beach rock is observed on the profile, the beach consist of two or three series of horizontal beach layers (Figure 12). The beach rock exposer extends further on the northern side of the island. Beach material on this profile is comparatively finer than the material observed on other profiles. Profile #2 and #3 has a fairly steep

slope from the high water mark. This indicates that these beaches are unstable and subject to shifting seasonally. The widest beach in the area was observed in Profile #2, where the beach width is over 30m. The narrowest beach in the area is in profile #3 where the measured beach width is approximately 15m (Figure 12) Overall the beach profile shows that large part of the existing beach on the north eastern end of GA Villingili is very dynamic to seasonal hydrodynamic conditions.

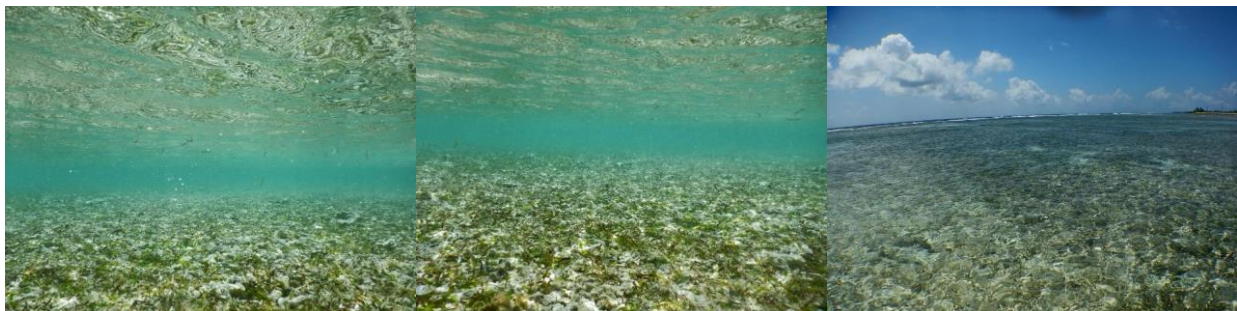
Figure 13: Substrate compositions on the NE end of the island, area proposed for artificial beach development.

The lagoon on the eastern side of GA Villingili has an average depth of 0.5 – 1.5m during high tide periods. The original lagoon covered with sandy substrate has already been reclaimed. The existing area between the reclaimed shoreline and the reef is a 200m wide shallow reef flat. The reef flat is covered with seagrass with occasional coral colonies. Seagrass grows on nutrient rich eutrophic and slow-moving water bodies particularly in fishing islands where large amount of organic waste is dumped into the lagoon (Figure 13). The lagoon water on the eastern side was generally clear and visibility is excellent. The ocean ward eastern side reef flat of GA Villingili has a fairly ~~divers~~ rich fish diversity. Rays and juvenile sharks were encountered during the survey. Also fairly large (approximately 1m long) school of black tipped reef sharks were encountered during the survey (Figure 14).

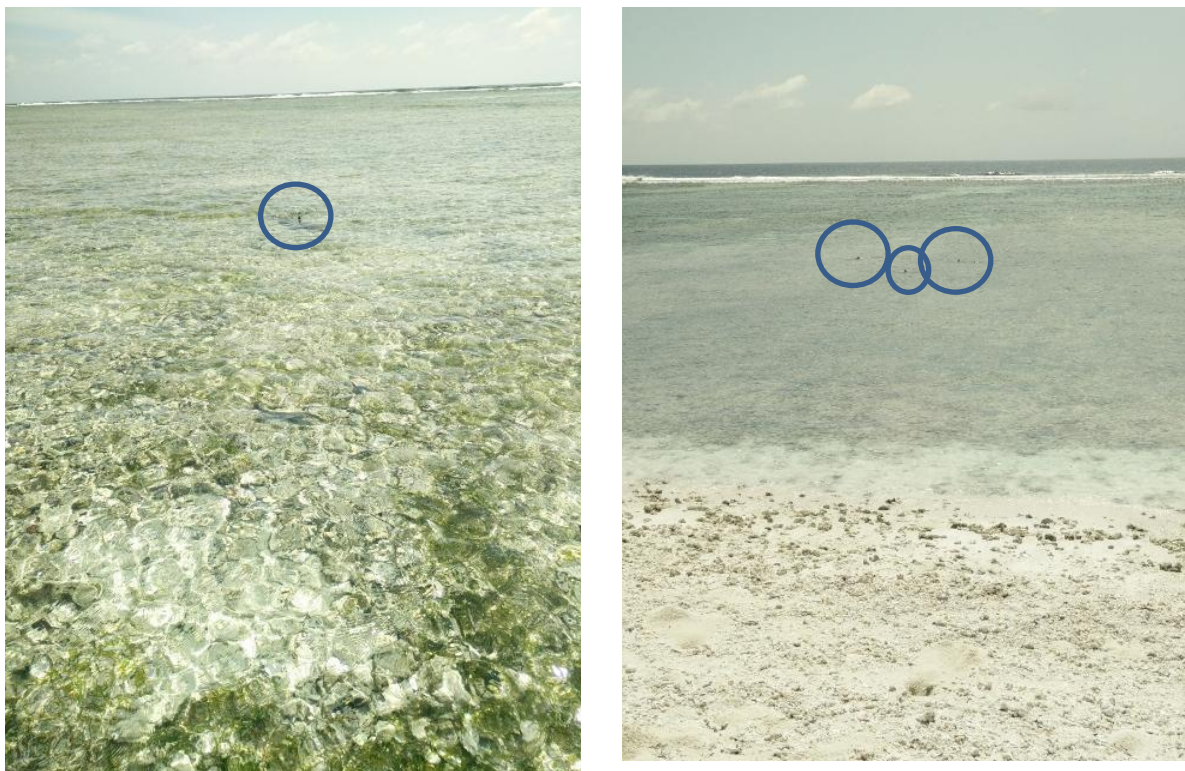
Figure 14: School of black tipped sharks encountered at the site, NE corner of Villingili

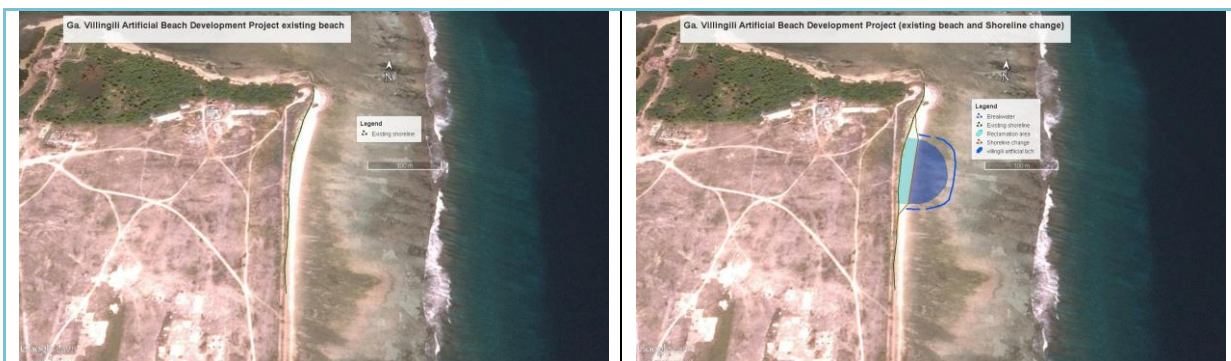
Figure 17: Existing shoreline and anticipated change in shoreline after the development

Development of the proposed artificial beach development project on the north eastern corner of GA Villingili Island is likely to change the overall hydrodynamic regime within of the nearshore due to creation of shore perpendicular structure and increase in water depth of the area. Further the structure will block sediment movement in the nearshore area and therefore the beach on either side of the structure may undergo severe erosion conditions may take a number of years to stabilize against the prevailing conditions. Figure 17 shows the existing beach and anticipated change and shoreline after the development.

Depending on the severity of sand accumulation and erosion ~~considered~~ may affect the beaches and stability of protection structures. However, it is proposed to have in place a beach monitoring program against the baseline set up for this study should an unforeseen changes occur to the beach especially during unusual weather conditions.

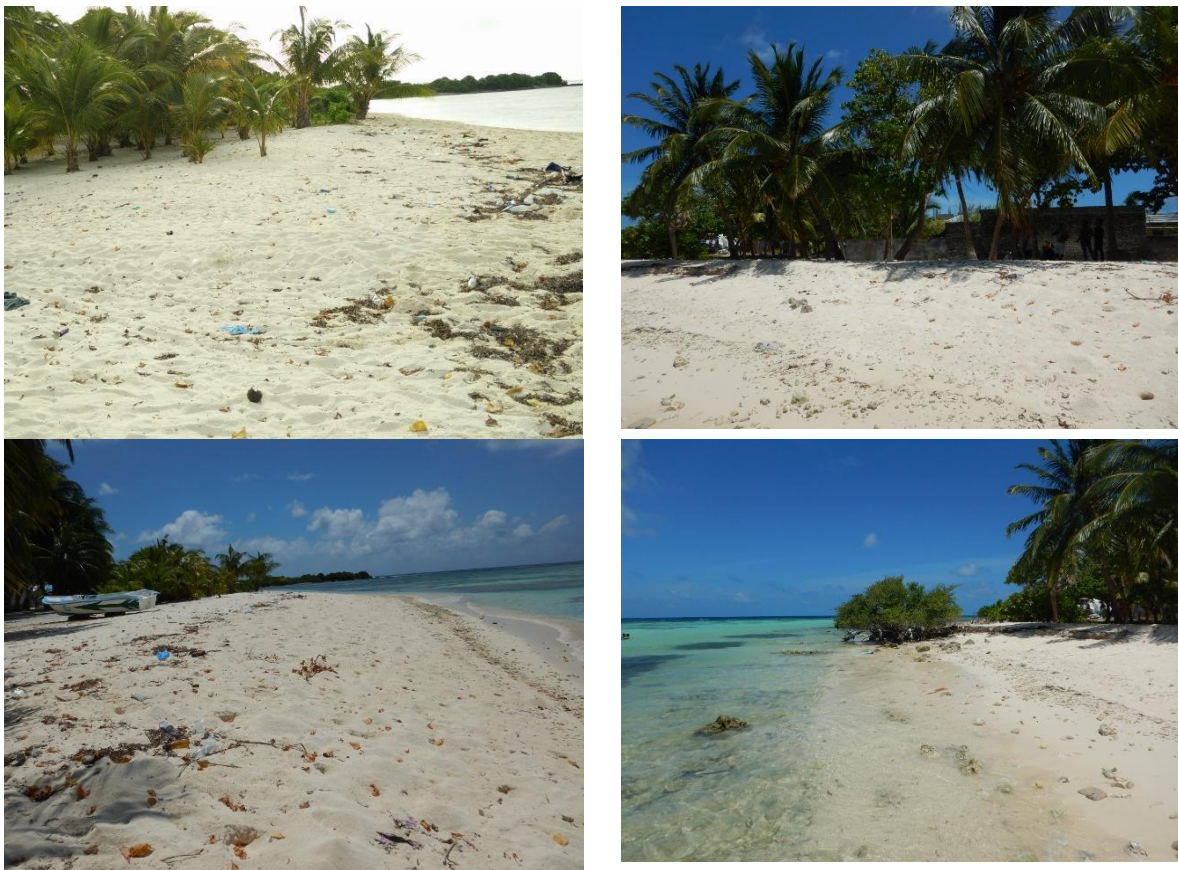
The southern end of GA Villingili is within the urbanised area of the island. Erosion is prevalent in this area at the time of survey fairly wide 3-10m sandy beach was observed. This wide beach is extremely dynamic evidence of coastal erosion was observed and fairly deep erosion scarps were noted. The area is also exposed to fairly strong current from the channel between Kooddo and Villingili (Figure 19- Figure 22).

Figure 19: Beach on the southern end of the island used by the public for swimming and recreation

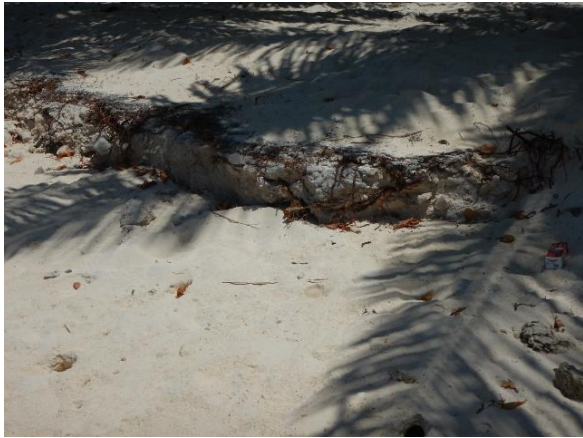
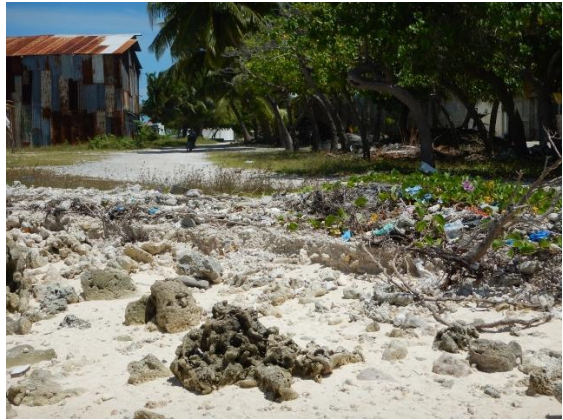
Figure 20: Severe erosion on southern end

There is a fairly wide (200m) and deep lagoon in this area. Average depth of the lagoon at low tide is about 1-1.5m. Therefore fairly strong and breakwater is needed to create safe swimming area. The protection should also be designed to address *Udha* and coastal erosion problem prevalent in this area.

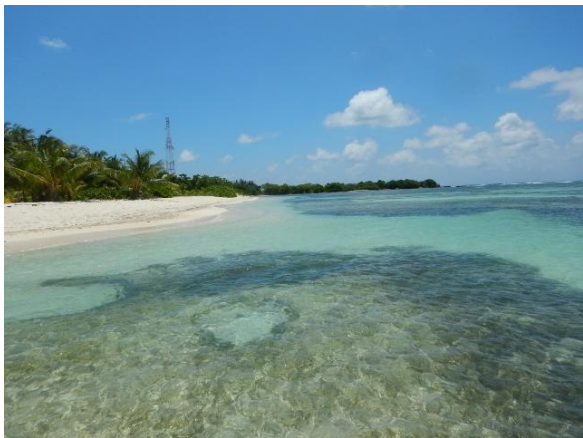
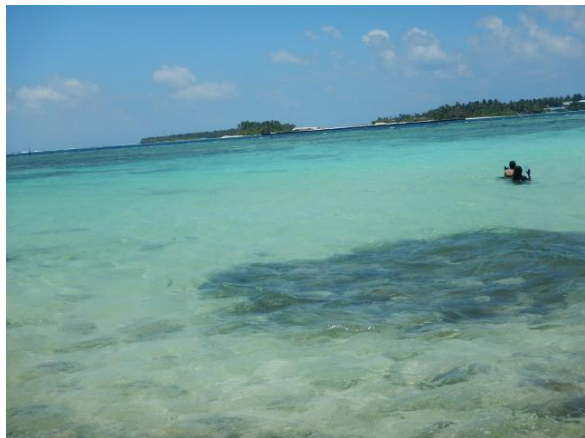
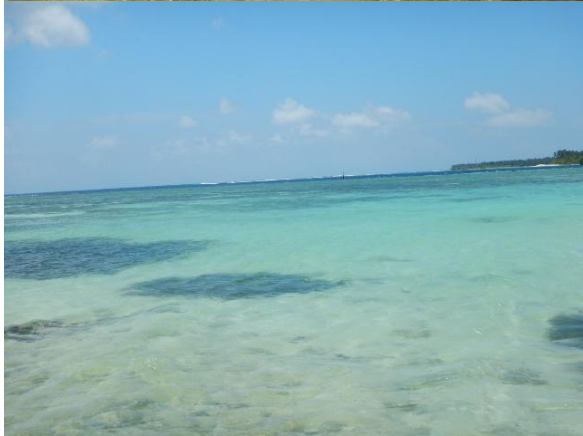
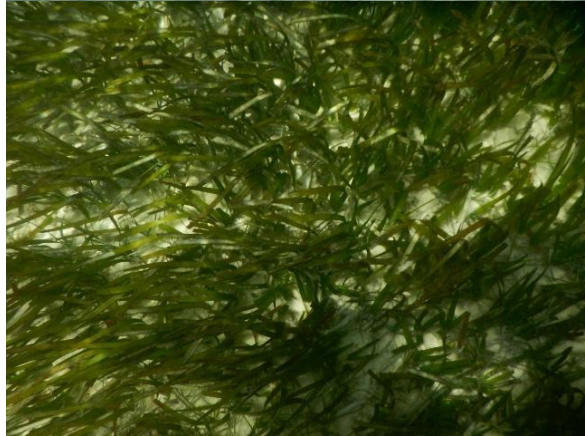
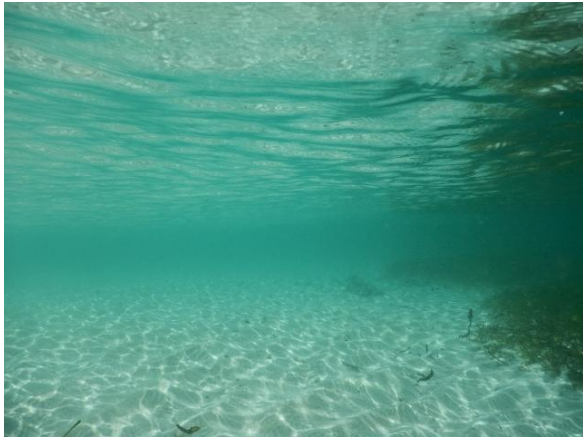
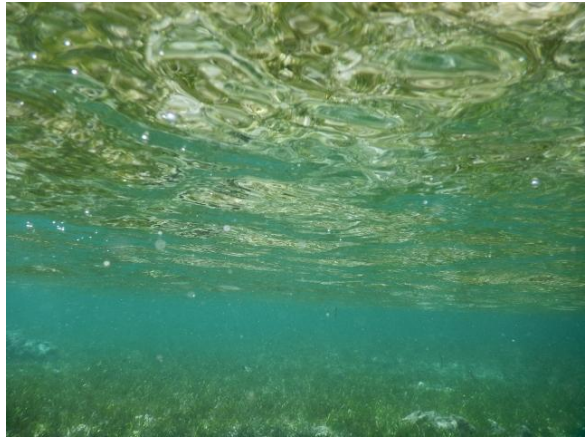
Figure 21: Lagoon and substrate cover on the southern end (L2)

Benthic cover of the lagoon consists of patchy seagrass beds alternated by sandy areas. This area is currently used by the locals for swimming.

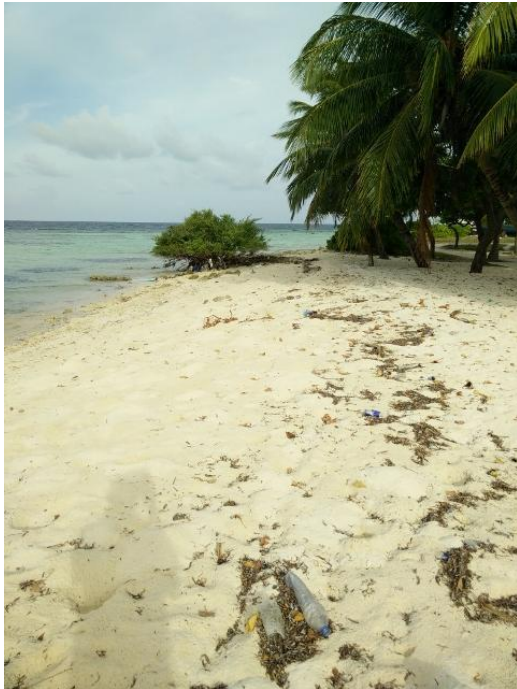
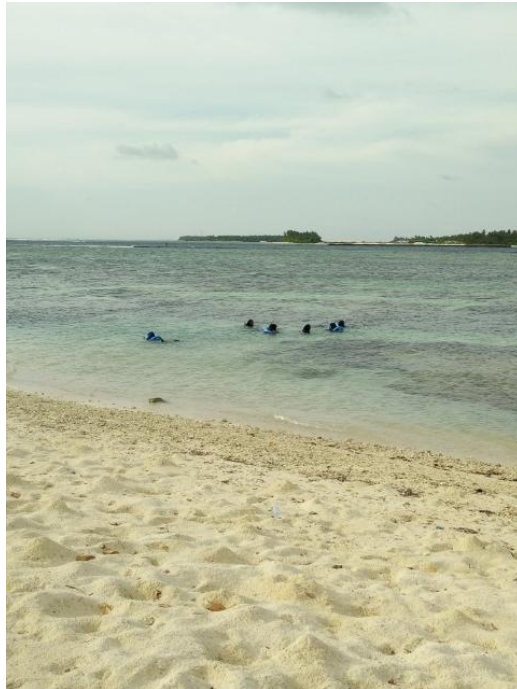
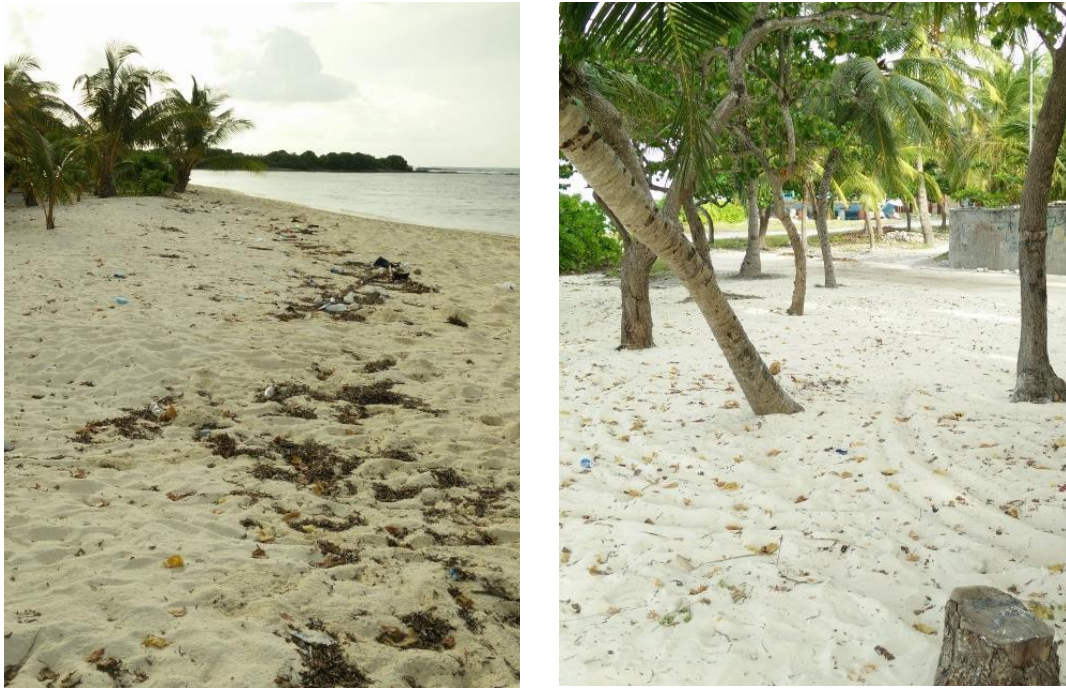
Figure 22: Southern end only available area for public recreation and swimming

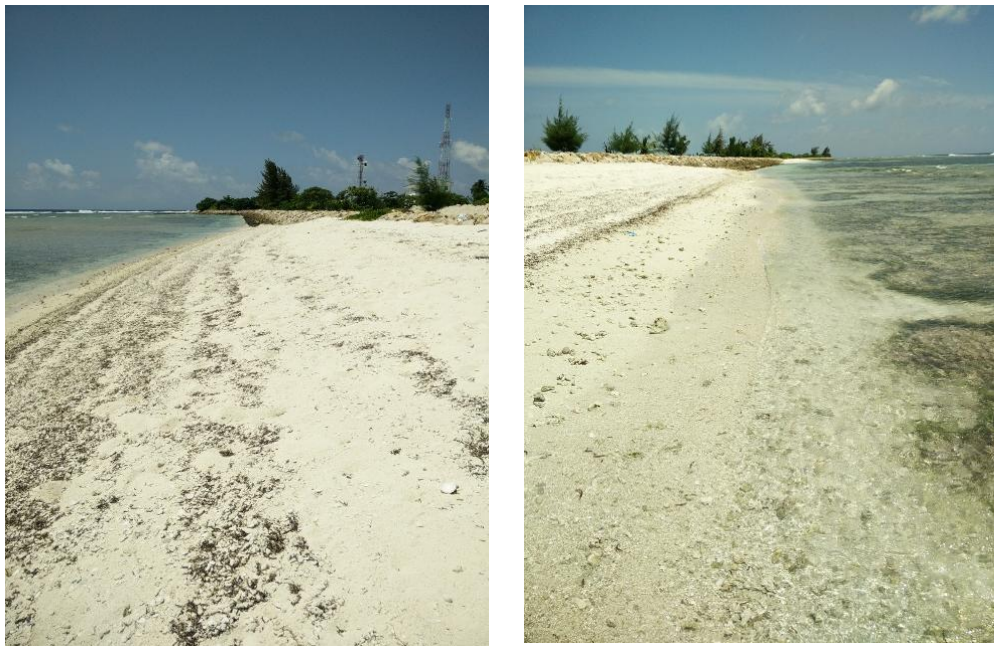
Figure 23: Reef flat and beach on the extended beach area location 3.

This area is located on the east coast 500m south of the locations one. The revetment, beach and vegetation in the area is very similar to location one. However, the distance between the reef and beach is shorter (Approximately 90m) than the reef-beach distance in location one. The seagrass bed on the reef flat is patchier in this area and alternated by sandy areas.

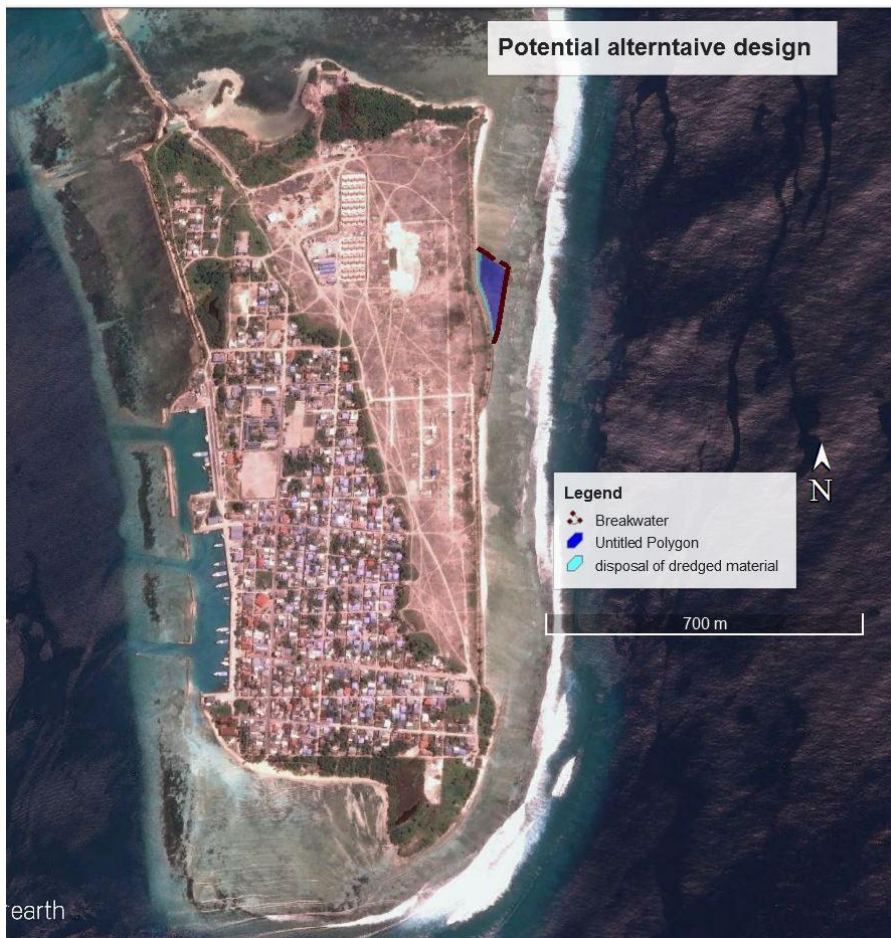
Figure 25: Potential alternative concept design for location (L3)

The mitigation measure for this location would be same as the mitigation measure for the NE corner of the island. However, the breakwater should be stronger and should not be perpendicular to the coast as in the proposed design. Suggested design is shown in Figure 25.

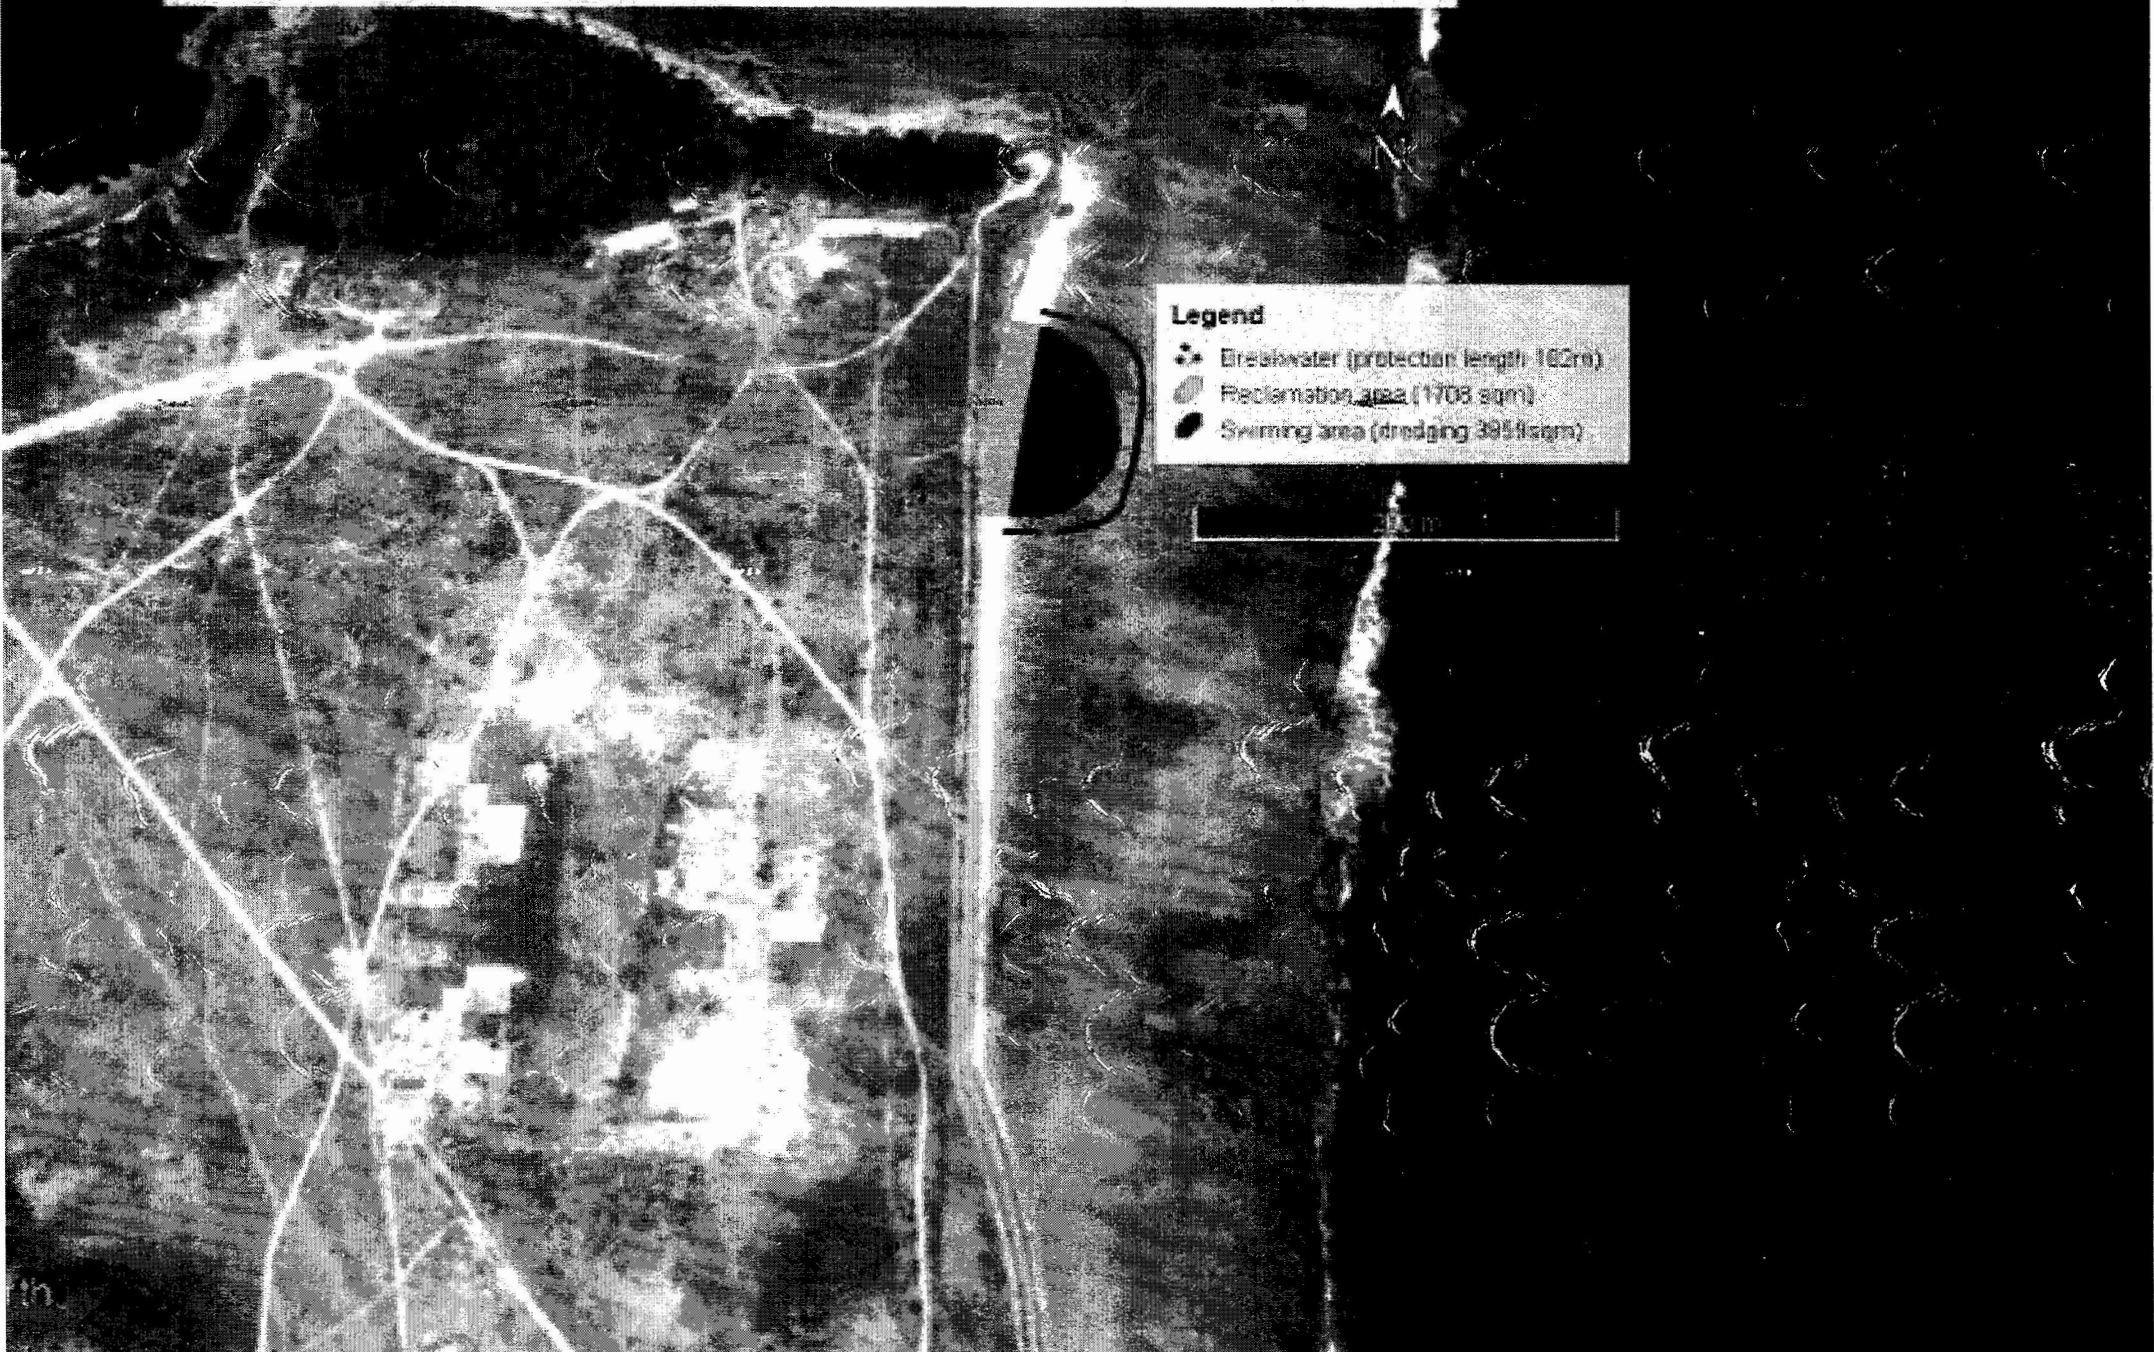
Ga. Villingili Artificial Beach Developmnt Project Conceptual Design

- ★ Freshwater (protection length: 162m)
- Reclamation area (1708 sqm)
- Swimming area (dredging 395 sqm)
