ENVIRONMENTAL IMPACT ASSESSMENT FOR THE PROPOSED AGRICULTURE PROJECT ON DHANDHOO, BAA. ATOLL

PREPARED FOR
Mr. Mohamed Shareef
M. Sunny Coast, Malé

March 2013

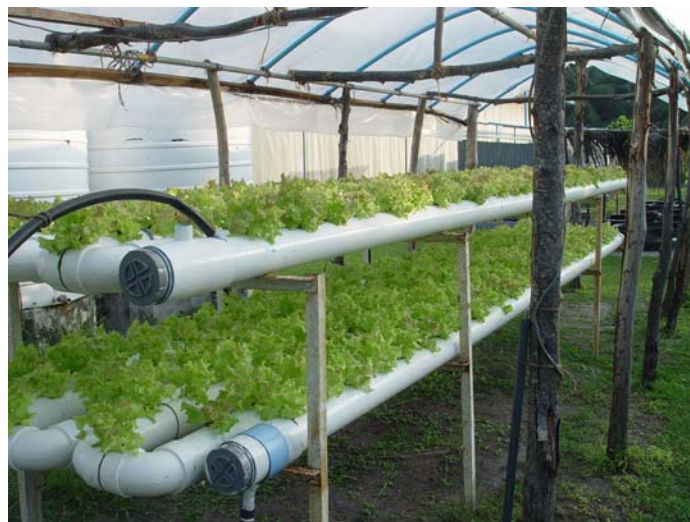
Figure 4: A hydroponics system growing lettuce. Water medium supplemented by ‘growth solution’ circulates in the pipe system.

Researchers discovered in the 18th century that plants absorb essential mineral nutrients as inorganic ions in water. In natural conditions, soil acts as a mineral nutrient reservoir but the soil itself is not essential to plant growth. When the mineral nutrients in the soil dissolve in water, plant roots are able to absorb them. When the required mineral nutrients are introduced into a plant's water supply artificially, soil is no longer required for the plant to thrive. Almost any terrestrial plant will grow with hydroponics. Hydroponics is also a standard technique in biology research and teaching

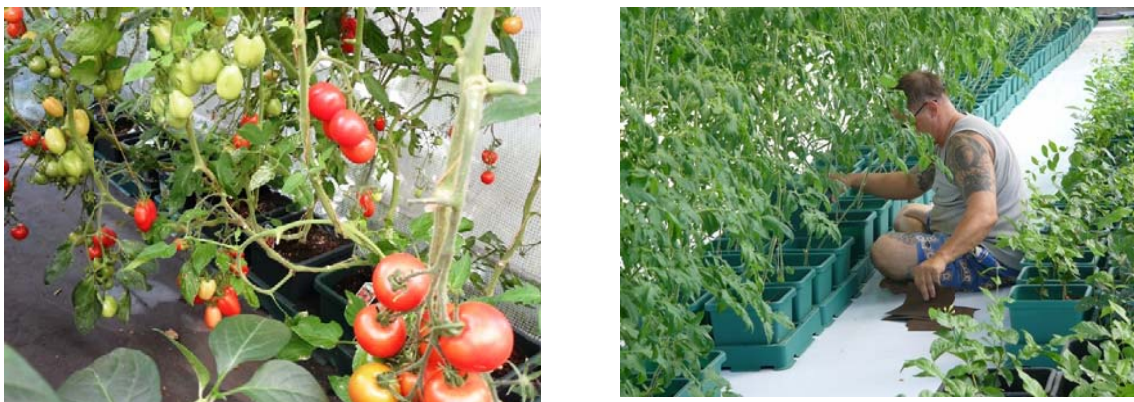
Figure 7: Images from AutoPot System Catalogue. In the most recent catalogue, they report a system that uses 1,500 pots to grow chillies, cucumbers, and tomatoes to supply Hilton Resort in the Maldives.

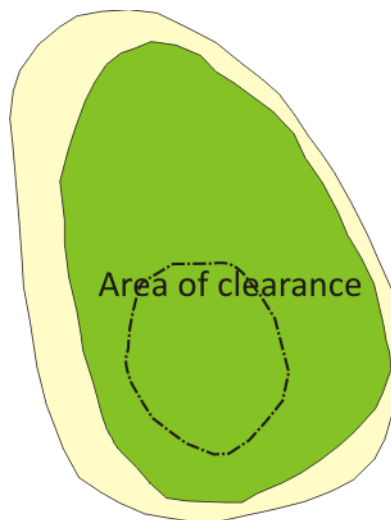
Figure 10: Schematic figure to show the main area of clearance on Dhandhoo for the development work.

1. Stilt Jetty / Jetty head on the western side (up to the reef edge).
2. Green House 6 x 4,000 sq feet
3. A small laboratory for onsite chemical tests
4. Storage area for harvest crops / cold rooms for vegetable storage
5. Fertilizer / chemical storage room
6. Reception facilities for visitors
7. Staff accommodation / kitchen / mess room
8. Senior staff accommodation
9. Power house / RO Plant
10. Fuel / water tank / Rain water tanks
11. Mosque
12. CAM treatment rooms on the north of the island.

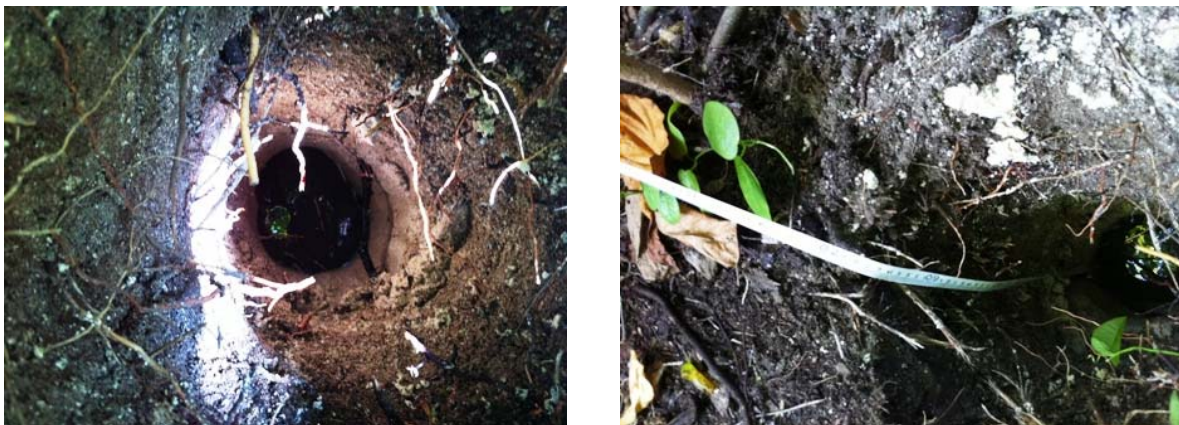
Figure 13: Image of the ground water sampling station. The depth of the water was 65 cm.

Groundwater Assessments: A single randomly chosen location was decided to dig a small well. Once the water is settled (after about 2 hours) water samples were collected in clean 1.5 L PET bottles after washing them with water to be sampled. Parameters tested for ground water quality assessments were physical appearance, temperature, pH, electrical conductivity, total suspended solids, Biological Oxygen Demand. All parameters were analyzed at the Maldives Water and Sewerage Company laboratory.

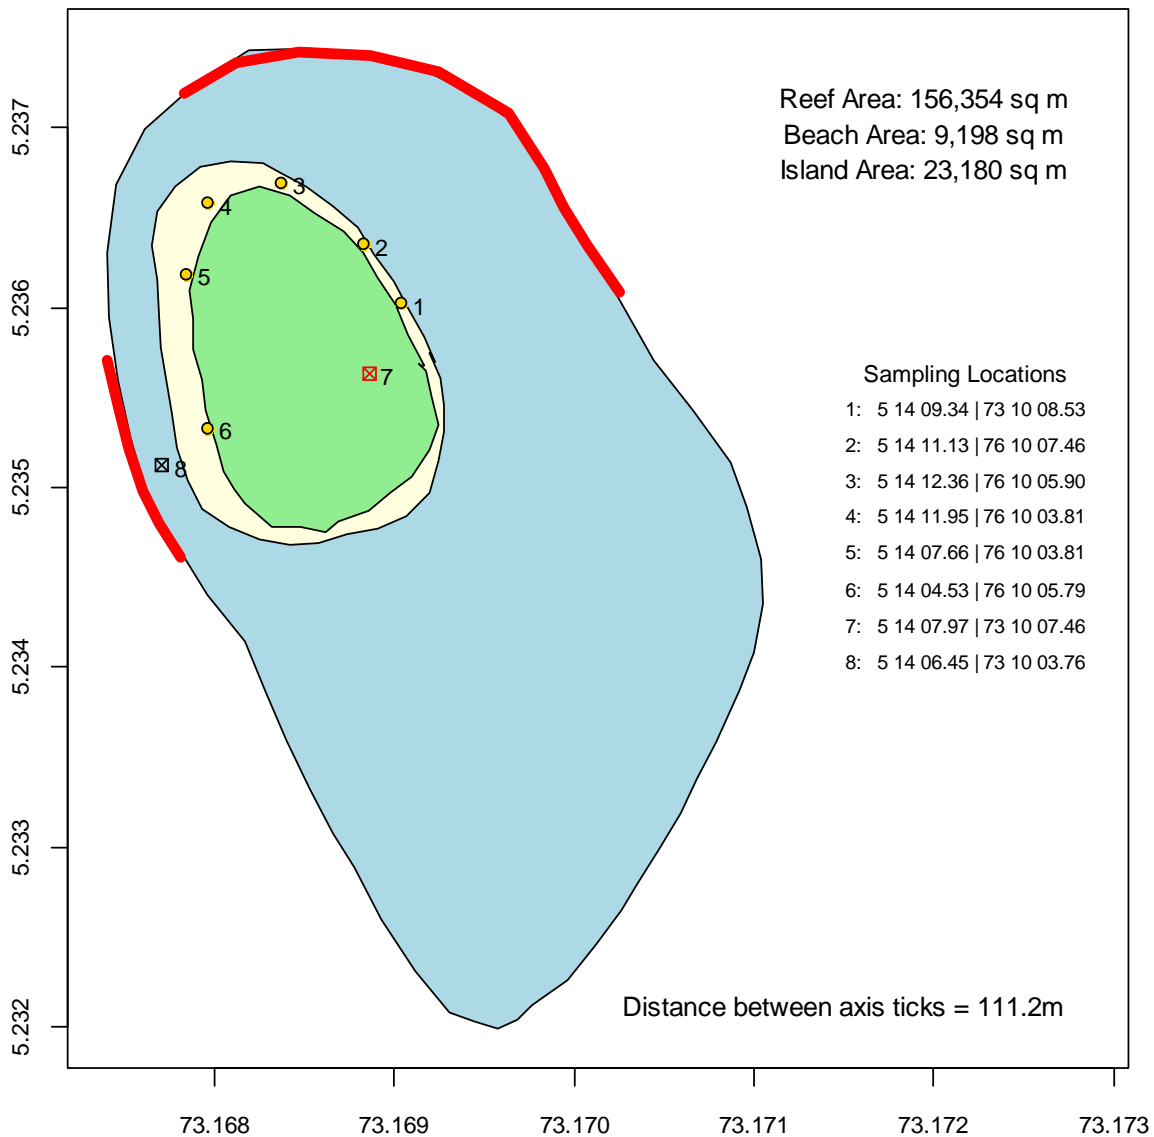
Figure 14: Study area and Survey locations, Sampling Locations 1-6 are position of beach profiles [degree, minutes, seconds in 2 decimal place], 7: ground water sample, 8: lagoon water sample, the coloured line indicates area covered in the reef survey.

The study area covers the terrestrial environment of the island is given in Figure 14 below shows the specific study area and survey locations with their respective GPS co-ordinates.

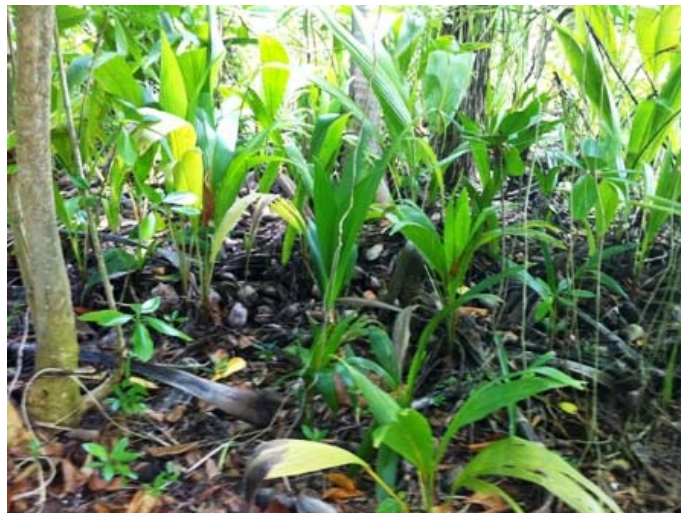
Figure 21: Large number of young palms was growing under canopy in places where sunlight streams in.

There were large number palm shoots and young palms in several areas. Some of these young palm trees were clustered while others appear to be randomly distributed. It appears that there is no harvesting of dried coconuts fallen to ground.

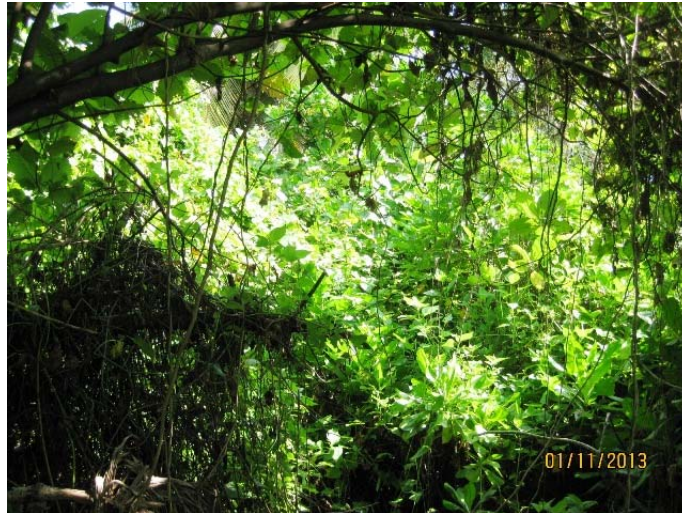
Figure 22: In some areas thick undergrowth was present.

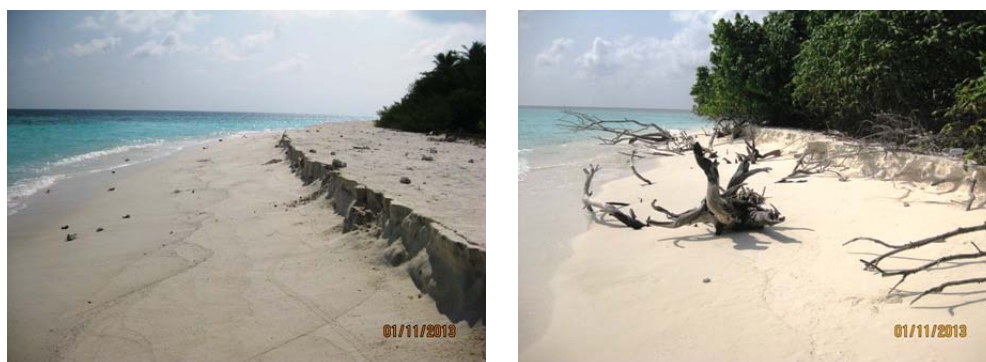
Figure 23: Erosion scarp along the north / north-eastern side was visible, and in some areas high tide mark is close or inside the vegetation line.

The island has soft white beaches all round the island. Beach rocks were not present on any part of the island. There was severe erosion on the north/north-eastern and eastern ends of the island. On the western side, and in some places, the high tide line very close or within the vegetation line. Several trees fallen and buried in the inter-tidal area suggests that erosion has been going for some considerable time.

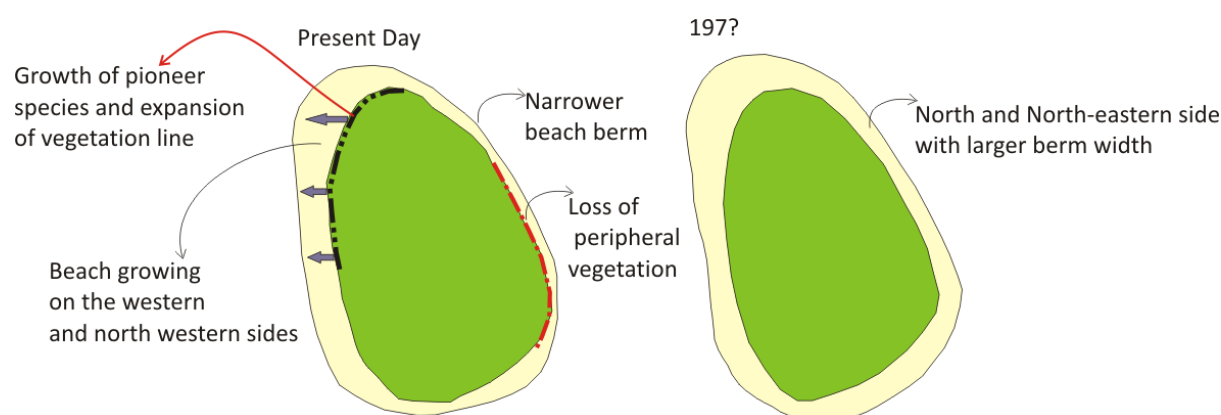
Figure 24: Schematic diagram (to scale as much as possible) to show the change in the morphology of the beach line and growth of new vegetation on the north western side.

Studying earlier satellite images of the island (c.f. Figure 12, Figure 25&Figure 24) and comparing with the current situation it appears that the western side is north and eastern side is being eroded while the island is being accreted ion the west Figure 24).

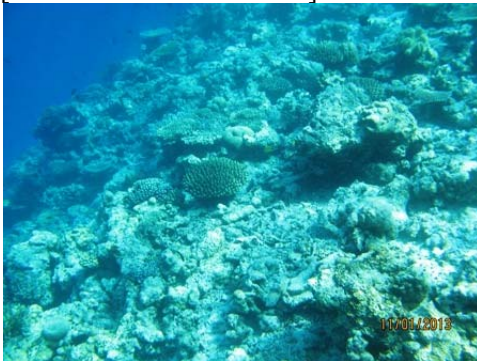
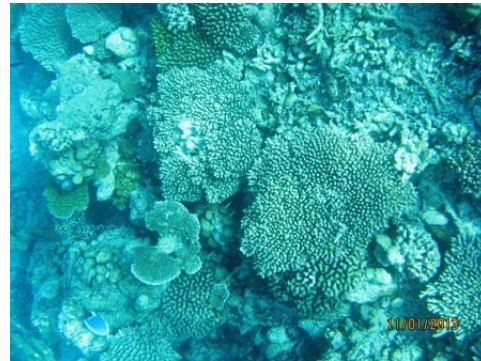
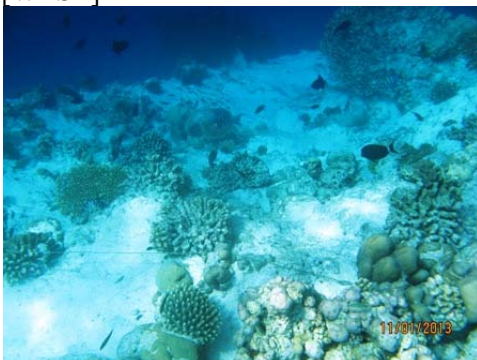
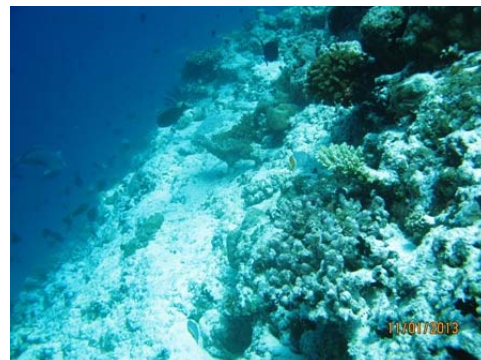
Figure 26: Typical (wide field) images to show representative substrate conditions for site 1 and site 2 (see Figure 14 for area location).

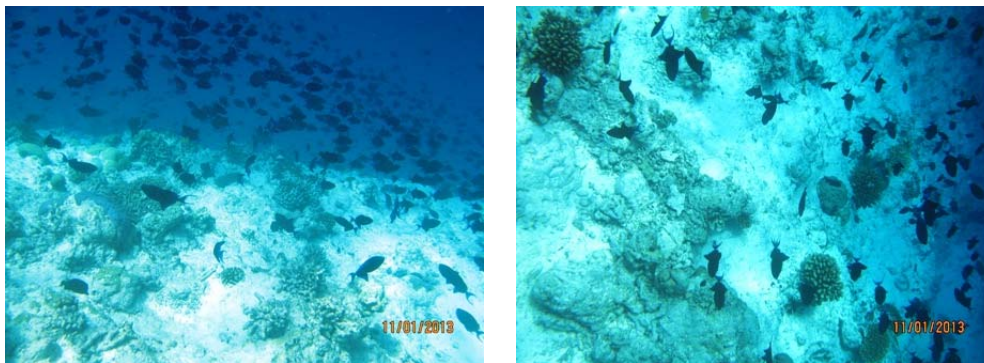
Figure 27: There are large numbers of red-tooth trigger fish (*Odonusniger*) on the west and in some section of the north eastern section of the reef.

There were large number of *Odonusniger* (the red-tooth trigger fish), and this is more visible on the western site. Large schools with literally thousands were hovering on the slopes.
