First Addendum

ENVIRONMENTAL IMPACT ASSESSMENT

**For the Proposed Coastal Protection Project at Villimale, North Male'
Atoll, Maldives**

Proponent: Ministry of Environment and Energy

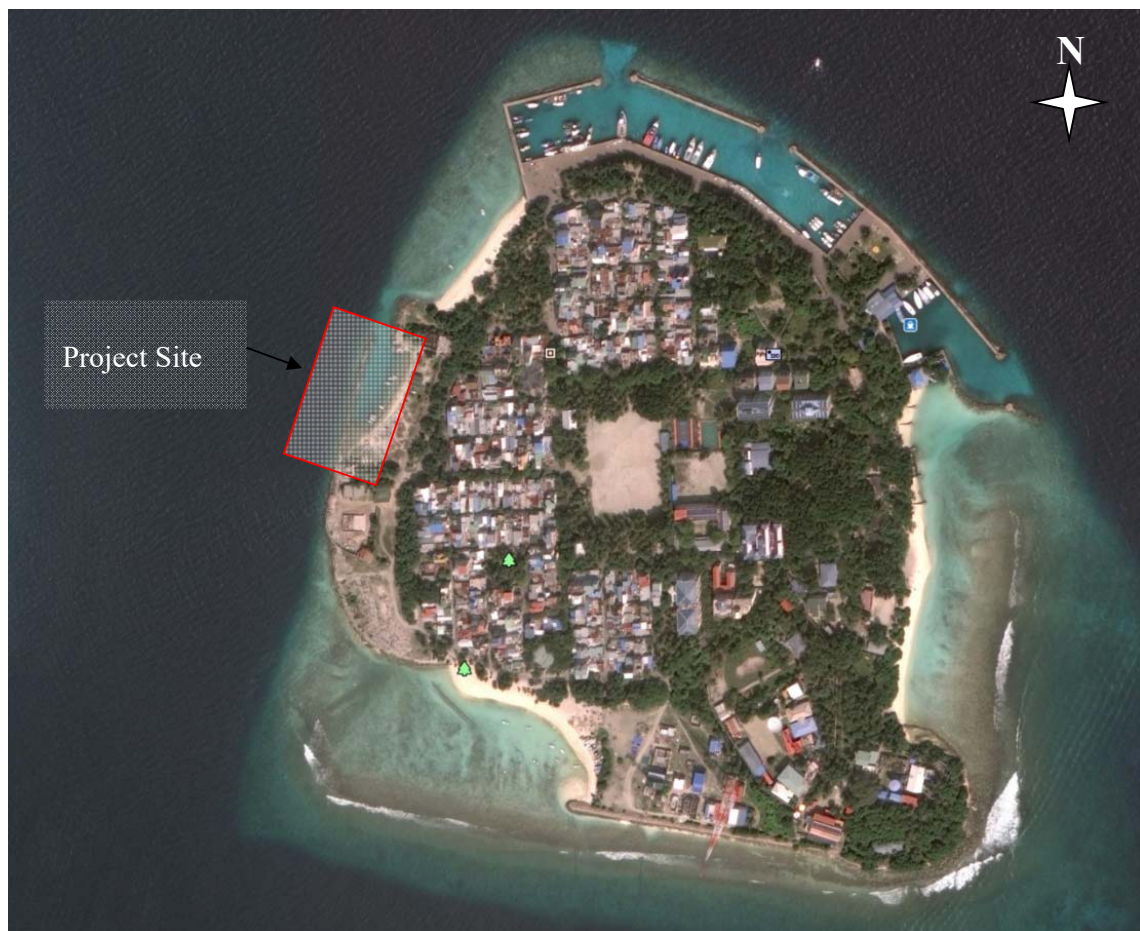
Figure 2-1: Location of revetment

The proposed revetment is on the western side of Villingili.

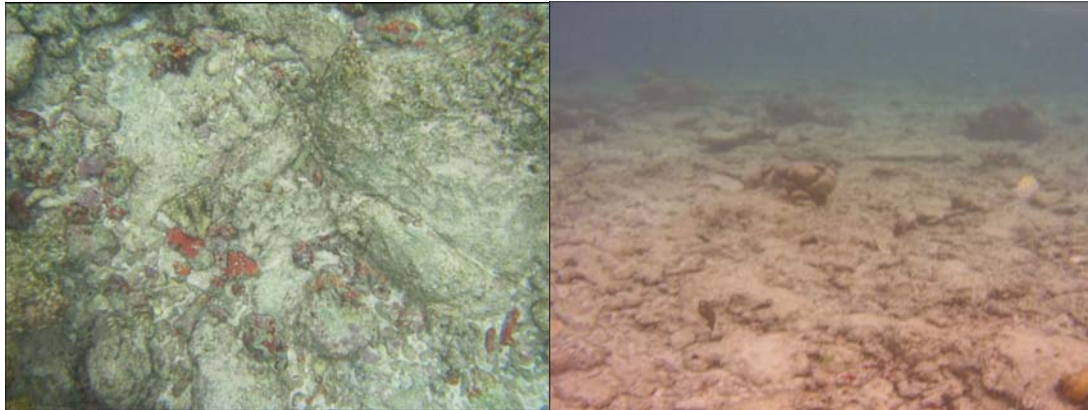
Figure 3-2: Benthic Cover percentages of M1

Site 1 was chosen from the northern part of the proposed project area. This area has very narrow reef flat and is the area where the proposed change to revetment under this addendum is focused on. Initial EIA studies showed that there were no live corals in the area and the benthos was dominated by hard substrate; such as dead coral covered by turf or encrusting coralline algae. No significant change has been observed at this site at present compared to baseline.

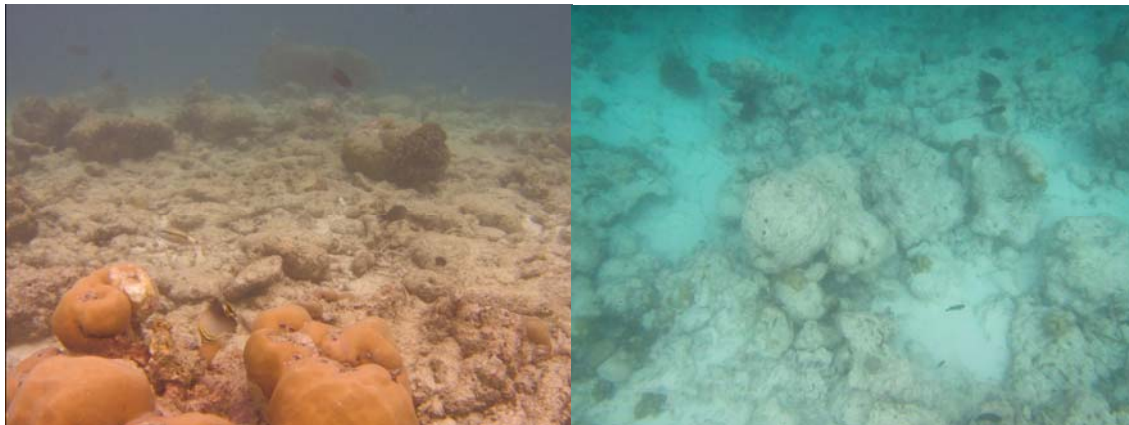
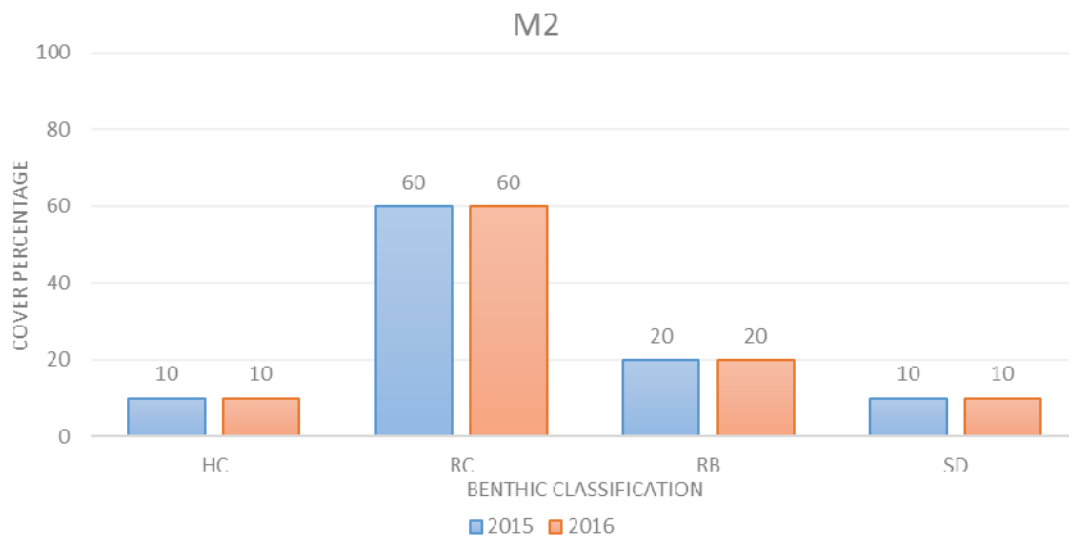
Figure 3-3: Benthic Cover percentages for M2

Site 2 was chosen from towards the middle of the proposed revetment. Similar to Site 1, this site was dominated by hard coral substrate with algae. However, few live coral colonies were also observed. No change from baseline was observed during this survey.

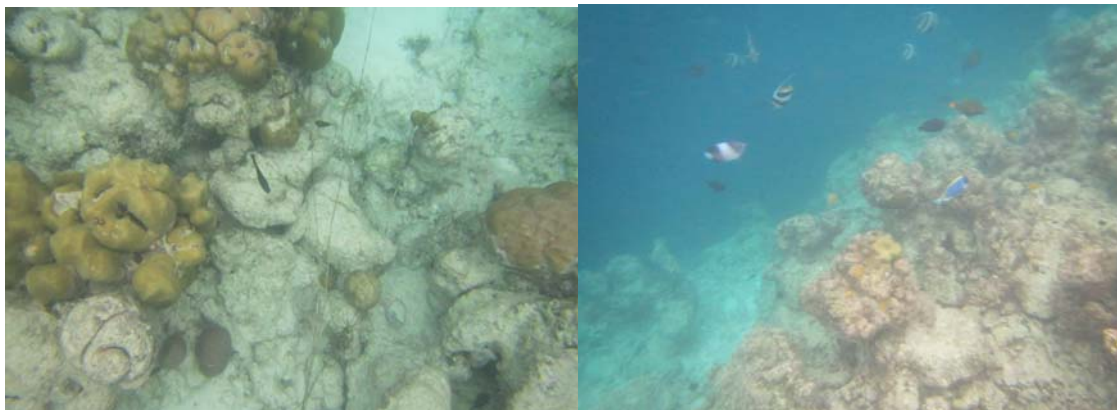
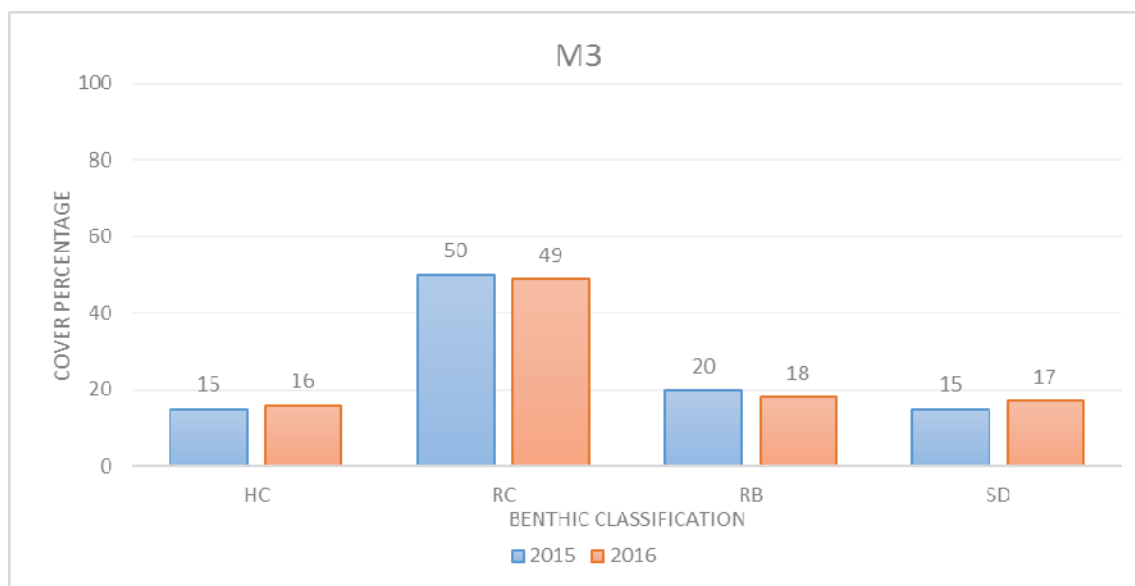
Site 3 was chosen from south of project area. Similar to the previous two sites, the benthos was dominated by dead coral with algae. However, in contrast to the other sites more live corals were observed at this site.

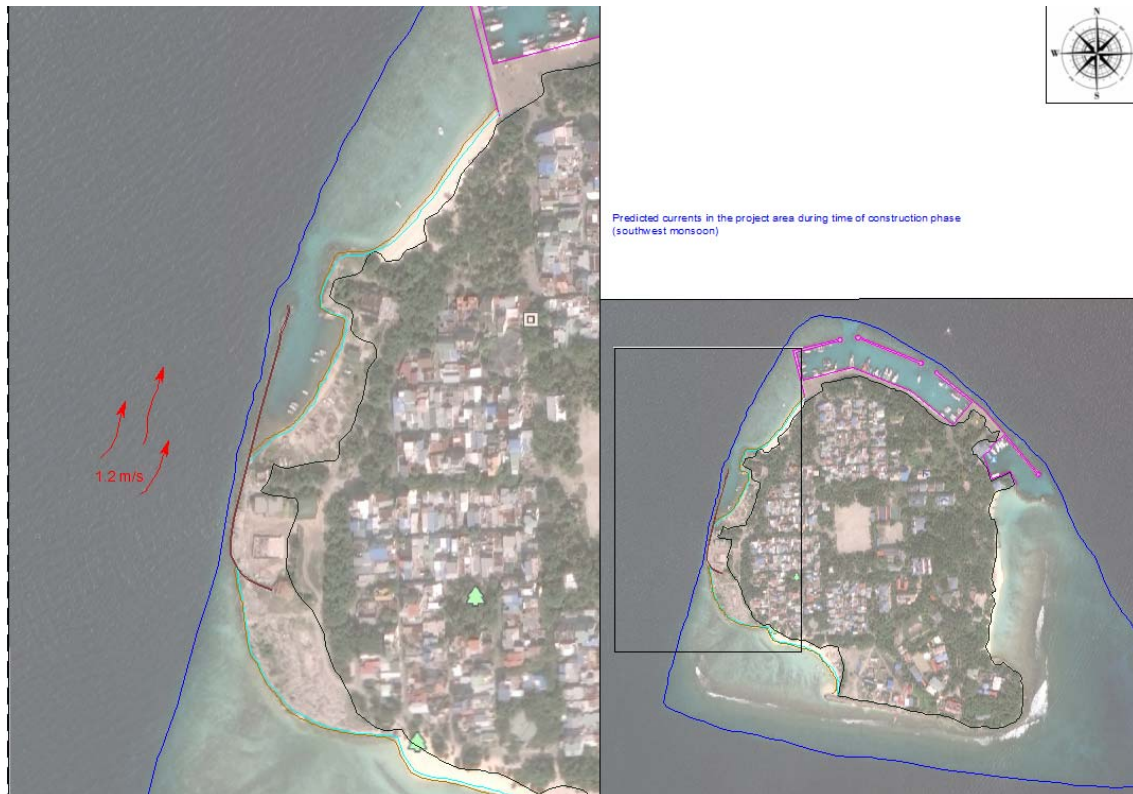
The currents in the area were assessed during field survey and based on general current flow in Maldives, currents in the project area during construction phase were predicted. The figure below shows general hydrodynamics of the area. During southwest monsoon; from April up to November, due to the channel between Villingili and Gulheefalhum, currents are usually southerly to southwesterly.

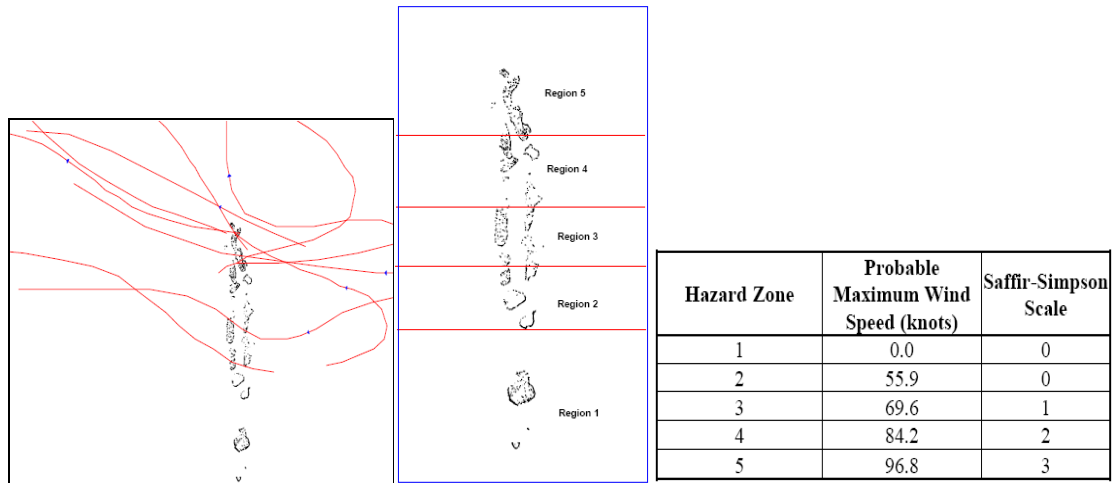
Figure 3-4: Natural hazard map of Maldives (after UNDP, 2005)

Referring to Suffir-Simpson Scale, the proposed site is considered fairly safe zone when cyclonic winds and storm surges over the Maldives are concerned and also low risk when tsunamis and earthquakes are concerned (RMSI/UNDP 2005).

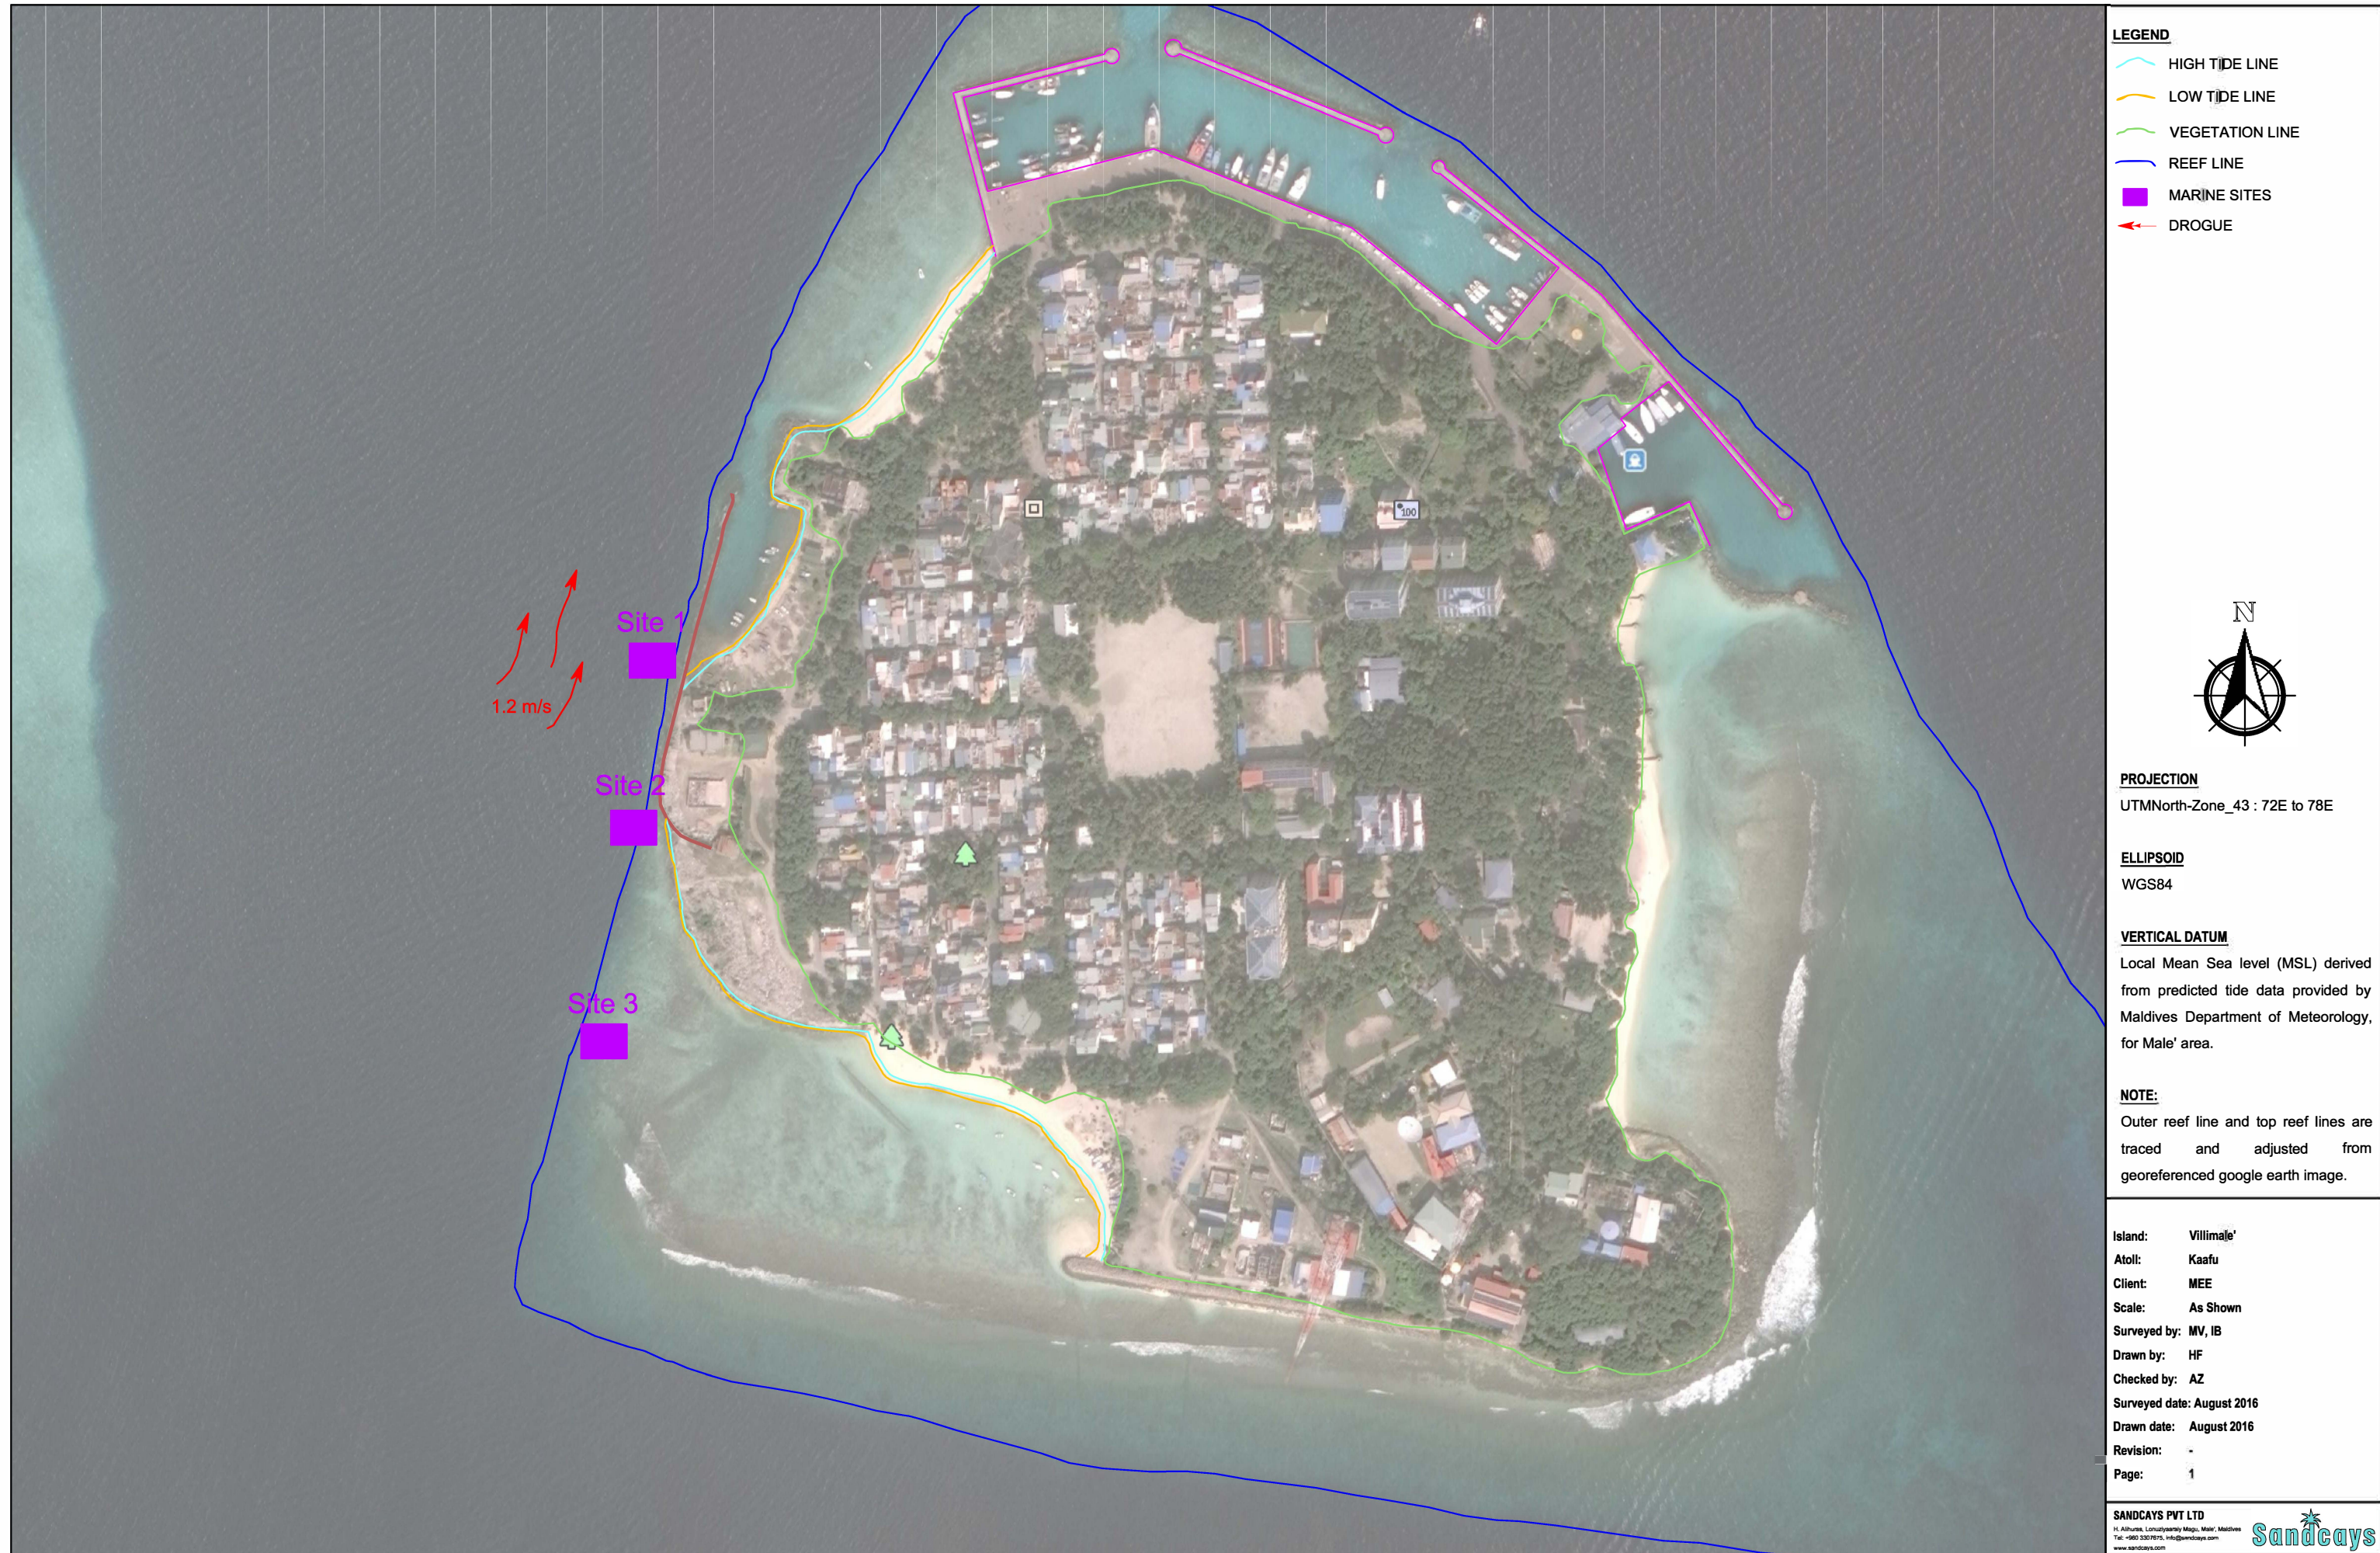
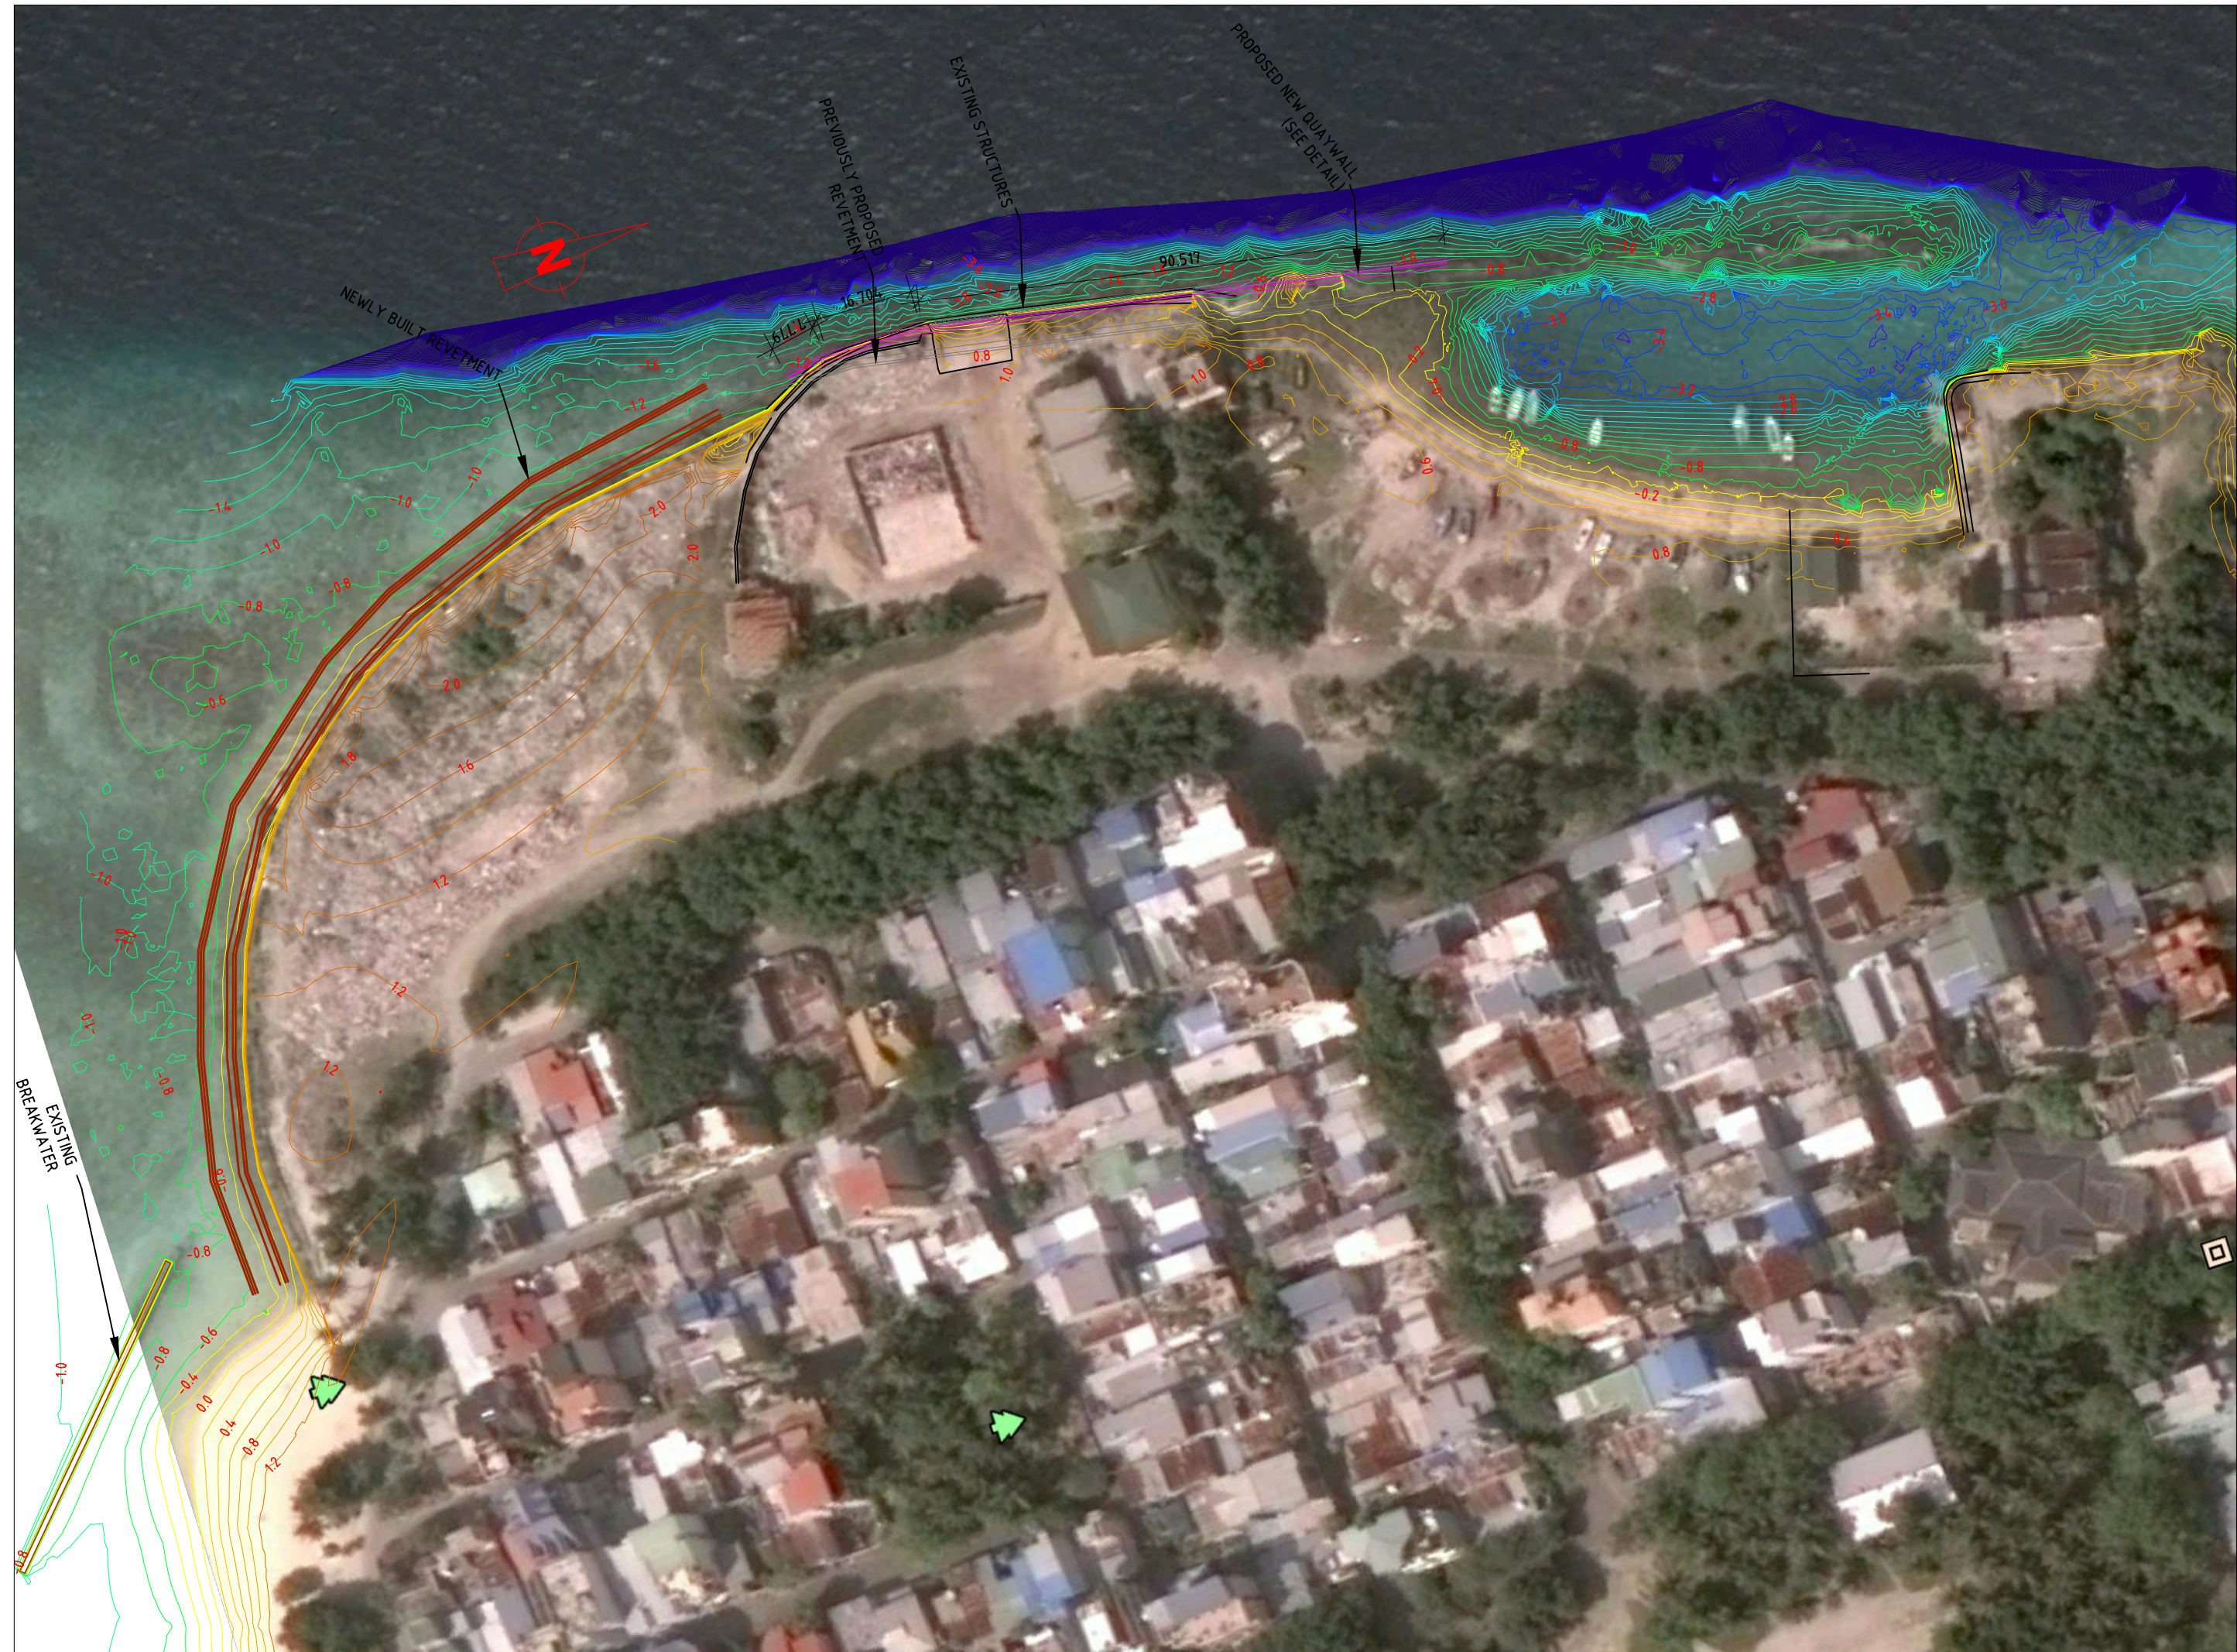
Figure 3-5: Shorelines and Monitoring Locations.

PROJECT TITLE	VILLINGILI COASTAL PROTECTION PROJECT
DRAWING TITLE	CONCEPT
SHEET TITLE	LAYOUT W/ CONTOUR
DRAWING NUMBER	MTCC/15/T10/01CB/C002
SHEET NUMBER	08A
SHEET TOTAL	SHEET 02 OF 03
