Environmental Impact Assessment Report

Ha.Madulu Island for Agricultural Development

Ihavandhippolhu Atoll

February 2008

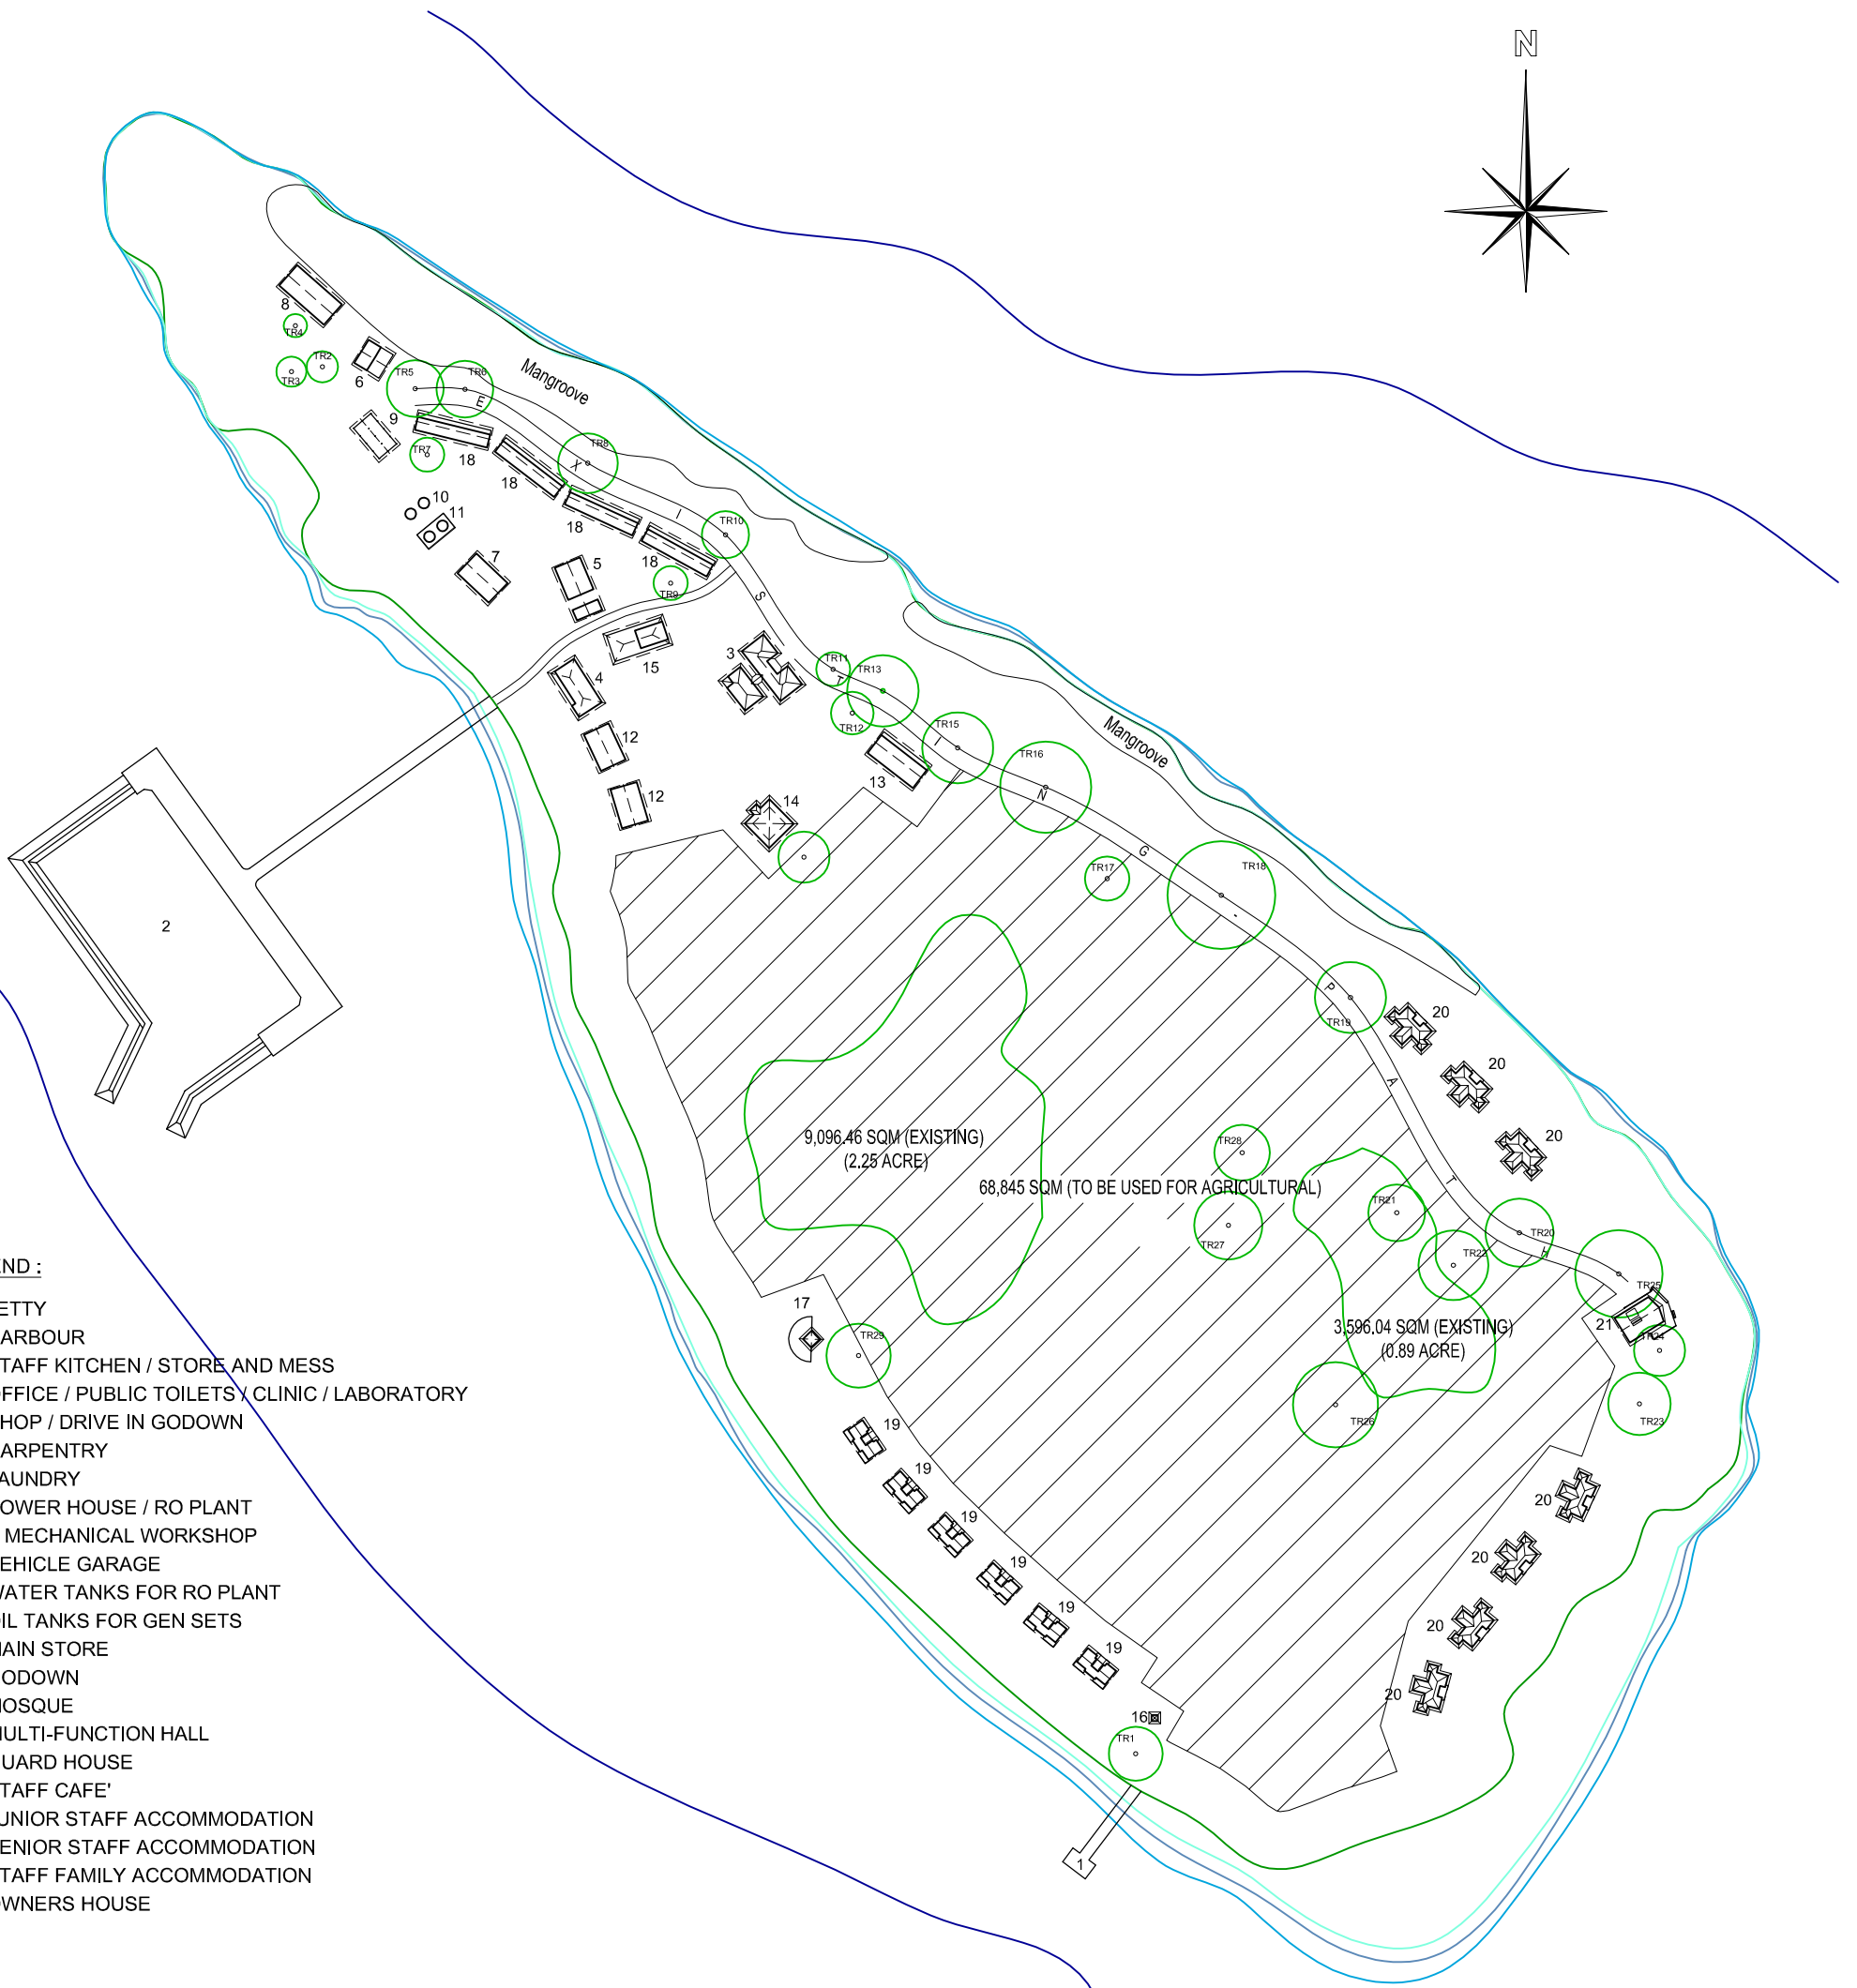
LEGEND :

- 1 - JETTY
- 2 - HARBOUR
- 3 - STAFF KITCHEN / STORE AND MESS
- 4 - OFFICE / PUBLIC TOILETS / CLINIC / LABORATORY
- 5 - SHOP / DRIVE IN GODOWN
- 6 - CARPENTRY
- 7 - LAUNDRY
- 8 - POWER HOUSE / RO PLANT & MECHANICAL WORKSHOP
- 9 - VEHICLE GARAGE
- 10 - WATER TANKS FOR RO PLANT
- 11 - OIL TANKS FOR GEN SETS
- 12 - MAIN STORE
- 13 - GODOWN
- 14 - MOSQUE
- 15 - MULTI-FUNCTION HALL
- 16 - GUARD HOUSE
- 17 - STAFF CAFE'
- 18 - JUNIOR STAFF ACCOMMODATION
- 19 - SENIOR STAFF ACCOMMODATION
- 20 - STAFF FAMILY ACCOMMODATION
- 21 - OWNERS HOUSE

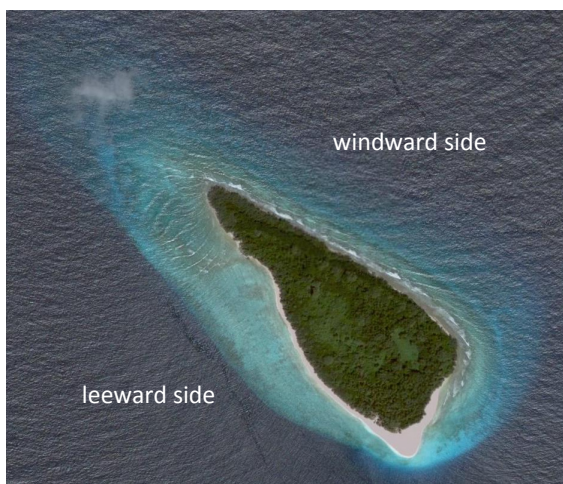
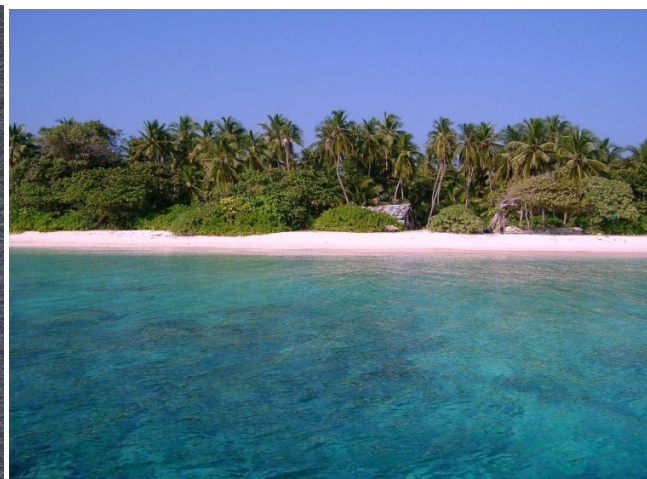
Plate 1 aerial phot (left) western side mid section (right)

Aerial photo of Madulu

Western side elevation of Madulu

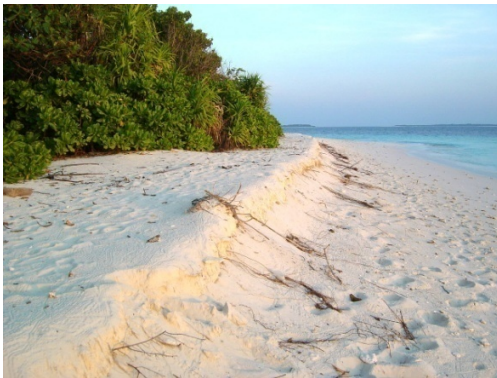
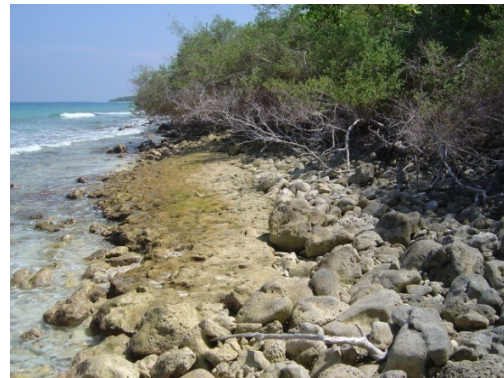
Plate 4 Beach

The sandy beach area is only found on western and southern side of the island whereas the entire northern and eastern side consisted of rubble and boulder beach. The total beach area was calculated as 1.5 hectares, which is approximately 2% of the entire island system. The western side beach is approximately 8m wide in average and 500m long. The southern side beach is the sand spit of the island and moves east and west with the changing monsoon wind and currents. Beach-rock is found on eastern and northwestern side of the island.

Sandy beach on western side

Rocky beach on northern and eastern side

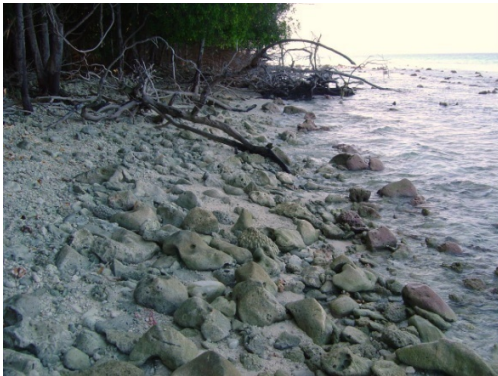
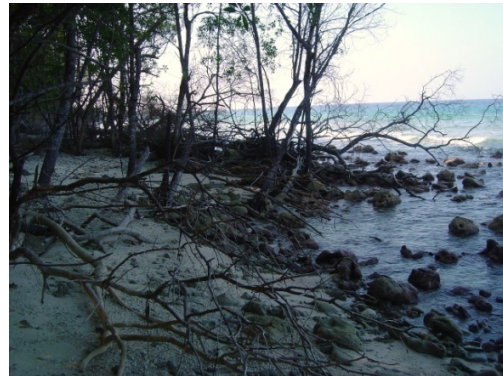
Plate 6 Beach Section A

Eastern side beach consisted of mostly boulders and sand in between on few areas

Section A is the eastern side of the island. This section of the beach materials are dominated by boulders followed by cobble, rubble and pebble and few sand within them. The larger size beach material on this section of the beach is originated from the windward reef-flat on eastern side of the island. Section A measures approximately 670m (35%) of the beach perimeter. The average width of the beach area in this section is 3m. Approximate average height of the beach above mean sea level is 1m. As this section of the beach faces the open sea on eastern side of the atoll the beach is exposed to constant wave energy and wind generated and tidal currents.

Section A is relatively large beach area consisting of mostly coral boulders, cobble, pebble, rubble and sand in small and few isolated areas. The beach material in this section is dominated by coral boulders. Sediment in this section is related to mostly boulders, cobble and pebble rather than sand. Therefore, involves extensive wave energy, which is only felt during occasional extreme weather conditions like tidal wave events so that the frequency of sediment dynamics in this section is less compared to other sections. However, most extensive in terms of energetic. Beach materials in found in this section are brought from the shallow lagoon and the reef on western side of the island by waves as shown in figure 2. Sediment dynamics in this section of the beach is most significant in terms of accretion of large areas altering the eastern side elevation of the island.

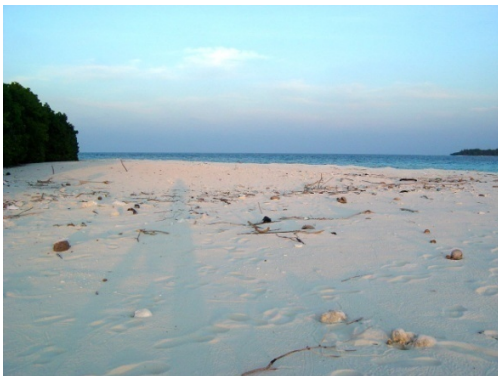
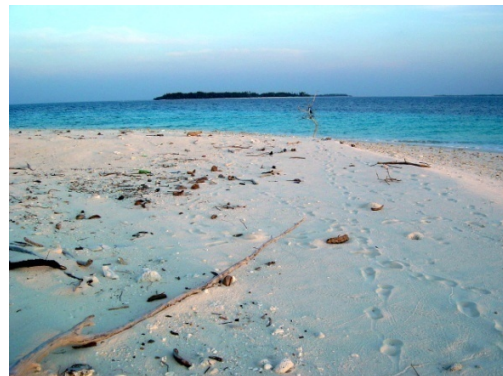
Plate 7 Beach Section B

The sand-spit on southern side of the island covering a very large area

Section B is the southern side of the island where the sand-spit of the beach is found. The beach material in this section is fine sand. This section of the beach has a length of approximately 250m (13%) of the island's beach perimeter. The average width of this section of the beach is 16m. The average height of the beach in this section is approximately 1.5m

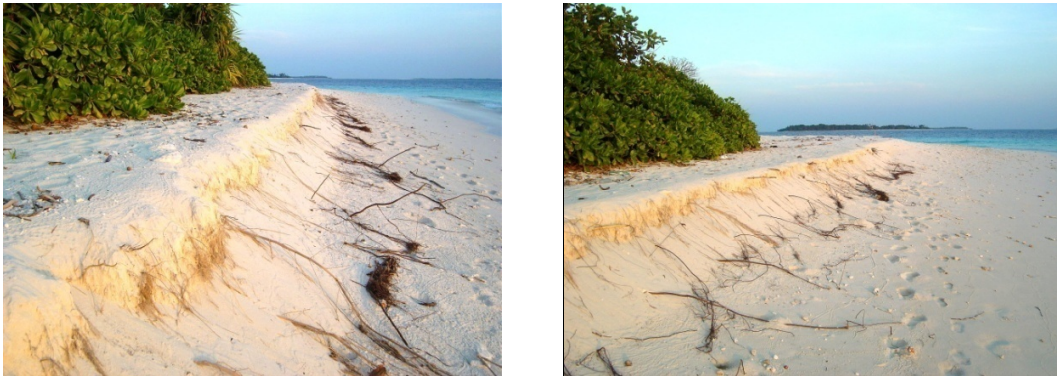
Plate 8 Beach Section C

Extensive seasonal erosion found on SW. side of the island beach.

Section C is the southwestern side of the island where sediment dynamics is most pronounced as this area is the intersection of sand most dynamic beach area and the stable beach area. Therefore most frequent seasonal beach erosion and accretion is found in this area. This section of the beach measures approximately 130m (7%) of beach perimeter and the beach width in this area varies significantly with the monsoons currents. This section's beach materials consisted of fine sand.

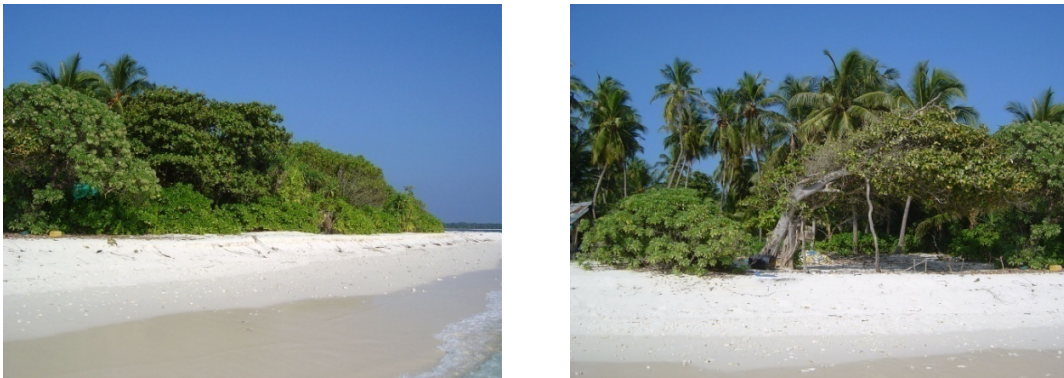
Plate 9 Beach Section D

Stable beach on central area of western side of the island

Section D is the western side of the island where the most stable beach is found. Beach materials in this section of the beach consisted fine sand. Length of beach in this section is 370m which is 20% of the total perimeter of the beach. The average width of beach in this section is 7m. This is the longest beach area of the island.

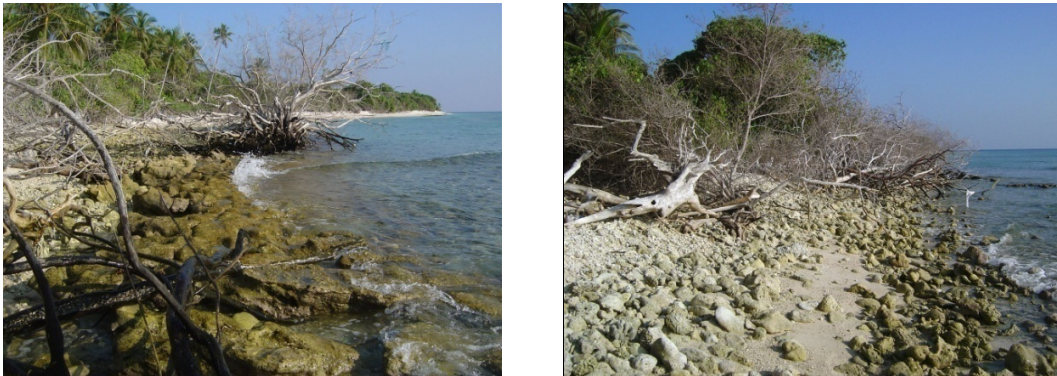
Plate 10 Beach Section E

Beach rock and rubble found on NW side of the island beach

Section E is the northwestern side of the island where the beach receives high wave energy especially during the transitional period of monsoon from southwest to northeast monsoon. The beach length of this section is 140m (7%) of the perimeter of the island beach. The beach materials in this section are dominated by cobbles followed by rubble and sand. Beach rock further from the beach found is in southern area of this section of the beach.

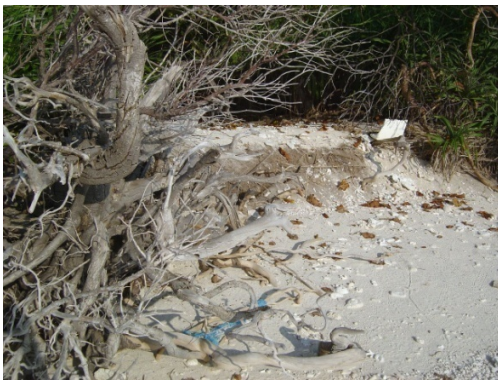
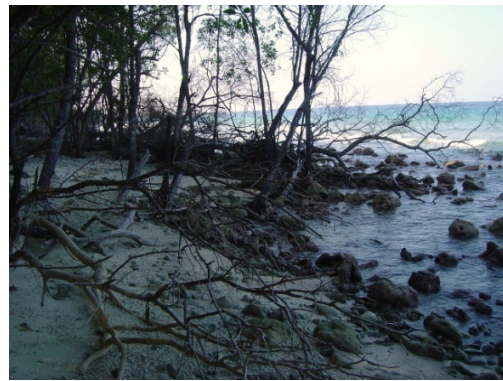
Plate 11 Beach erosion in NW

Beach all around Madulu receives very high wave energy, especially in eastern and north eastern sides of the island corresponding beach Section A and E in figure 2. Permanent beach erosion is found in these areas. Some of the coastal vegetation in these areas, especially in northwestern areas corresponding Section E in figure 2 are being lost due to the erosion in these areas. However, due to the high wave energy larger size materials had accumulated in these regions. As a result of accumulation of larger size beach materials beach erosion is minimized to some extent so the erosion is relatively slow.

Continuous beach erosion on NW side of the island.

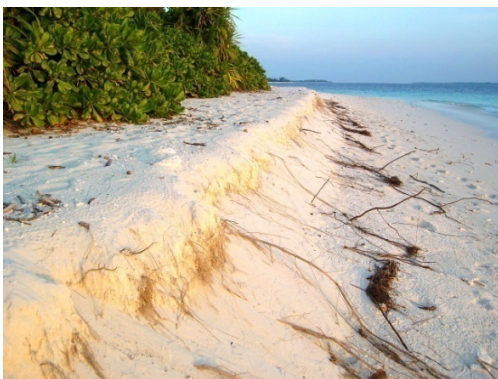
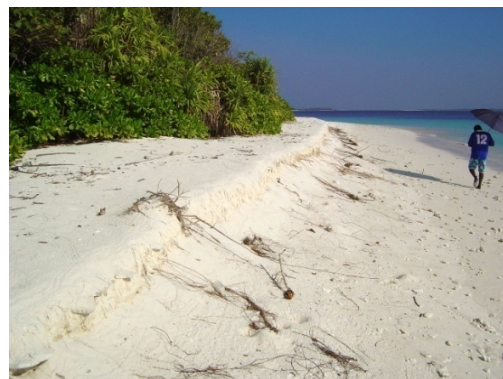
Seasonal beach erosion during SW monsoon was observed to be severe but not serious in southwestern side of the island corresponding Section C in figure 2. Roots of the coastal vegetation (sea lettuce and screw pines) in this section of the beach are being exposed due to erosion in this section of the beach.

Seasonal beach erosion on SW side of the island

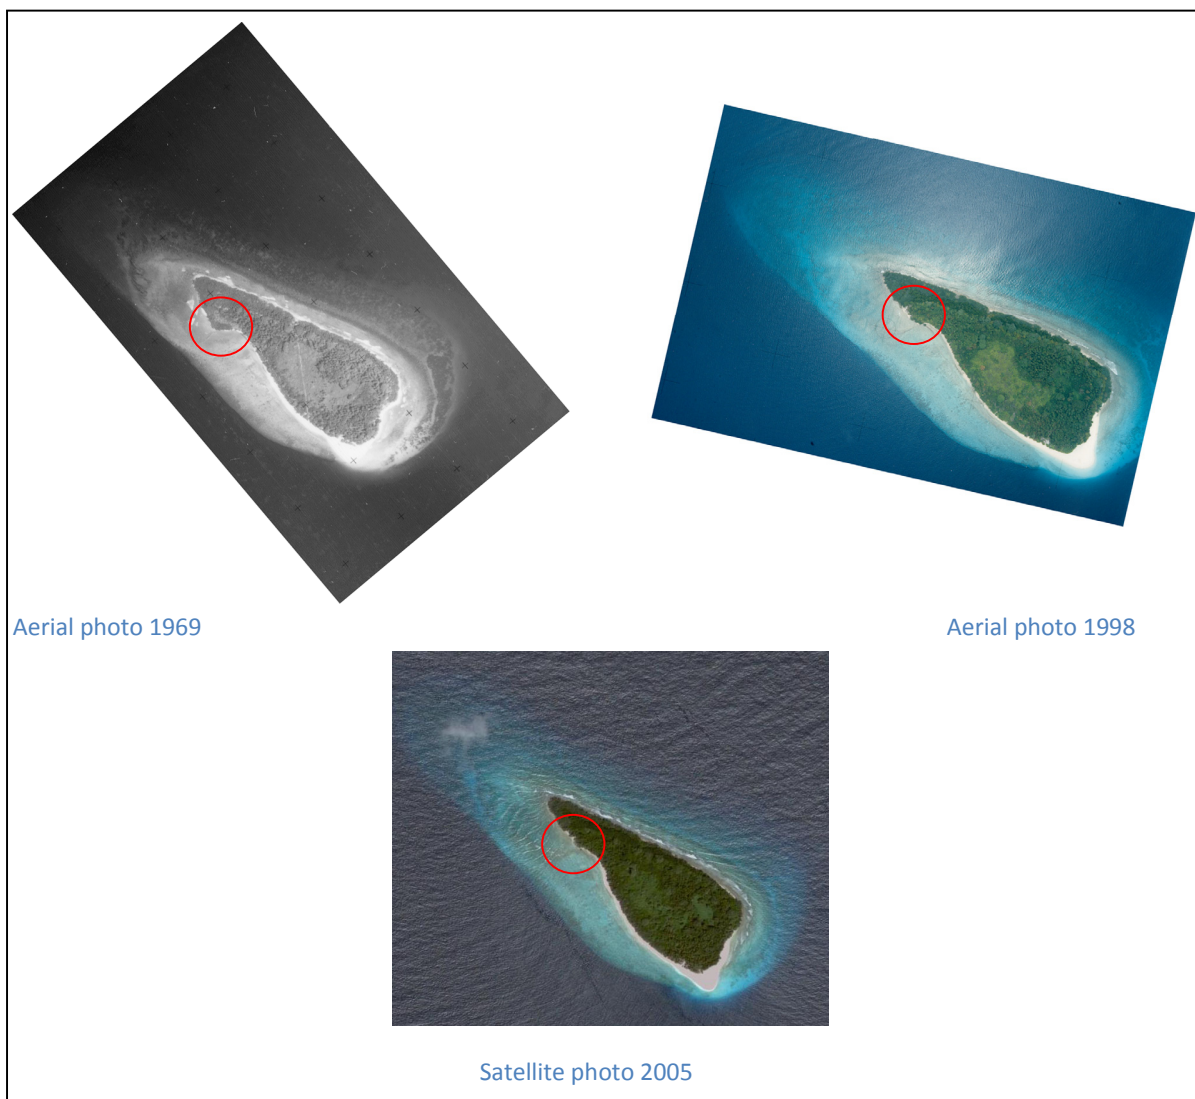
Plate 13 Aerial photos of Madulu

Historic beach erosion assessed by comparing scale aerial photos taken in 1969 (top left), 1998 (top right) and 2005 (bottom) show that there has been significant beach erosion in northwestern side corresponding Section E of figure 2 within the last 35 years. Approximately 4,030m² of the island (3%), with the beach had been eroded in this area of the island and beach rock has been exposed. This assessment also showed that erosion in this area had taken place faster within the last 10 years. The more recent aerial photos and the field surveys showed that this area continues to erode relatively slowly compared to some of the islands undergoing erosion. Other area of the beach was found to be relatively stable in terms of permanent beach erosion as shown by the historic aerial photos and the recent field surveys.

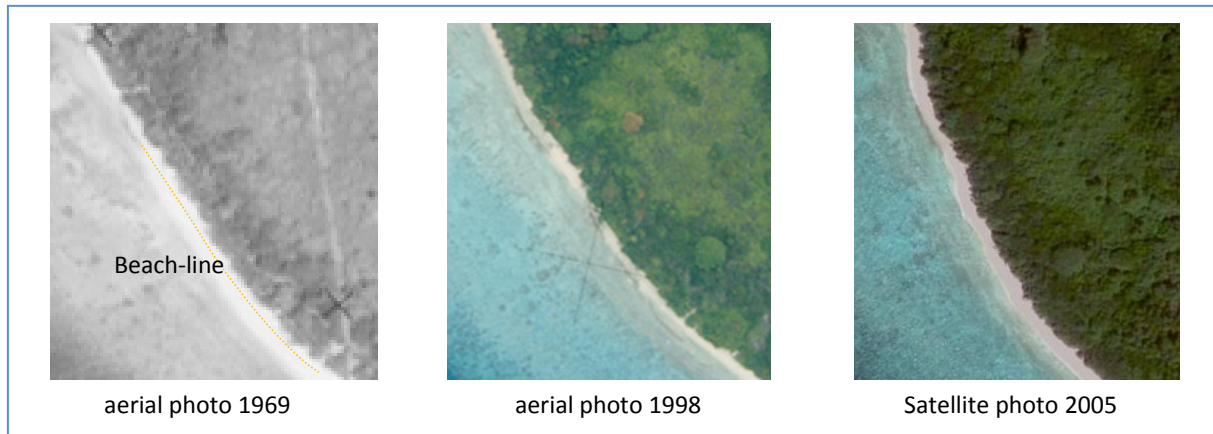
Figure 5 Beach accretion

Comparison and analysis of aerial photos taken in 1969, 1998 and 2005 field data and observations showed that there is slow beach accretion in western side of the island corresponding Section D in figure 2. This accretion is partly due to erosion in northwestern areas of the beach and partly due to natural accumulation of beach sediment from the lagoon on western side.

Beach has been growing due to sediment accretion on western side of the island as shown in figure 4. The surveys and observations also showed that the vegetation has also extended westward during the last 30 to 40 years meaning that the island is growing on western side but eroding in northwestern side.

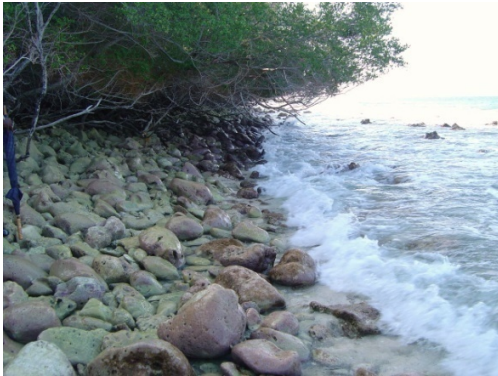
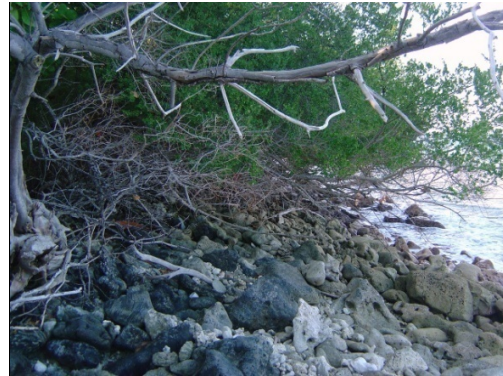
Plate 15 Beach section A

Eastern side beach area consisted of mostly coral boulders and rubble

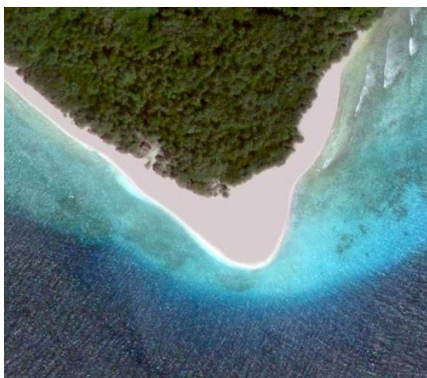
Section BC is the most dynamic beach area of the island as it is the sand-spit of the island. This section of the beach is most dynamic in terms of frequency however, least in terms of energetic. Beach sediment movement twice a year in relation to the alternating monsoon is found in this section of the beach. Sediment in this section of the beach moves from west to east during SW monsoon (May – November) and from east to west during NE monsoon (February – May). Observations showed that beach sediment in this section is spilling into the deep atoll lagoon and lost from the sediment budget of the island to some extent. The spilling sand may be partly coming from the eroding area in Section E as shown in figure 2 and partly from the natural accretion in Section D. The spilling of sand from Section B in to the deep atoll lagoon is occurring as the shallow lagoon of the island in southern area is very narrow and saturated. The access sand will naturally spill out of the sediment budget then the shallow lagoon area is full.

Sand spilling out of the sand-spit slowly in southern side of the island.

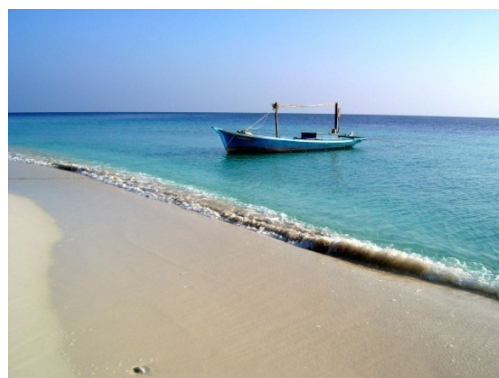
Plate 18 Beach Section D

This is the western side of the island beach. This section of the beach is the least dynamic in terms of frequency, extent and quantity. This section is the most stable beach of the island where least beach erosion is found. This section was observed to be having net accretion over the long-term. The accreted sediment may be partly coming from the eroding area in Section E and from the lagoon in the natural accretion process of the beach sediment.

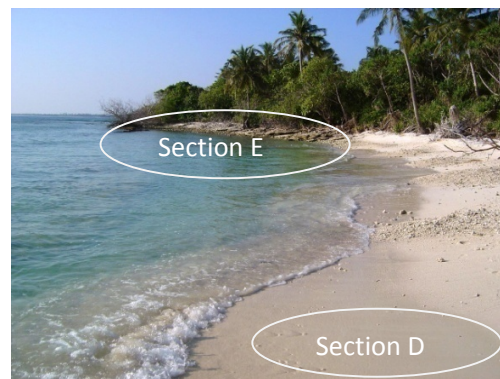
Plate 19 Beach section ED

Section E is the northwestern side of the island where there is serious beach erosion. Sediment in this section of the beach is partly fine sand and partly pebbles and cobbles to some extent. Sediment dynamics in this section is most significant in terms of net erosion. Field surveys and observations showed that sediment in this section is moving from northern areas of this section to Section D as shown in figure 2 in NW monsoon resulting permanent beach erosion in this section of the beach.

Eroding area on NW side

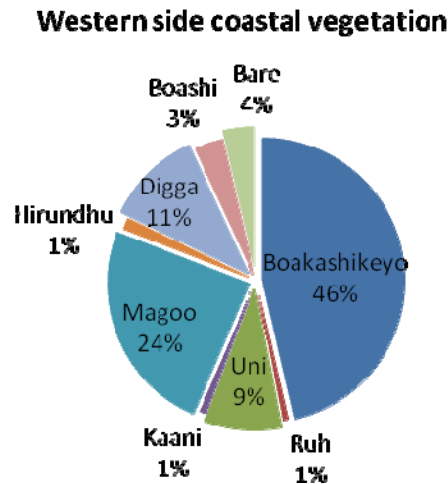
Figure 8 Western side coastal vegetation cover

The following figure shows the coastal vegetation covered by different species of plant as relative percentages, assessed by transects conducted on western side coastal vegetation.

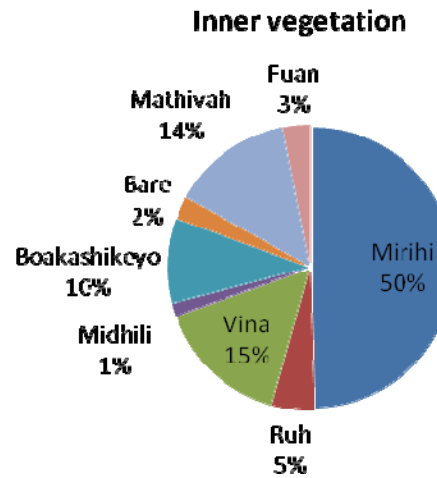
Figure 12 Inside vegetation cover

Transects surveys were also conducted inside the island to assess the vegetation cover of the island. The following figure shows the inside vegetation covered by different species of plant as relative percentages, assessed by transects conducted in central area of the island.

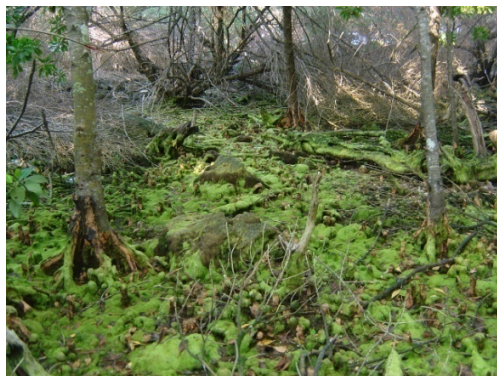
A long stretch of mangrove area is found close to the eastern periphery more to the NE area of the island as shown in figure 5. Southern part of the mangrove area covers part of the coastal vegetation and is less muddy whereas the northern part of the mangrove is more muddy and waterlogged. Rainwater is retained in the northern part during the rainy season and gets dry during dry seasons. The

Waterlogged area in north of mangrove area

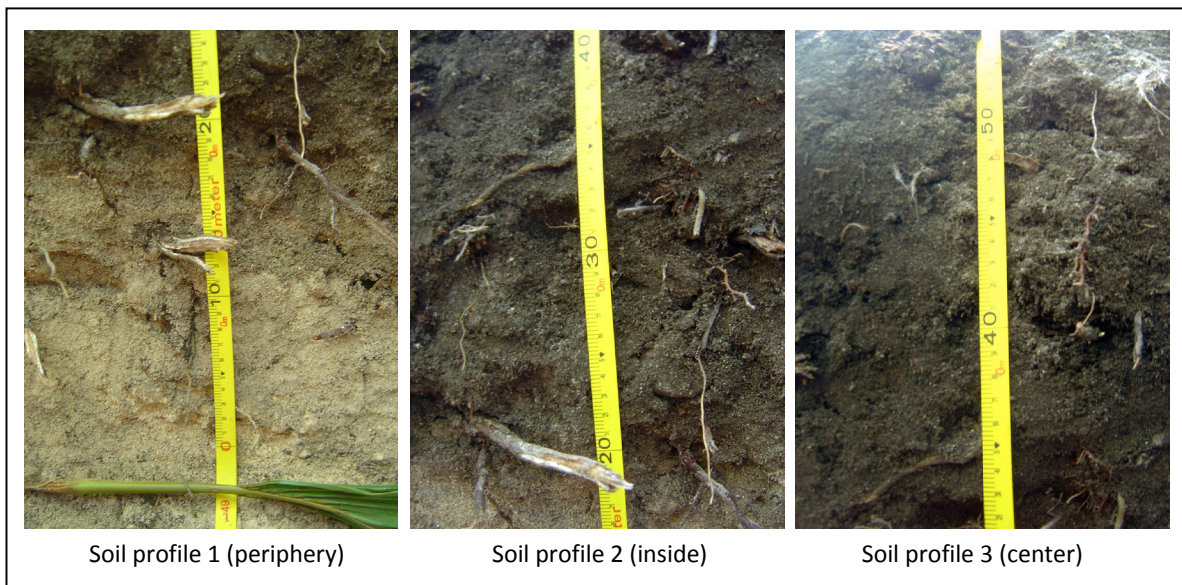
Plate 27 Locations of soil profiles

Soil profile 1: the periphery of the island is less fertile having thin layer of dark soil measuring 10cm and more white sand. Soil profile 2: Soil inside the island consisted of thicker layer of dark soil measuring 20cm. Profile 3: The soil profile taken in central area of the island showed that the fertile layer of soil has a thickness of 25cm and a humus layer on top of the soil.

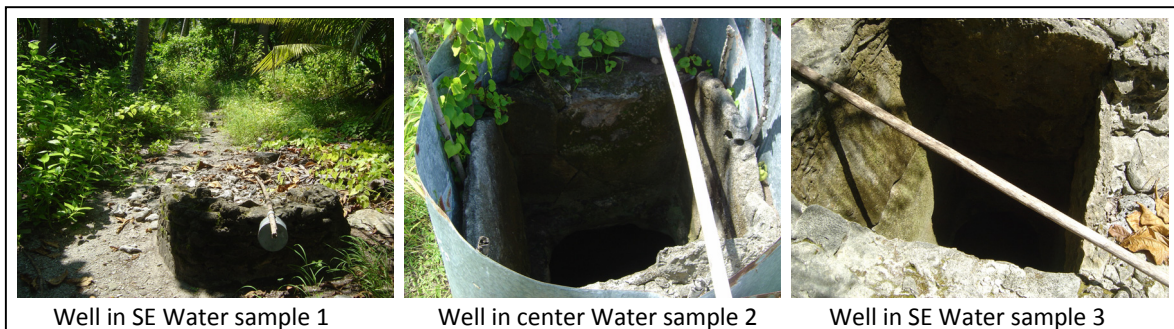
Plate 28 Groundwater sampled locations

The status of the groundwater varied from periphery to the central areas of the island as found in other similar islands in the country. The groundwater in periphery of the island has more salt content (higher salinity) than in central area as shown in table 2. Sulphate concentration in the groundwater is higher in periphery of the island. No particular such pattern of concentration of other contents tested was found in the groundwater as shown in table 2.

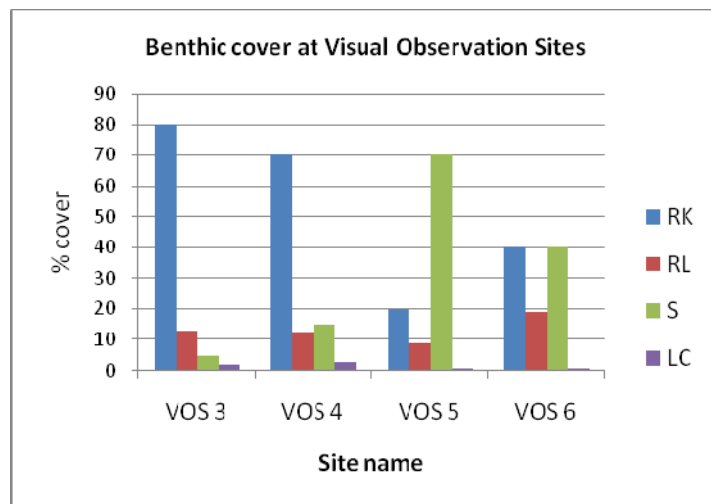
Figure 15 percentage cover of benthic substrate at visual observation sites

The dominant forms of benthic cover are rock, rubble and sand. Branching forms of *Acropora* spp. (staghorn) corals predominates the live benthic cover. Massive types corals namely *Porites* spp., *Favites* spp. and encrusting type *Pavona* and *Echinopora* were also present. The benthic covers are given in percentages of the bottom area surveyed. LC = live corals, RK = rock, RL = rubble, and S = sand

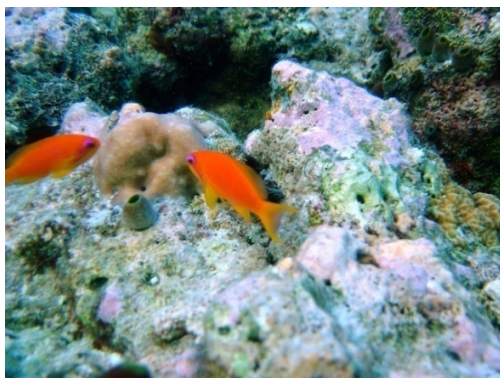
Serranidae sp.

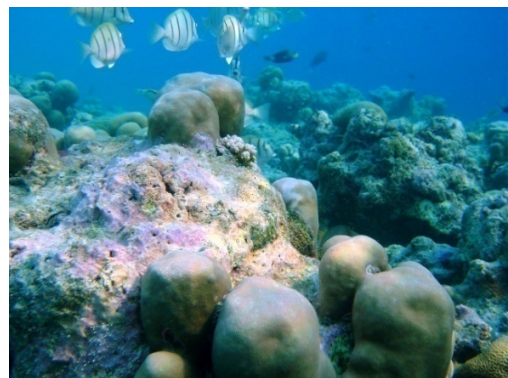
Acanthurus triostegos

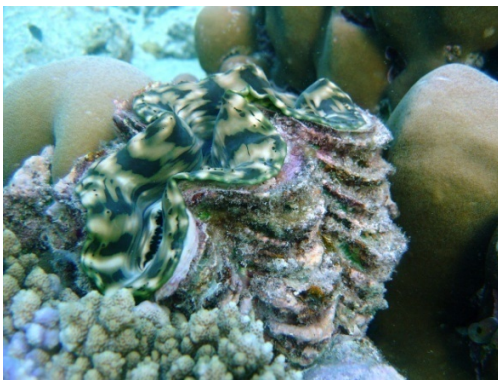
Giant clam

Only a few species of mollusks and echinoderms were encountered in these 2 sites whci area shown in Plate 31. This may be due to the nocturnal nature of mollusks and echinoderms. What was observed during the timed swims is presented in the table below.

Common name	Count S1	Count S2
Giant clam	5	6
Sea cucumber	4	2
Starfish	6	4
Tiger cowrie	1	-
Urchin	3	7

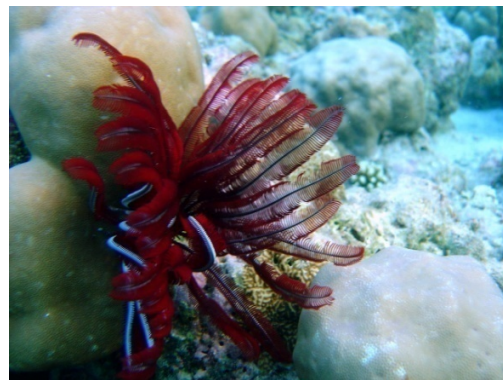
Feather star

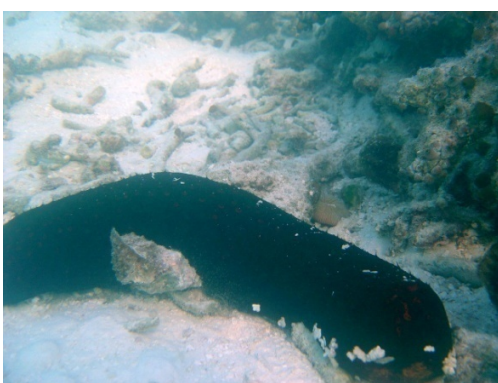
Sea cucumber

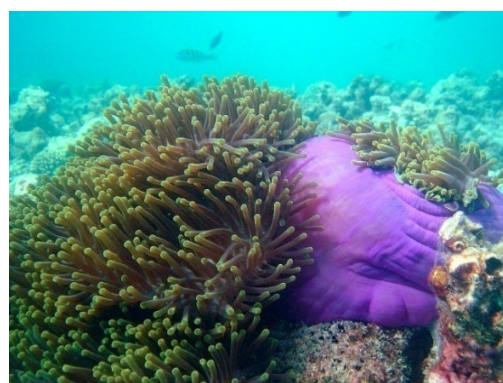
Sea anemone

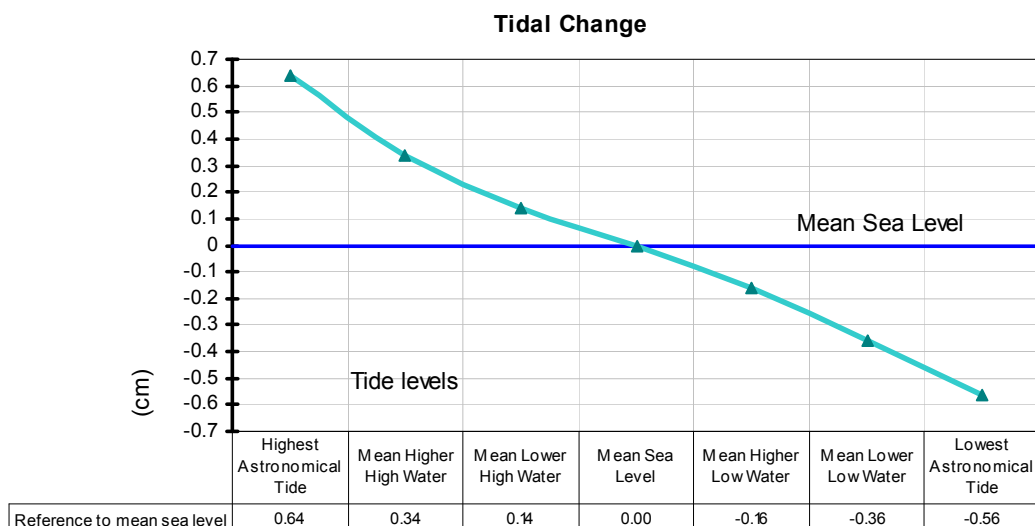
Figure 18 Tidal change

Like most of the places semidiurnal tides are experienced in the atoll, that is two high tides and two low tides a day. The tide varies from place to place, depending on the location and on the shape and depth of the basin, channels and reefs and also time of the year.
