# **Environmental Impact Assessment Report For Coastal Protection at Gn. Fuvahmulah, Maldives**

November 2016

**Name of the Project:** Proposed coastal protection at Gn. Fuvahmulah

**Project Proponent:** Ministry of Environment and Energy

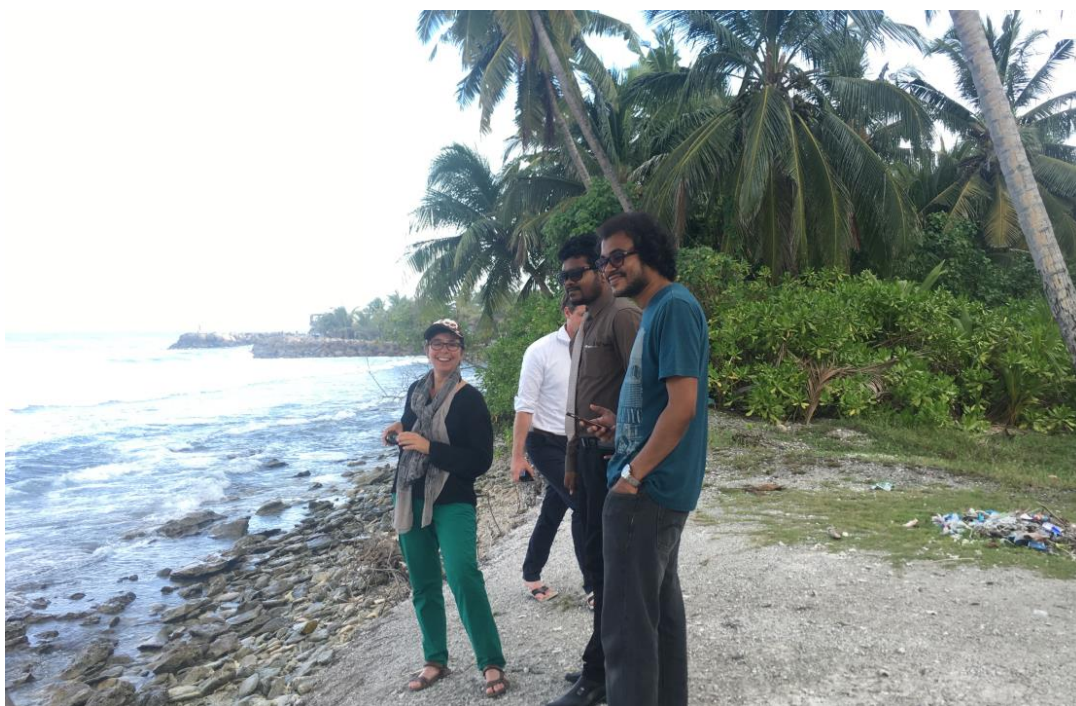
*Figure 11: Team inspecting the eroding coastline during July 2016 visit*

A team from MEECO & RHDHV travelled to Fuvahmulah from 10<sup>th</sup> to 15<sup>th</sup> July 2016 for conducting environmental and Socio economic surveys for the EIA report (Figure 11). An official from the MEE also attended the visit List of participants in the field visit is given in **Annex 4**.

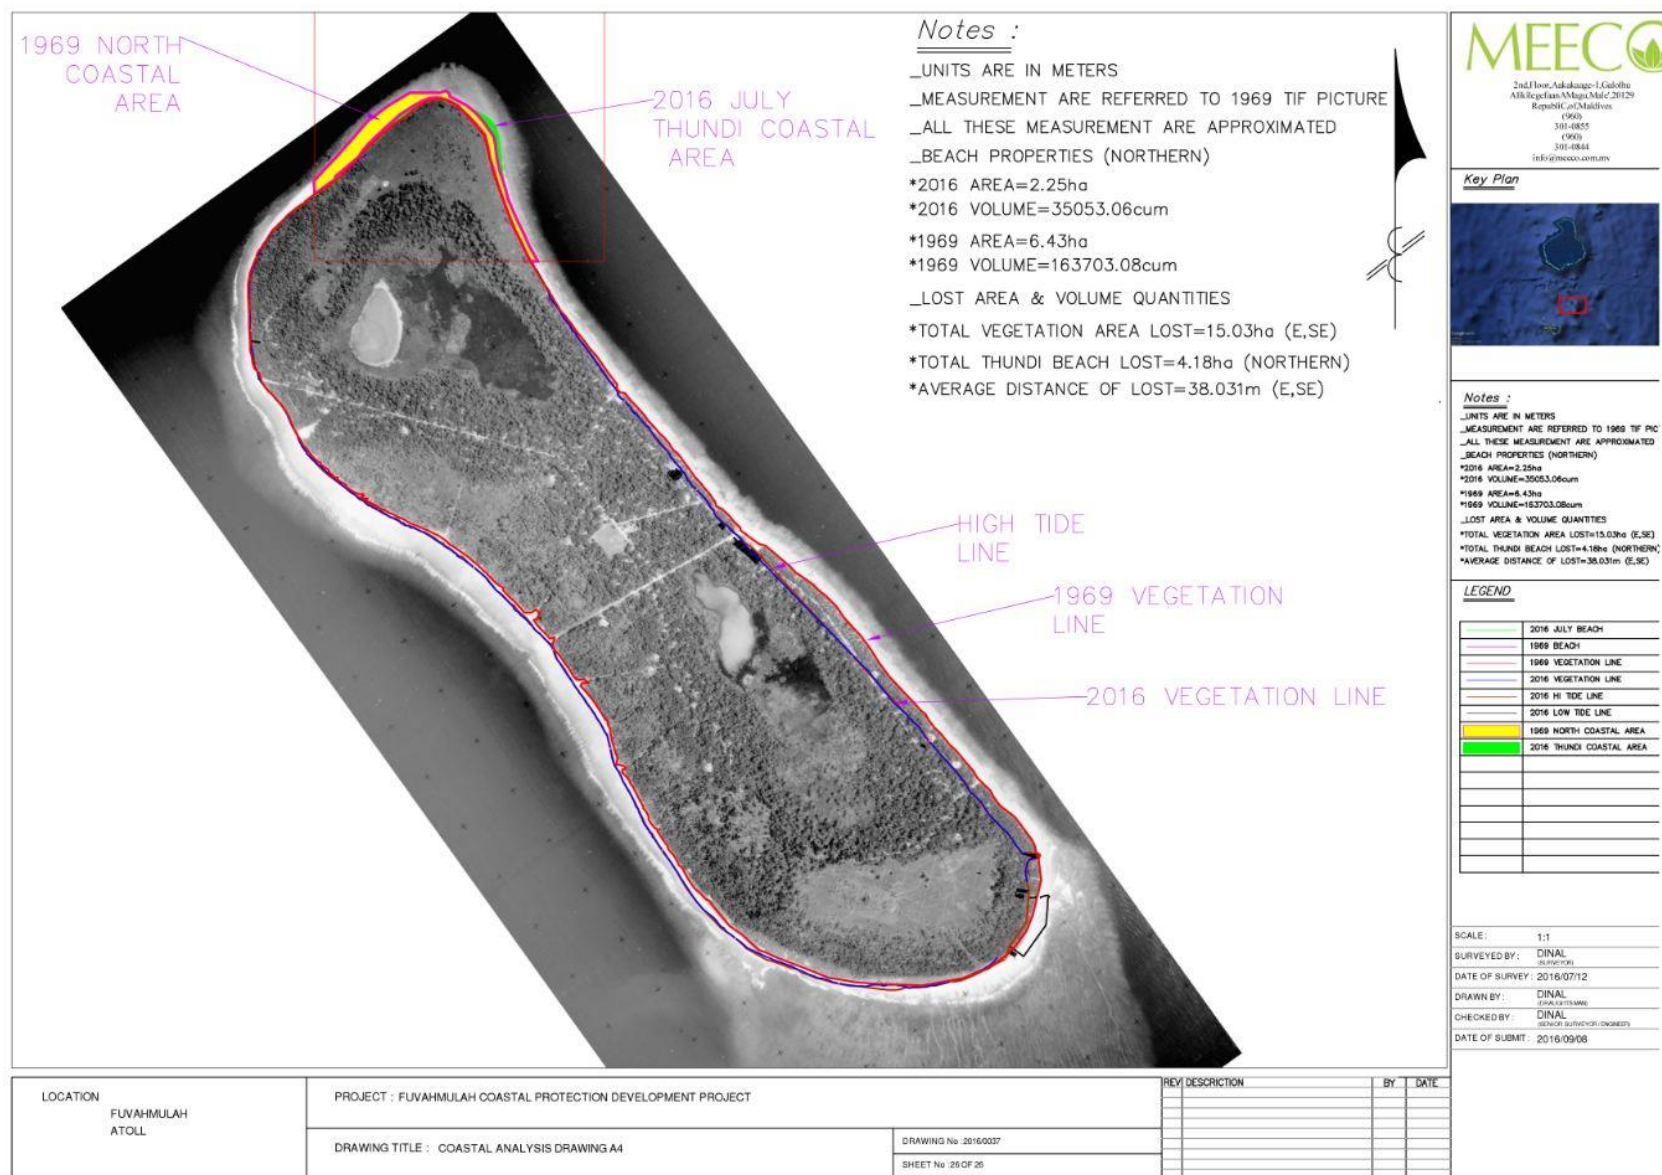
Figure 23: North-eastern shoreline erosion of Fuvahmulah from 1969 to 2016

*Thundi* beach also showed significant changes in the study of the aerial photographs from 1969 to 2016. Estimates are that *Thundi* beach had diminished by 4 ha in the comparison (see Figure 23). Approximately 64% of sand had been lost from *Thundi* beach based on estimates calculated after comparing survey data obtained during the field trip with historical satellite images taken during 1969, 2004, 2014 and 2016. It was observed that in the past *Thundi* beach greatly extended towards the west. The average area of the *Thundi* beach up until 2004 was approximately 6.4 ha. Since then *Thundi* beach did not extend to the west as much as it used to. The existing sand budget at *Thundi* beach was approximately 2.2 ha. Based on the surveys carried out under the current study it is calculated that the north-eastern shoreline erosion occurred at an average rate of 0.5 to 0.8 m/yr on average over the period 1969 to 2016 (Figure 23).

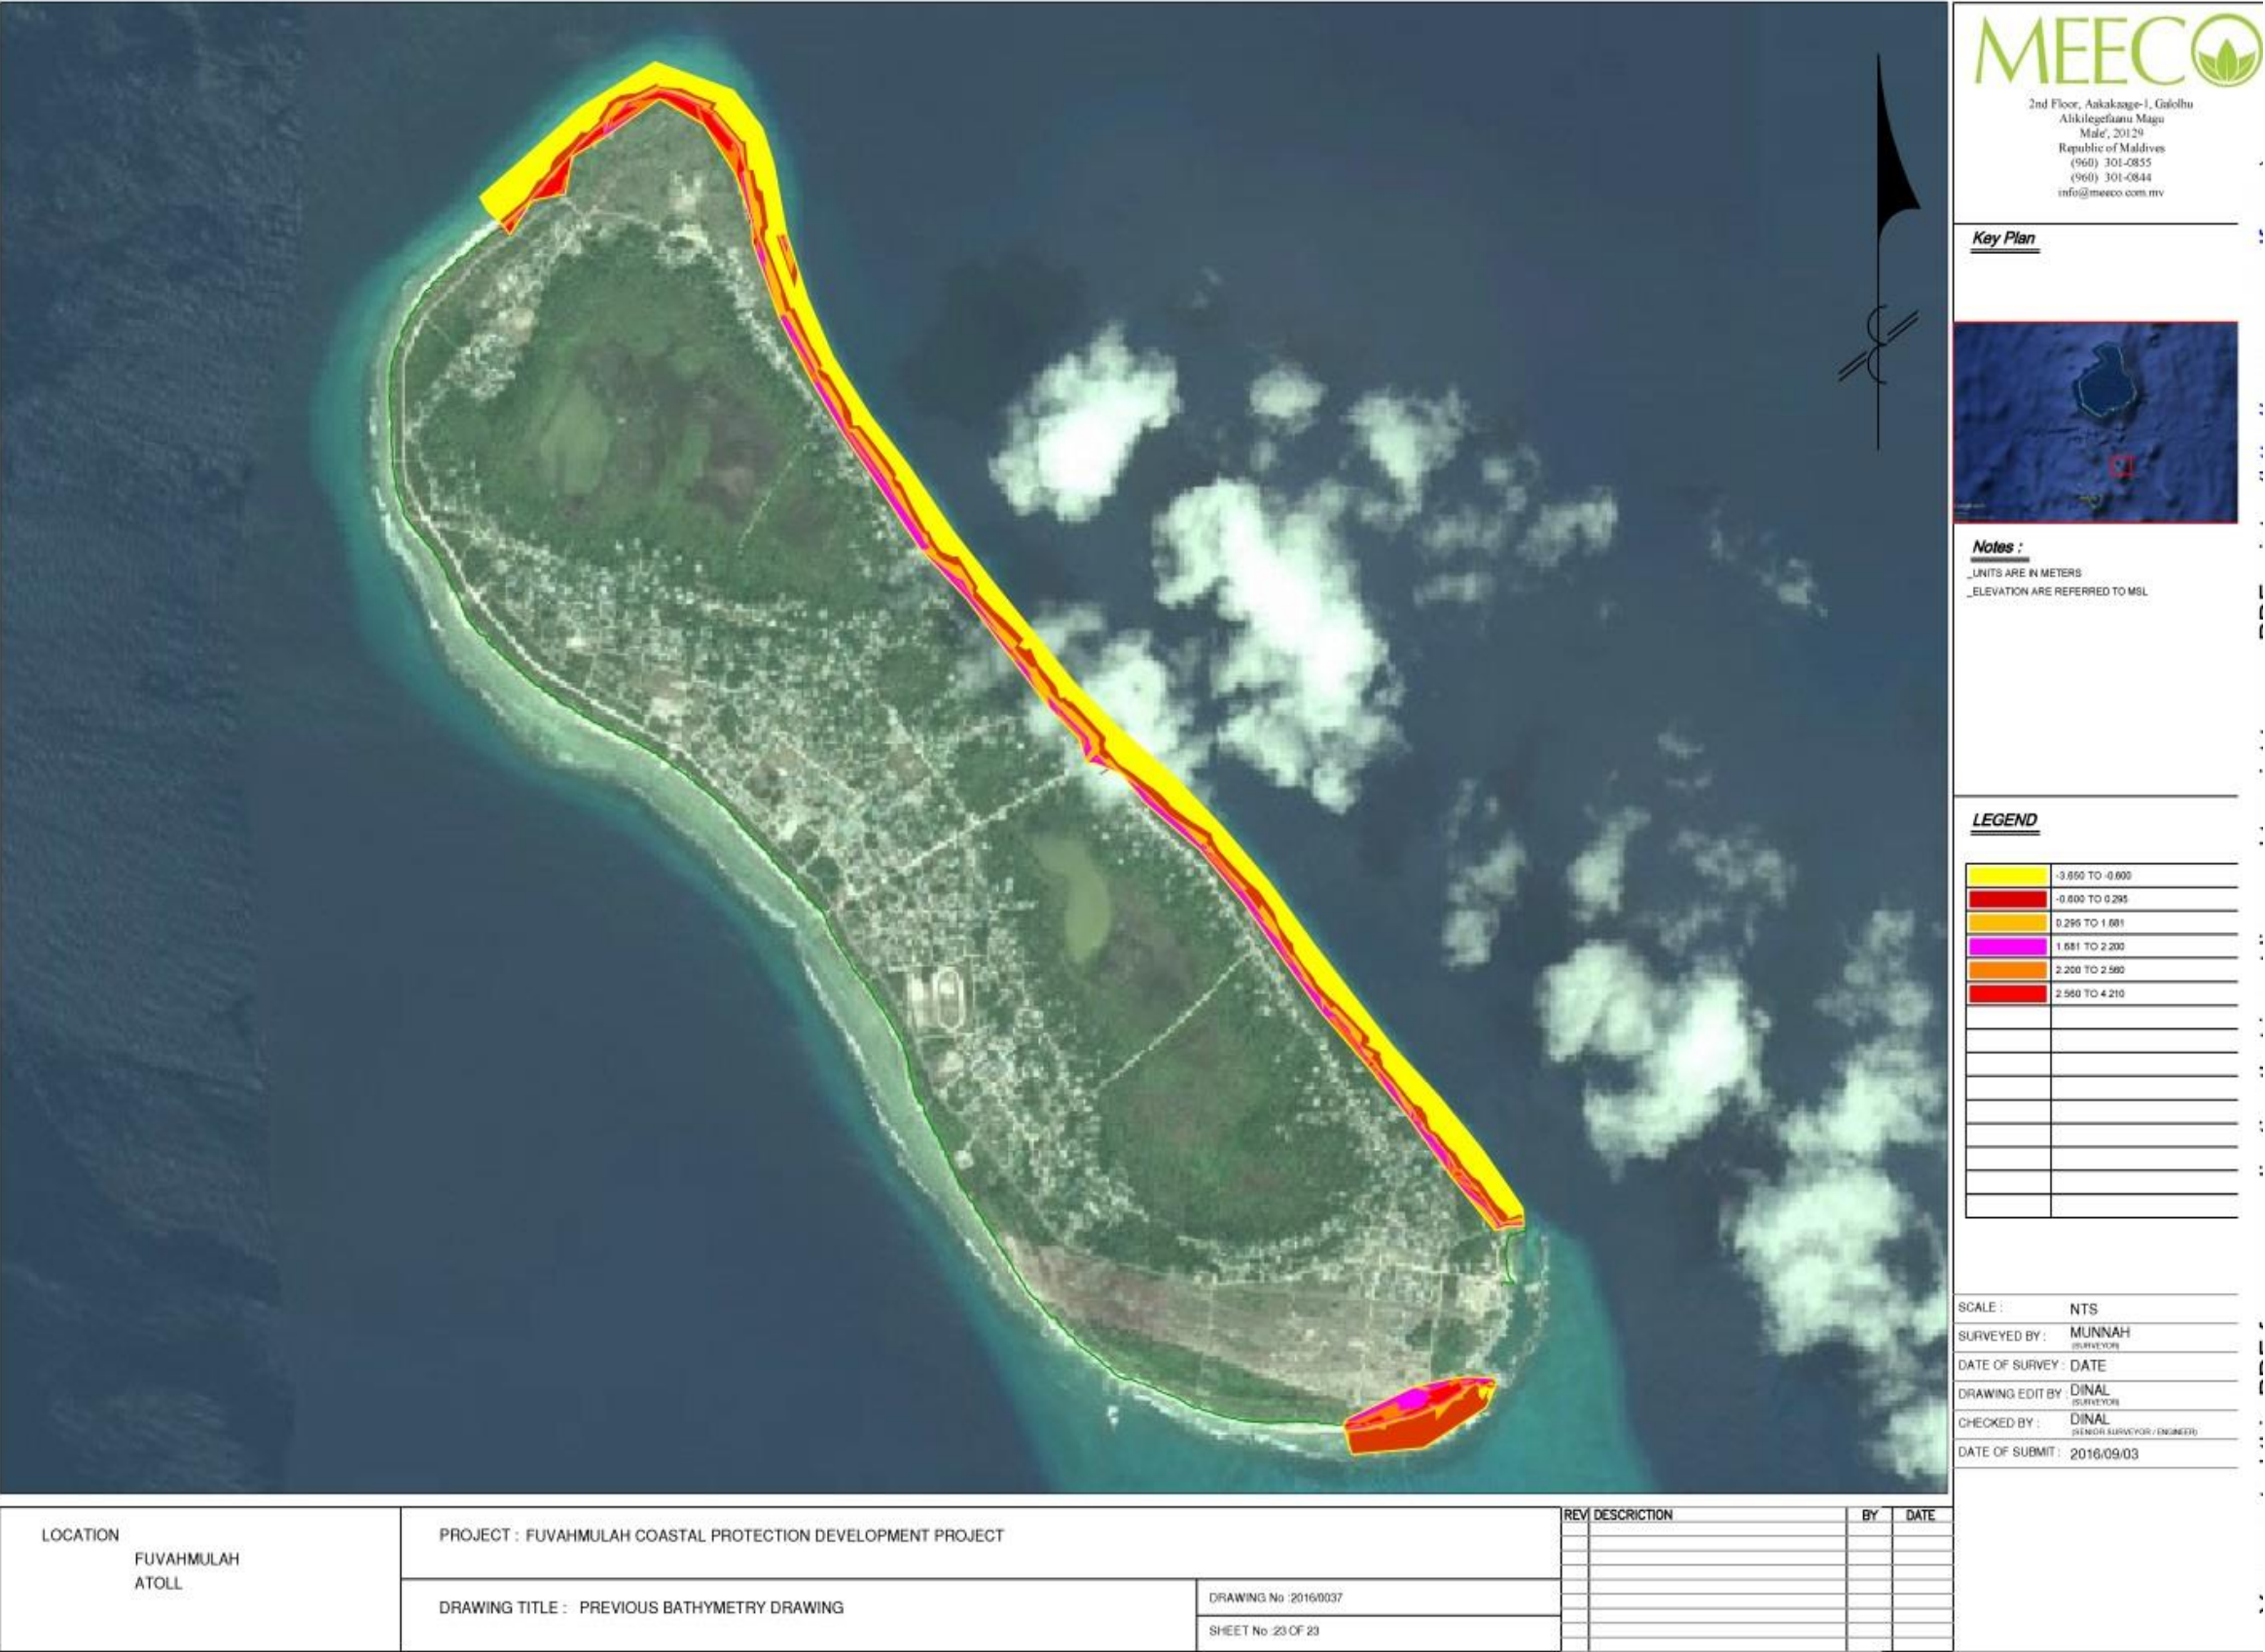
Figure 49: Bathymetry drawing of the north-eastern reef flat of Fuvahmulah

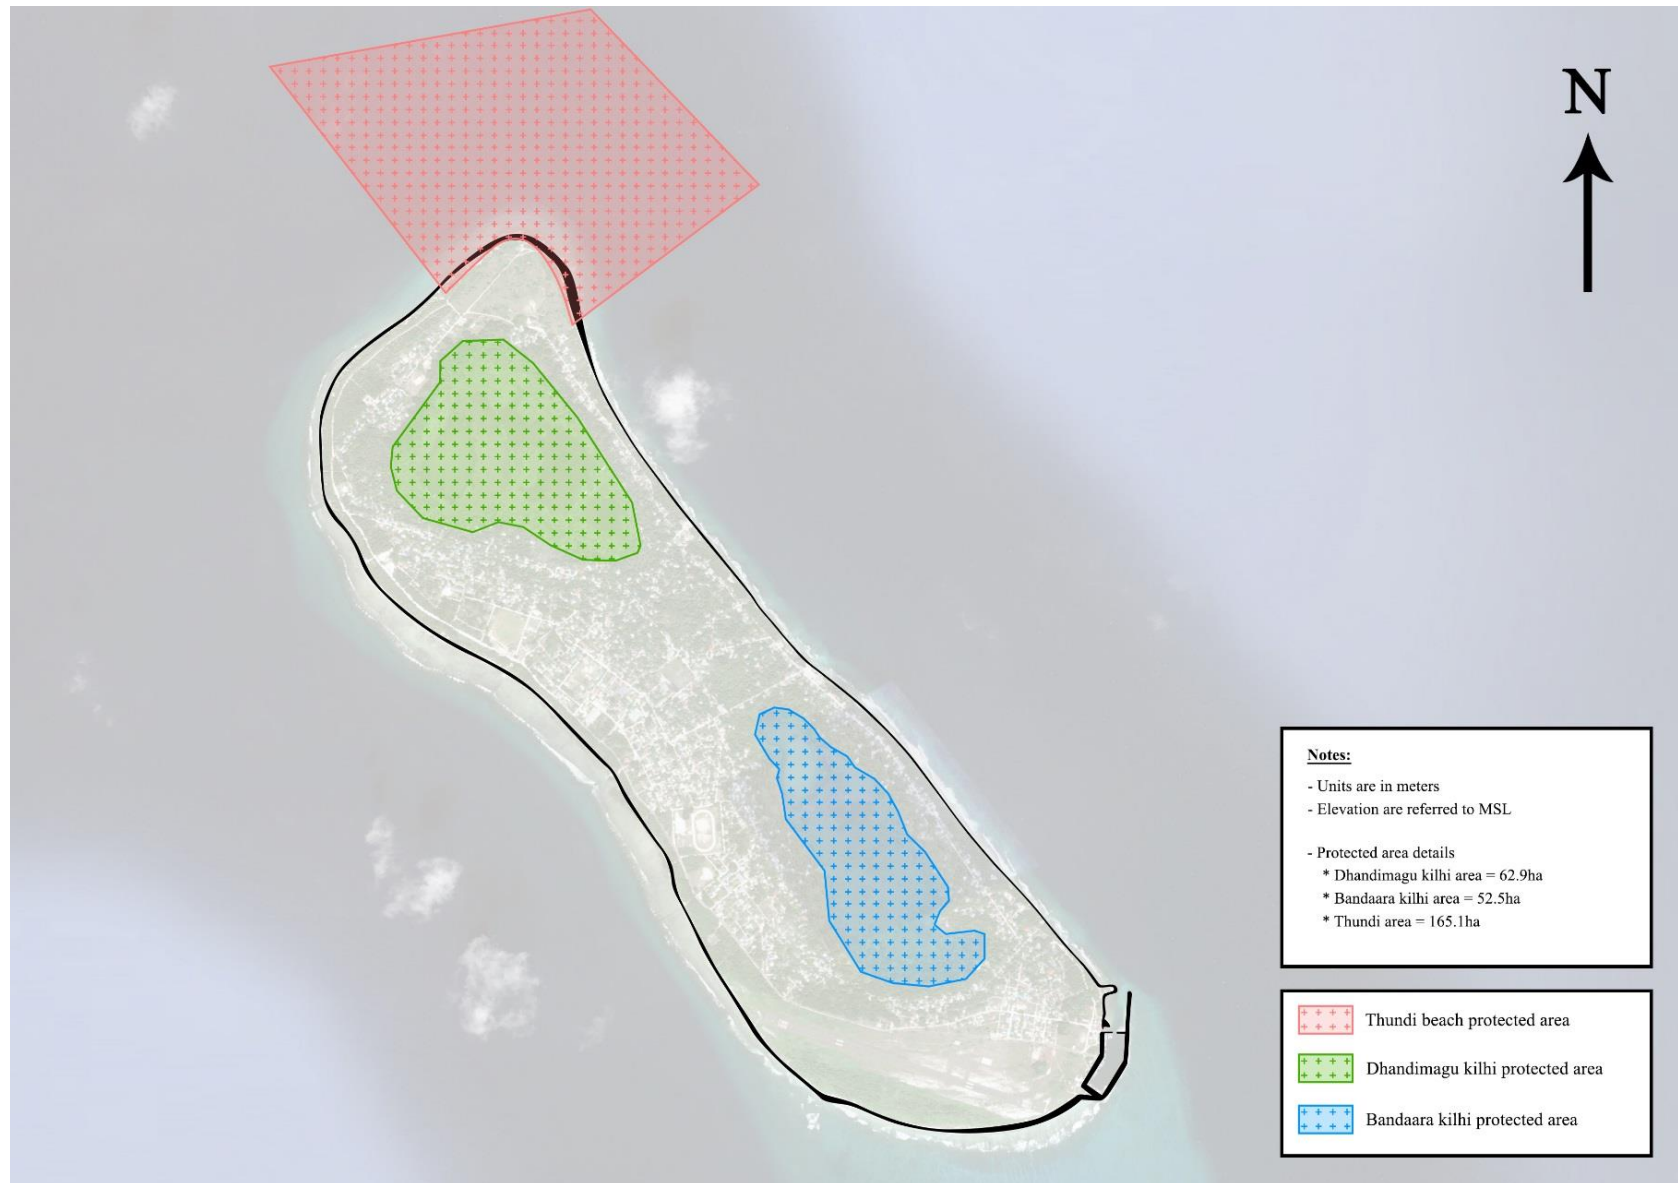
Figure 68: Protected areas map of Fuvahmulah

As illustrated in the figure 68, the onshore revetment does not directly affect any of the protected sites although the north end of the planned onshore revetment will be within 100m from the boundary of the *Thundi* area.

As the onshore revetment will be at the interphase between the land and the sea, the structure is expected to have some impact on the sediment transport along the northeast coastline of the island. There is no clear evidence available to indicate that sediment from *Thundi* moving too far into southwards during seasonal changes. Whereas it is believed that *Thundi* oscillation is limited to a relatively narrow region between part of the northern coastline and north-eastern coastline as demonstrated in the Figure 29. It is also believed sediment transport along north-eastern coastline has been limited by the harbour constructed on the southern end of the island. Although it is hypothesised that the impact of onshore revetment will not be significant, due to lack of clear understanding of the near-shore current regime and sediment dynamics, a long – term coastal monitoring program has been proposed in this report to assess any changes that may take place as a result of the revetment. It is also suggested that the monitoring of *Thundi* beach be incorporated into the on-going formulation of management plan under the CCTF project. Figure 68 shows the protected areas of Fuvahmulah and Figure 69 shows aerial pictures of *Thundi* area.

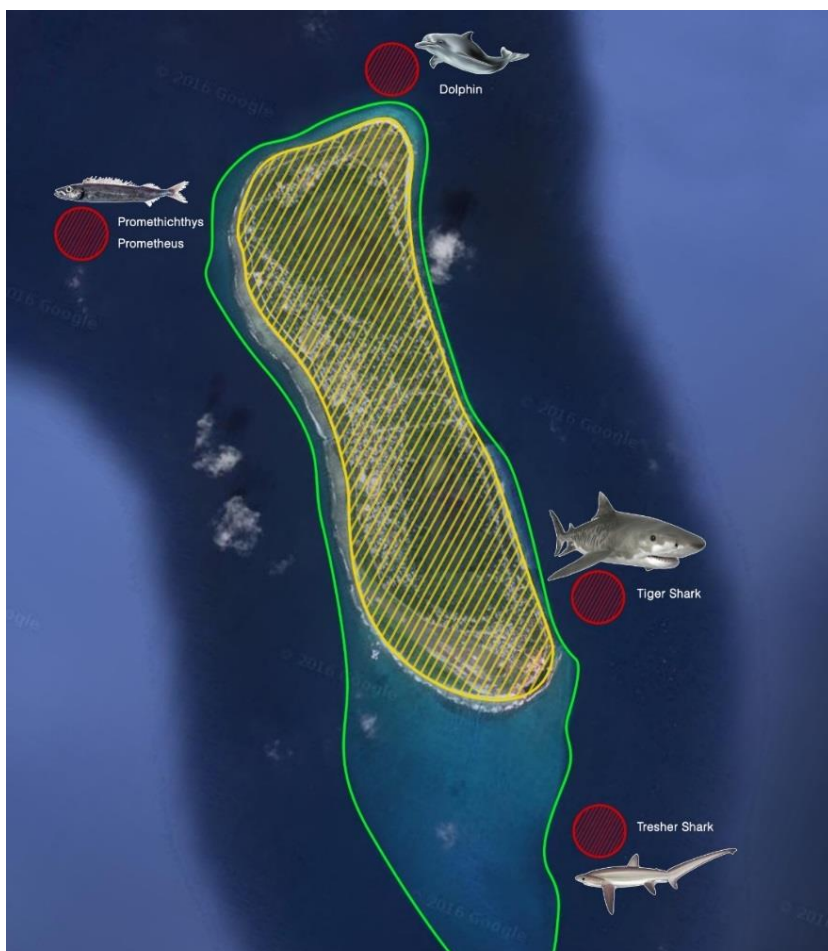
**Figure 70: Illustration of notable marine wildlife around Fuvahmulah**

Literature shows that the near shore ecosystem of Fuvahmulah is home to *katteylhi* (*Promethichthys prometheus*) – a unique large-toothed deep-sea fish (snake mackerel) that is only caught off the coast of Fuvahmulah at a depth ranging between 100 – 700 m. According to locals, *katteylhi* fishing ground is located on the western side approximately a kilometre off the reef edge. Figure 70 illustrates common locations for these species around Fuvahmulah coastal area.

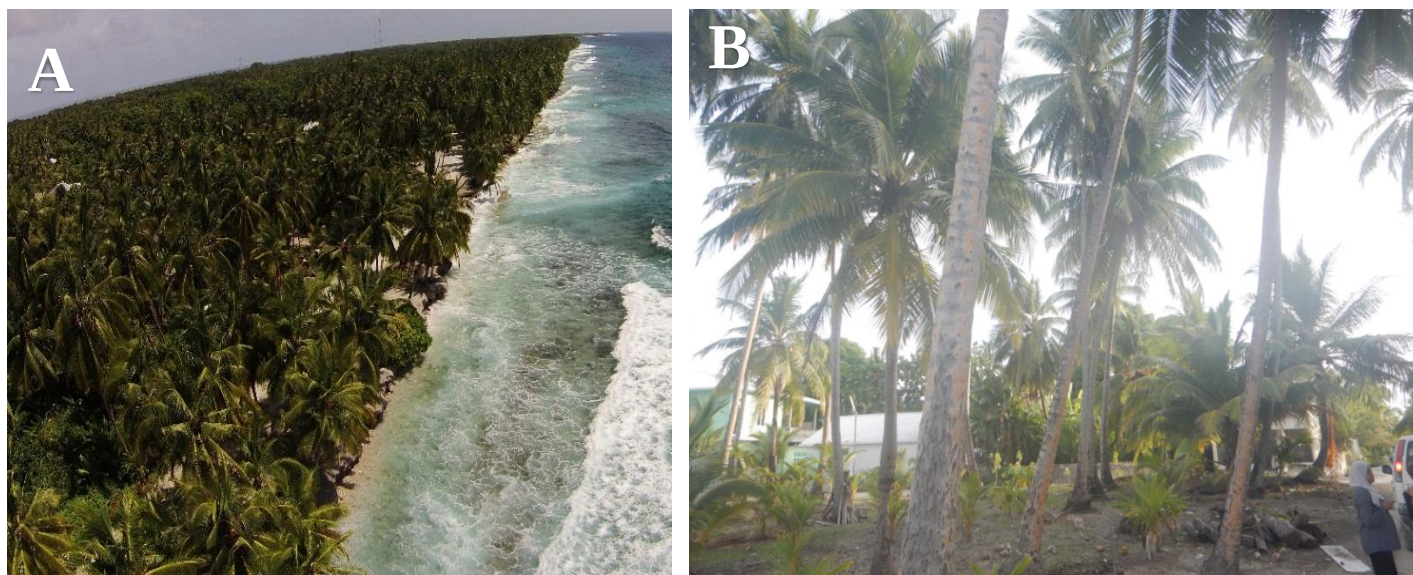
**Figure 71: Vegetation cover at the project boundary. A – aerial view -B – ground level view – shows the outpost zone was mostly consisted of coconut palms.**

The outpost zone vegetation close to the proposed project location was dominated by *Cocos nucifera* (Coconut palm) (Figure 71). Occasionally other coastal species that have widespread occurrence throughout the Maldives such as *Hibiscus tiliaceus* (Sea hibiscus) and *Cordia subcordata* (sea trumpet) were also observed (Table 29).

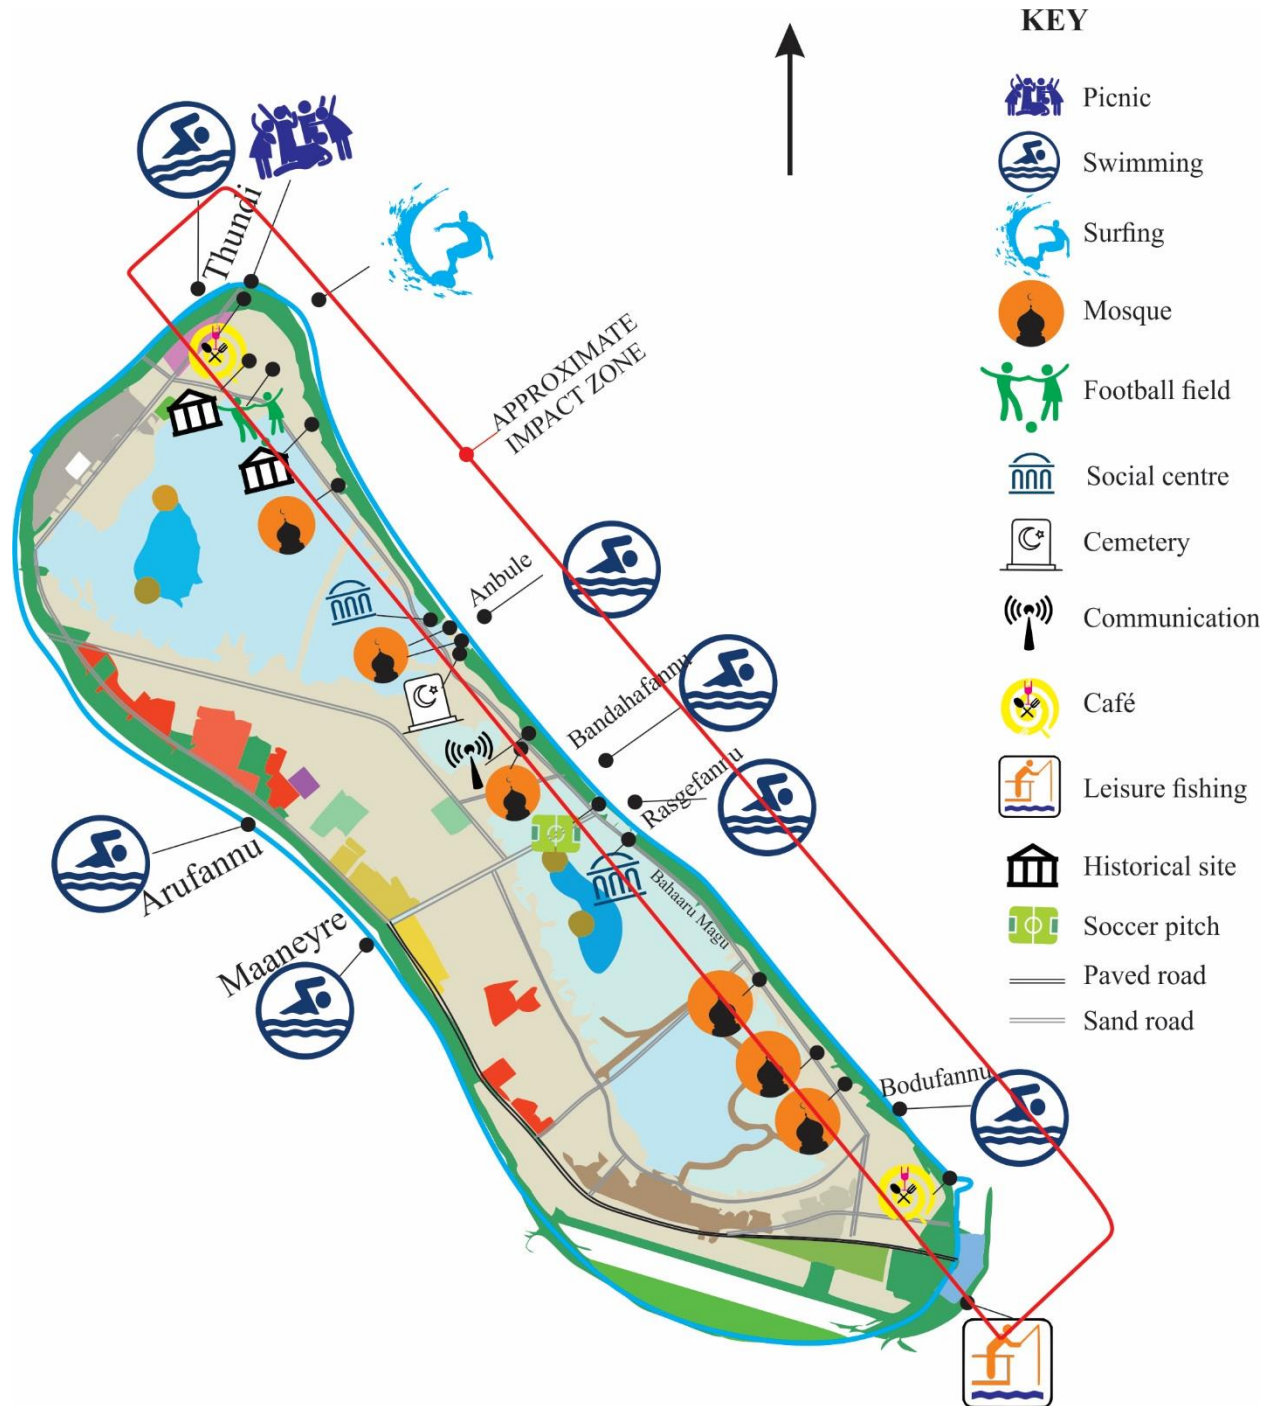
Figure 77: Social and institutional facilities in the impact zone

In Fuvahmulah, there is no safe swimming area. However, on calm days when the coastal areas are mild enough for swimming, swimming occurs at some spots near the beach (see Figure 77), also at the project area. Most youngsters take dips in the freshwater ponds. However, this swimming experience in a still water body cannot be compared to swimming in the sea.

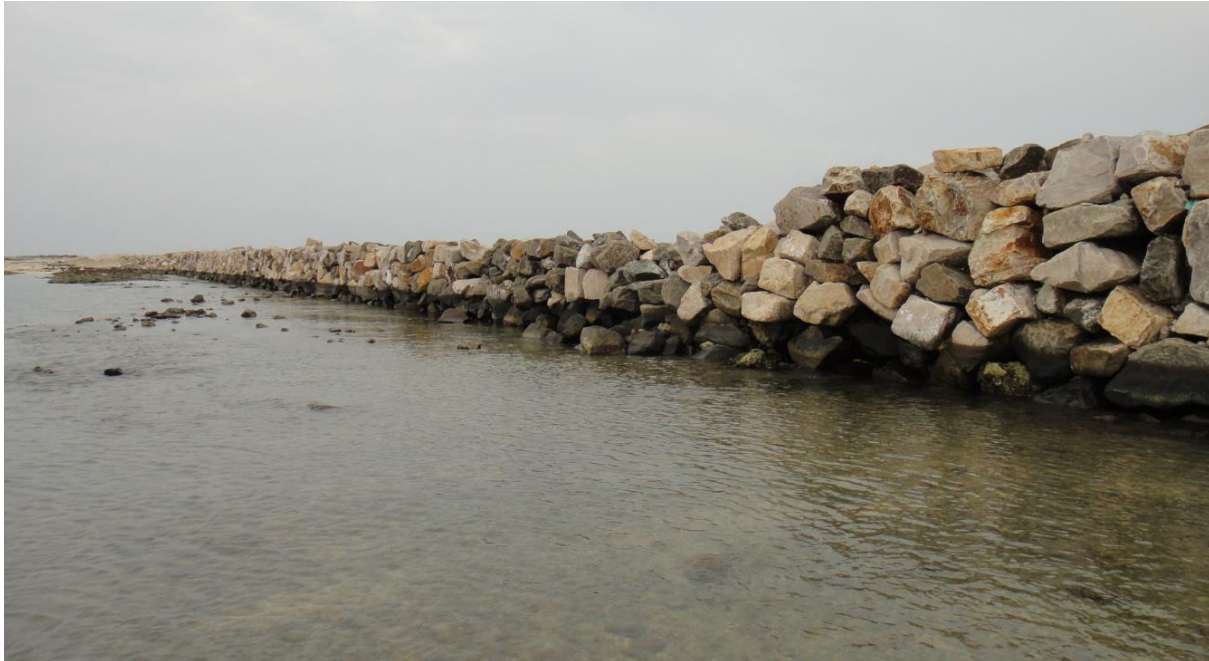
***Figure 91: Example of offshore breakwater constructed at Maamigilli Island***

- Offshore breakwater at the -1.0m MSL depth contour
- Relatively low crest level (+2.5 - +3.5m MSL) to reduce wave transmission
- Calculations have shown that this crest level is *insufficient* to stop the ongoing erosion of the coastline
- Core and top layer of the structure consists of rock armour, to be sourced abroad

Figure 91 shows an example of an offshore rock armour breakwater constructed in the Maldives.

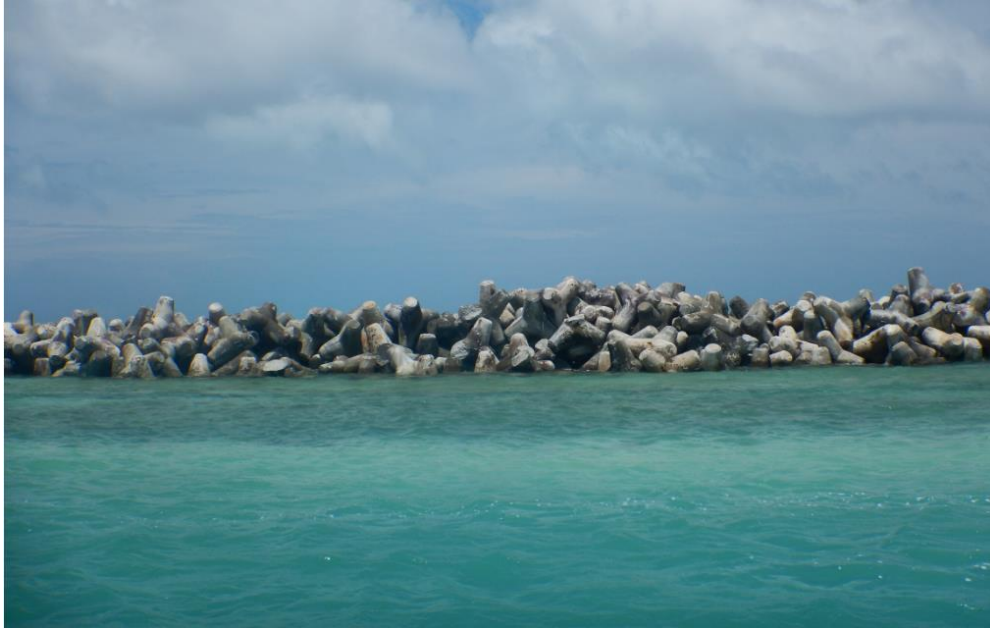
**Figure 92: Tetrapod concrete armour units offshore breakwater in Male'**

- Offshore breakwater at the -1.0m MSL depth contour
- Design comparable to IA, but with higher crest level (+4.5 - +5.0m MSL), to be more effective against erosion than the low-crested offshore breakwater
- Core and top layer of the structure consists of rock armour, to be sourced abroad

Figure 92 shows an example of concrete armour units used as sea defence in the Maldives.

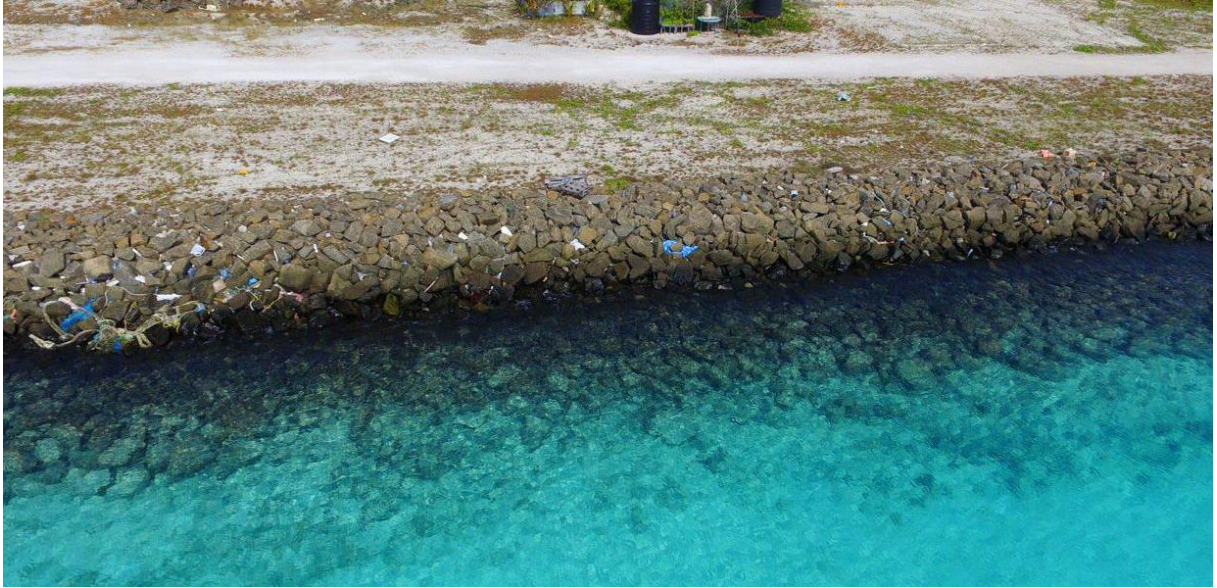
**Figure 94: Rock revetment used to protect coastline at Gulhifalhu**

- Onshore revetment, design comparable to IIA.
- Structure crest line is shifted seaward (figure 94), to reduce damage to vegetation belt. However material use and footprint on reef flat is larger compared to IIA.
- Core and top layer of the structure consists of rock armour, to be sourced abroad

Figure 94 shows example of seaward rock revetment used to protect coastline.

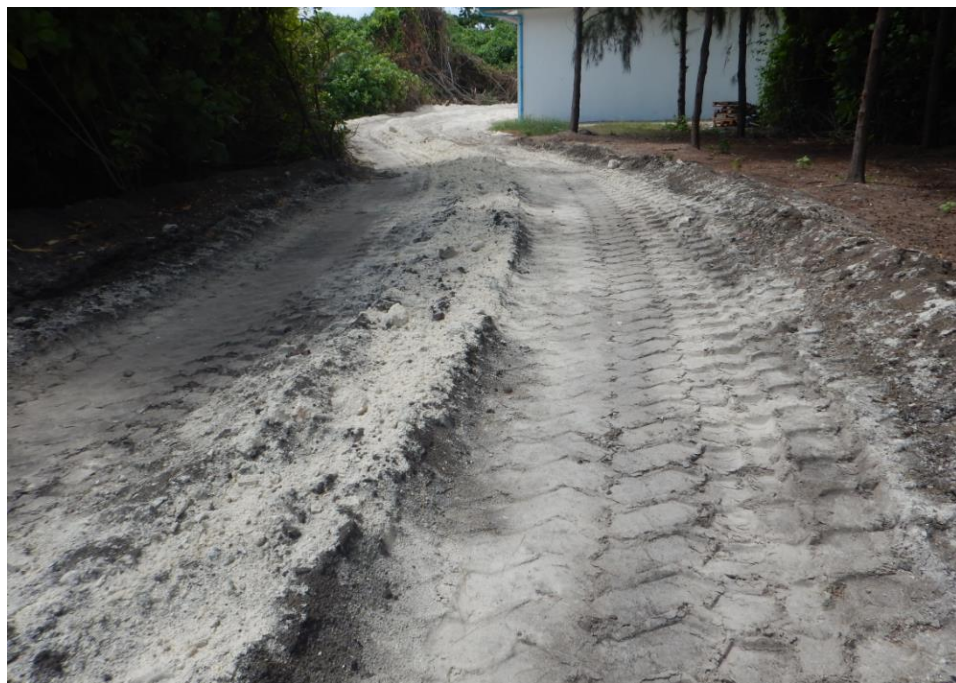
*Figure 97: Damage caused to sand-surfaced road in an island by heavy vehicles*

However, still the project will generate some transportation overland, which is additional to the current traffic. Land transport could create traffic, and may increase incidences of accidents, risks of spills on land can also be greater during the Project. Movement of vehicles can damage unsurfaced roads and cause compaction of soil and reducing the drainage capacity. Damage to the road surface can be more pronounced if the material movement period coincide with the rainy season (see Figure 97).

If movement of vehicles carrying materials and workers would happen on *Bahaaru Magu*, the main road along the east coast of the island, which is not paved, the impacts can be moderately severe (see Figure 97). The movement of heavy vehicle on unsurfaced roads can compact the soil reducing the soil absorption capacity and thereby causing local level flooding during rainy season. Considering these aspects, the work methodology has been carefully worked out to avoid having to use *Bahaaru Magu* as the main road for transportation (see Figure 9 (B)). With the proposed work methodology, the impact of the Project's land transport on the roads, in the case of on-shore option is believed to be moderate to minor. Nevertheless, the road areas where vehicle movements are expected to be concentrated, have not been paved and therefore mitigation measures have been proposed.

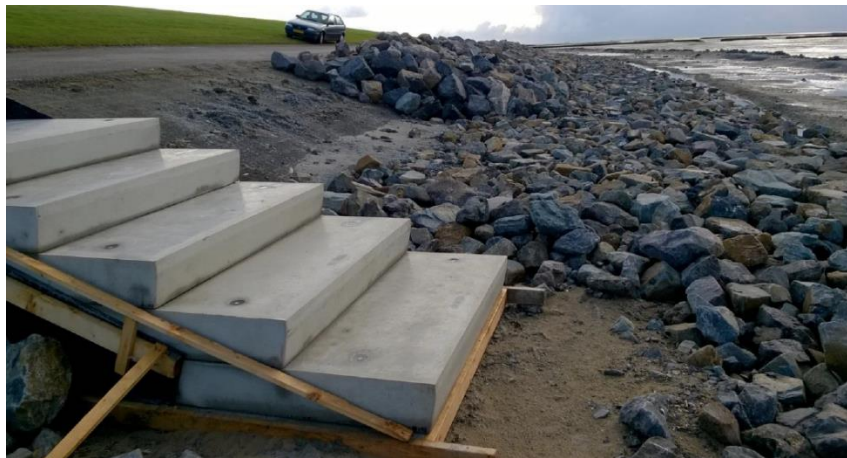
*Figure 102: Example of concrete steps in a rock armour revetment (isle of Ameland in the Netherlands), Source: RHDHV, 2016*

- Design features to include stairs conveniently located to ease the access to beach and sea (see Figure 90). In this way this major impact can be reduced to a minor impact.

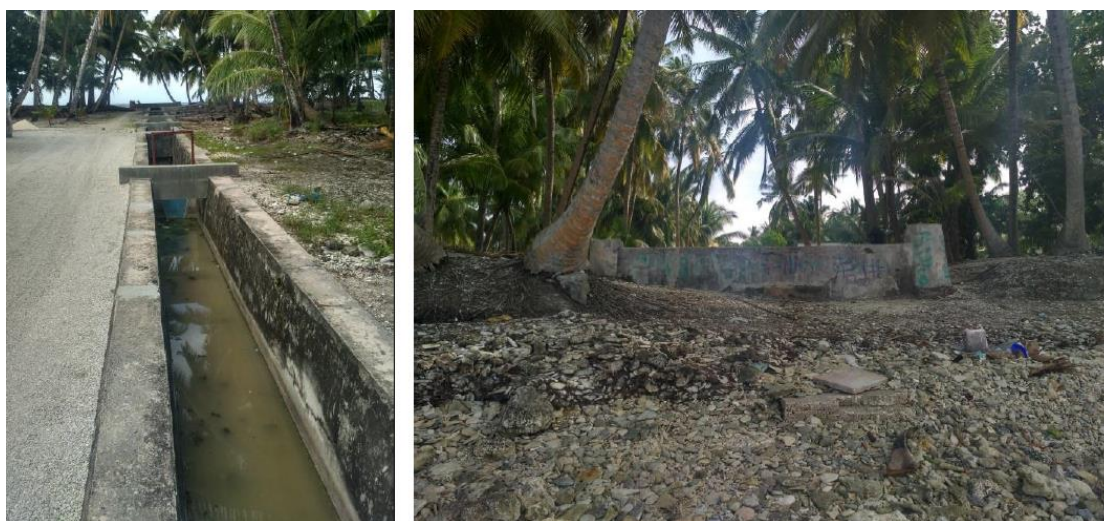
**Figure 103: Existing drainage channel (left) and location of outfall towards sea intersecting proposed revetment (Source: RHDHV, 2016)**

The proposed rock revetment alternative has the potential to negatively affect the existing drainage system of the island (Figure 103). At one location within the project area, a drainage outfall crosses the (proposed) revetment. This outfall pipe discharges the rainwater from the island into the sea during low tide. During high tides (or dry periods), the outfall pipe is closed with a valve.

Although the construction of the coastal protection may not lead to dis-functioning of the outfall pipe or drainage system, the outfall pipe shall be lengthened as part of the Project. The following requirements shall be integrated in the detailed design:
