EIA FOR CONSTRUCTION OF K. VILLINGILI WEST HARBOUR & SLIPWAY PROJECT

November 2015

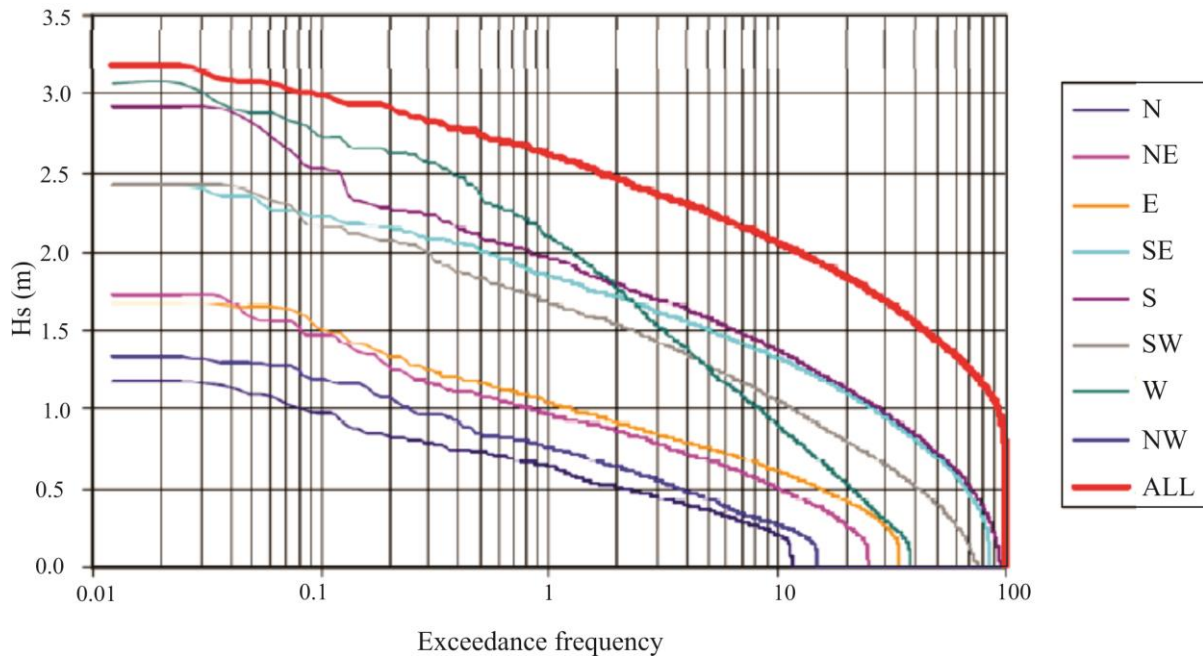
Figure 10: Wave height, H_s , exceedance curve for the southern region of the Maldives (source: DHI, 1999).

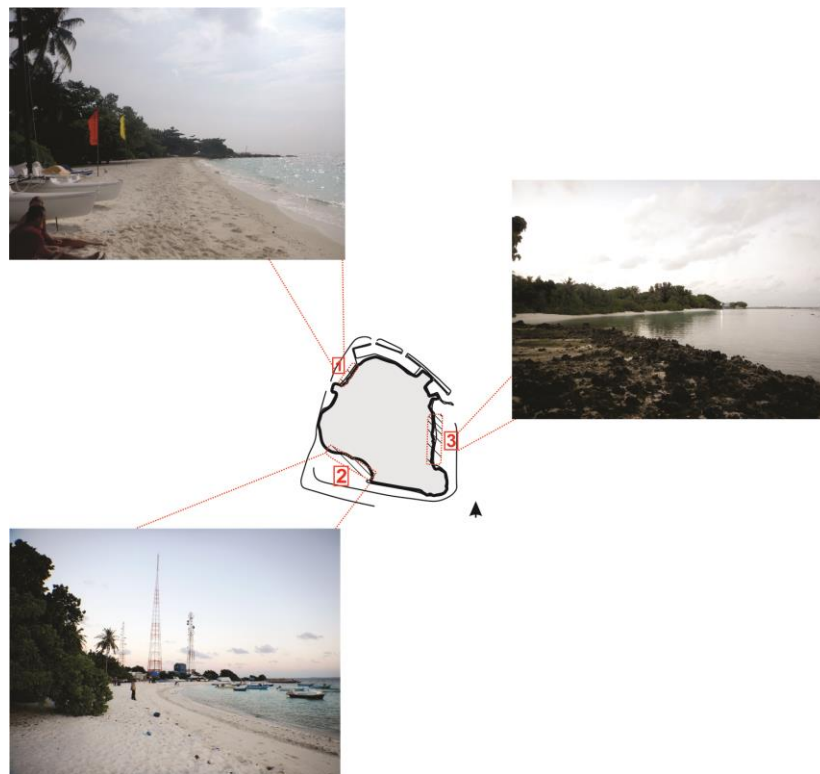
Figure 15: Fragments of beach found in Villingili

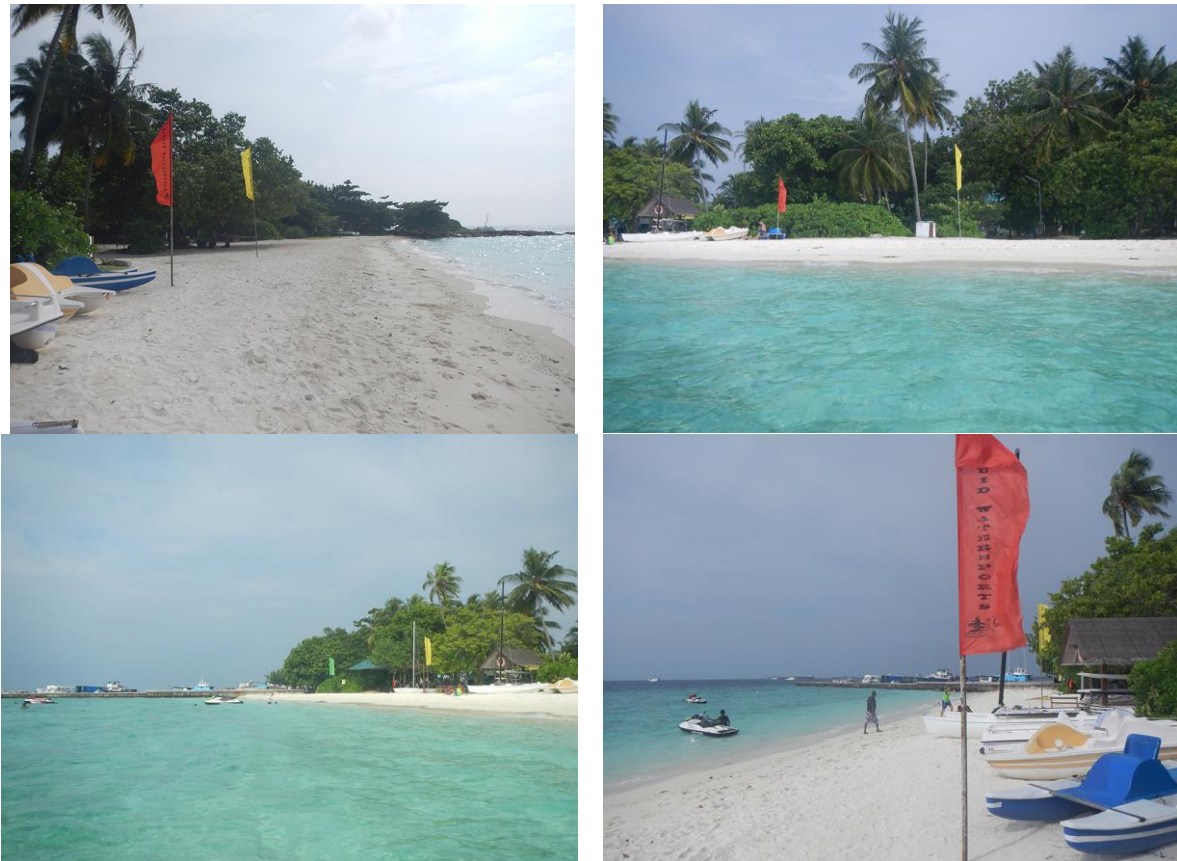
Figure 16: Stable natural beach on the northwestern side of Villingili

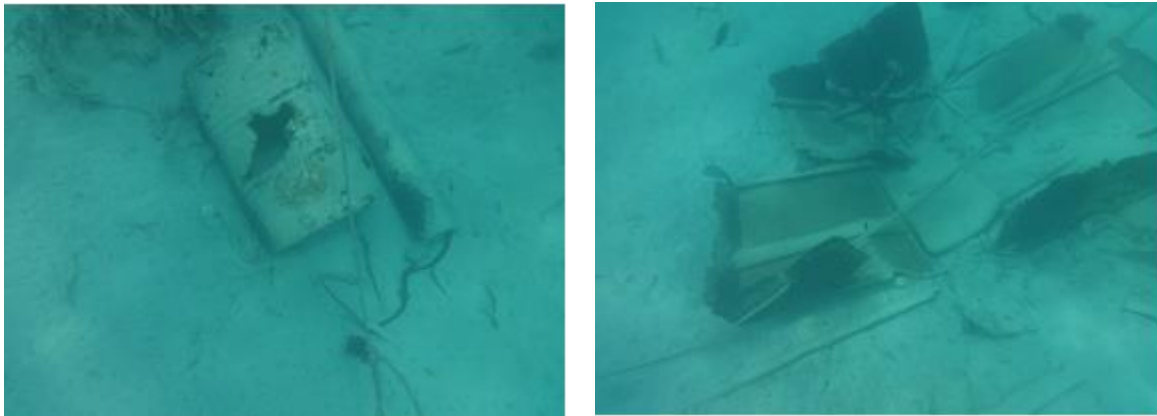
Figure 17: The benthic cover at the existing shallow harbour basin area at Villingili Island, showing rubbish accumulated in the area.

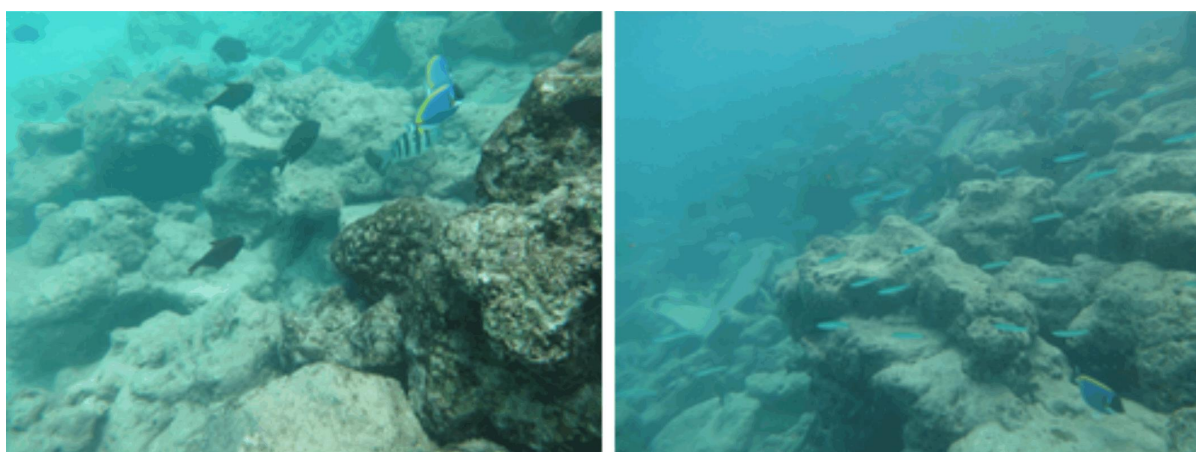
Figure 18: Some fish species observed in near the reef entrance

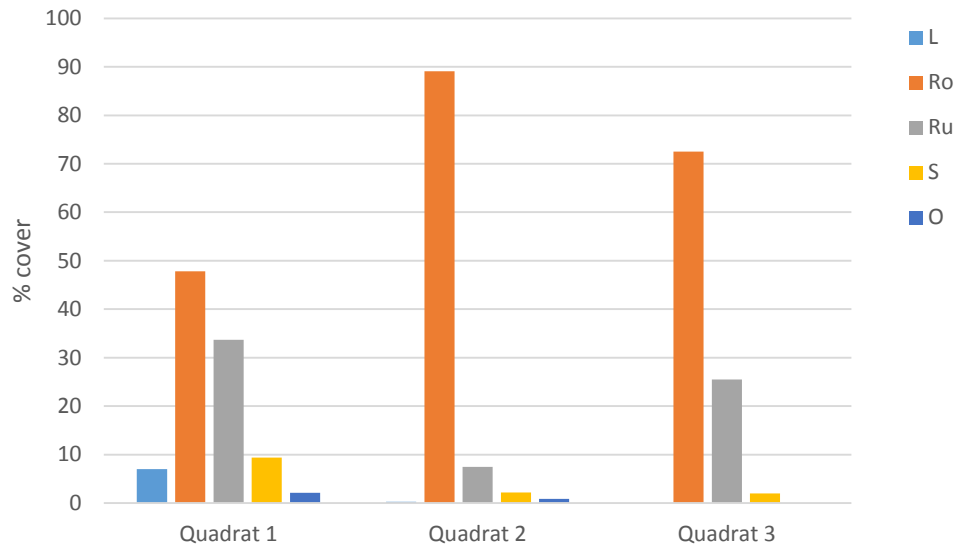
Figure 19: Benthic cover on the shallow reef edge at the channel of the existing harbour proposed for dredging (L = Live coral, Ro = Rock, Ru = Rubble, S = Sand, O = others).

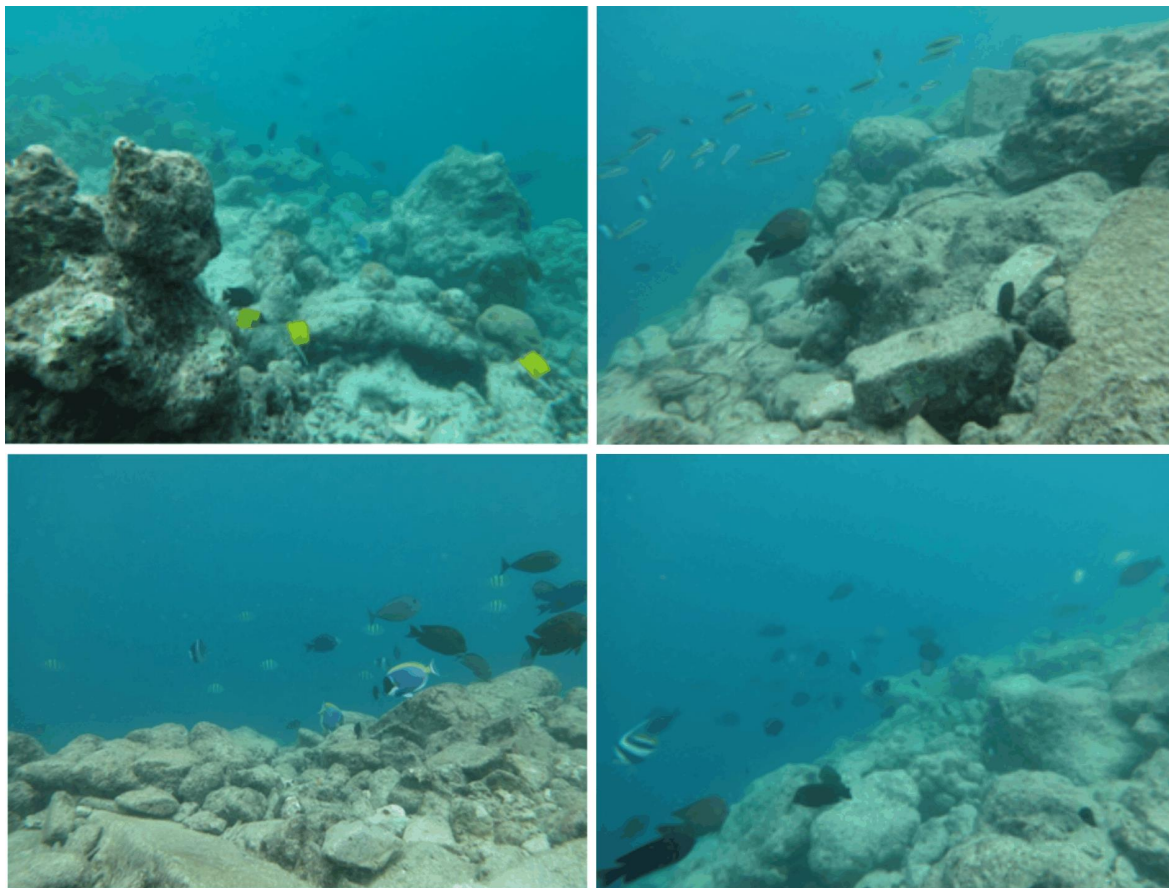
Figure 21: Some fish species observed near the harbour entrance

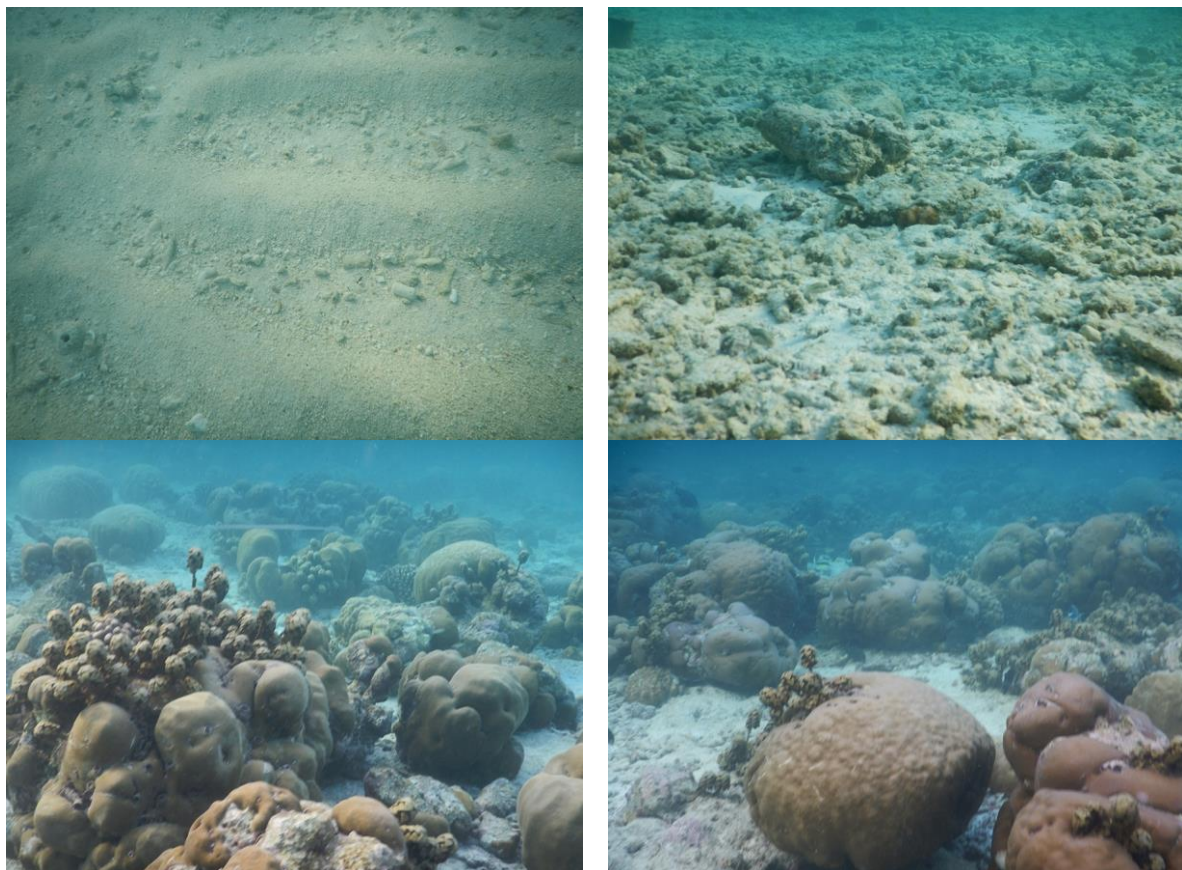
Figure 22: Benthic cover at the lagoon to the north of the proposed harbour. Near the beach the lagoon bottom was exclusively of sand and some rubble (top pictures) while from centre towards the reef flat live coral cover increased (bottom pictures)

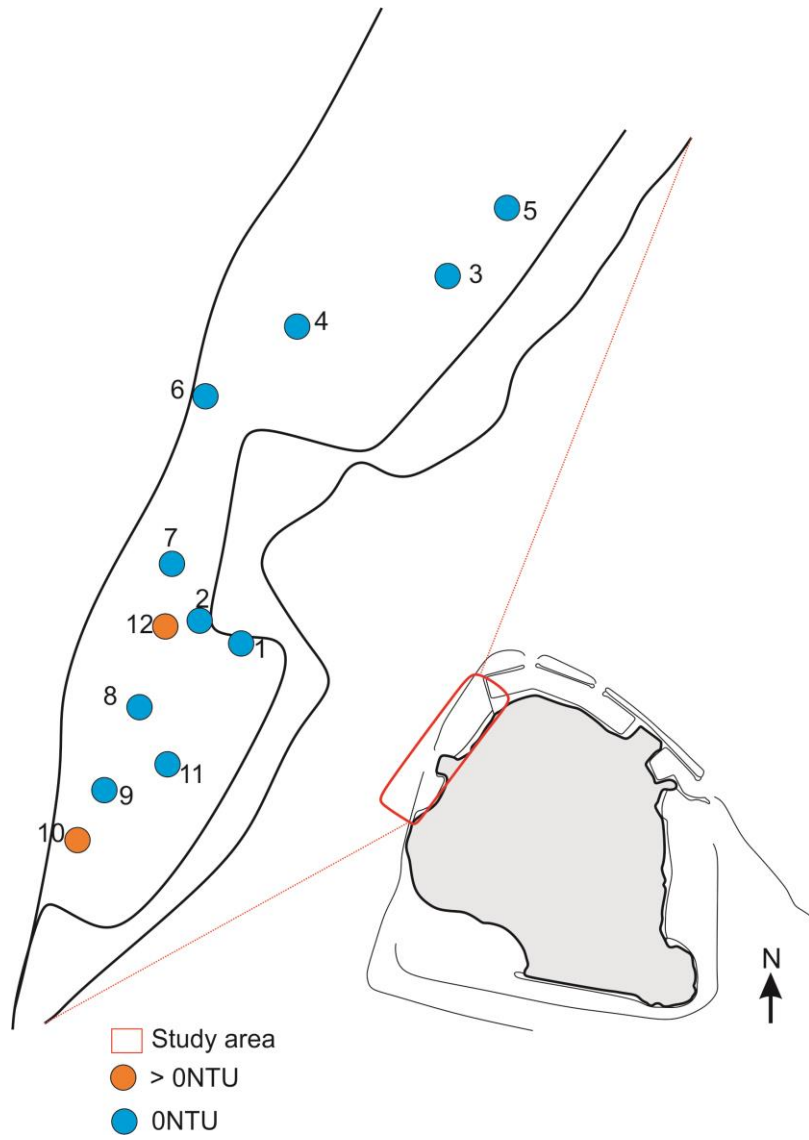
Figure 23: Turbidity measure at various locations of the study area

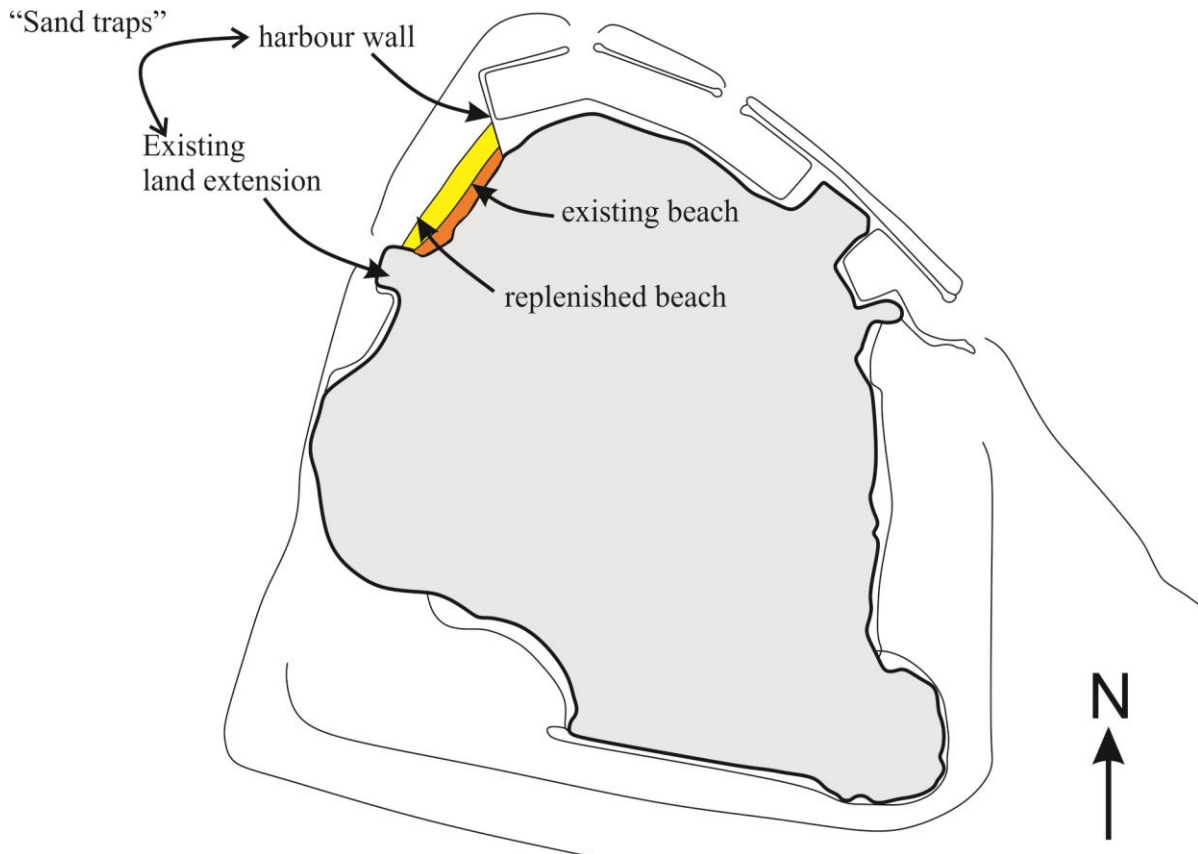
Figure 25: Beach stability at the replenished area

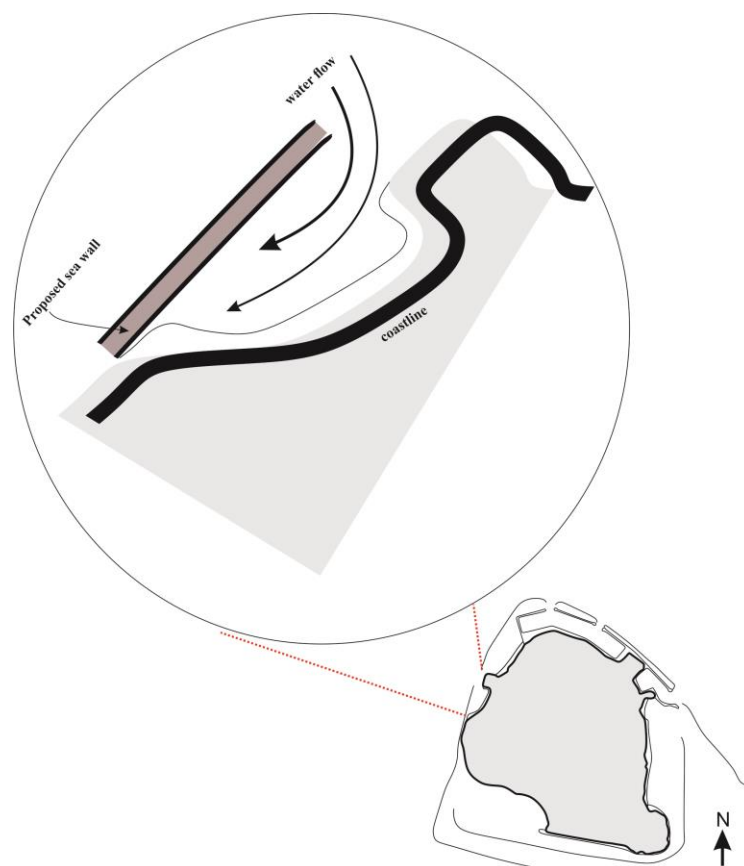
Figure 26: Expected water flow limitation

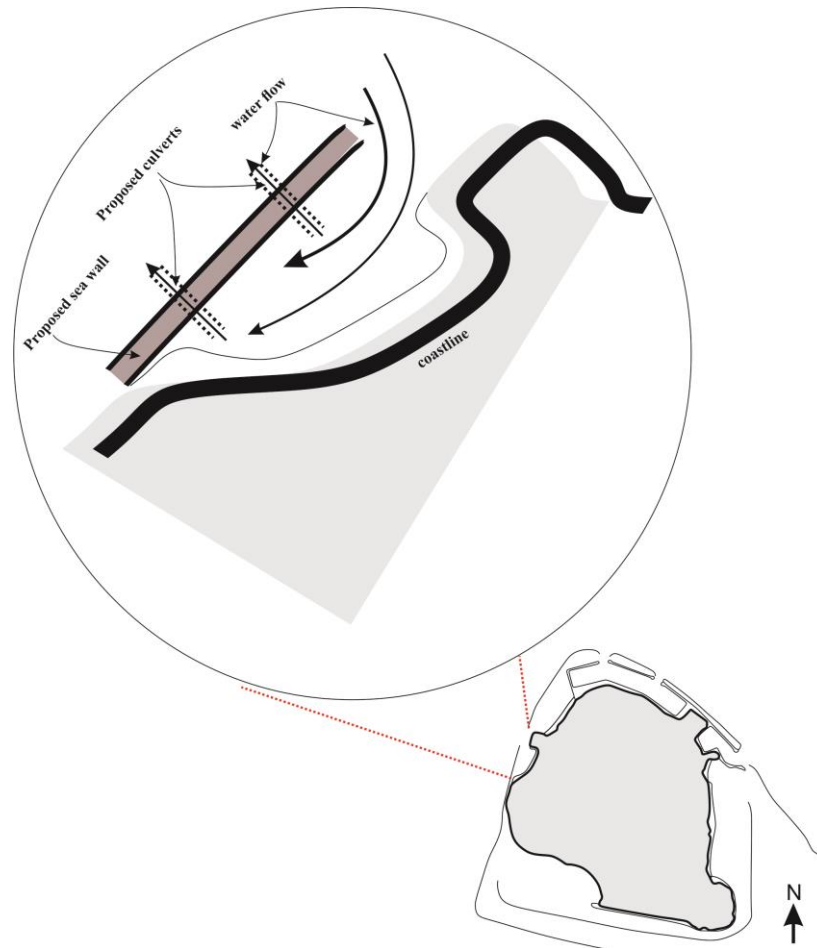
Figure 27: Insertion of culverts in the break water to channel water flow. Ocean water flow in through the channel while highly dense contaminated water from the harbour basin flow out, creating sufficient circulation

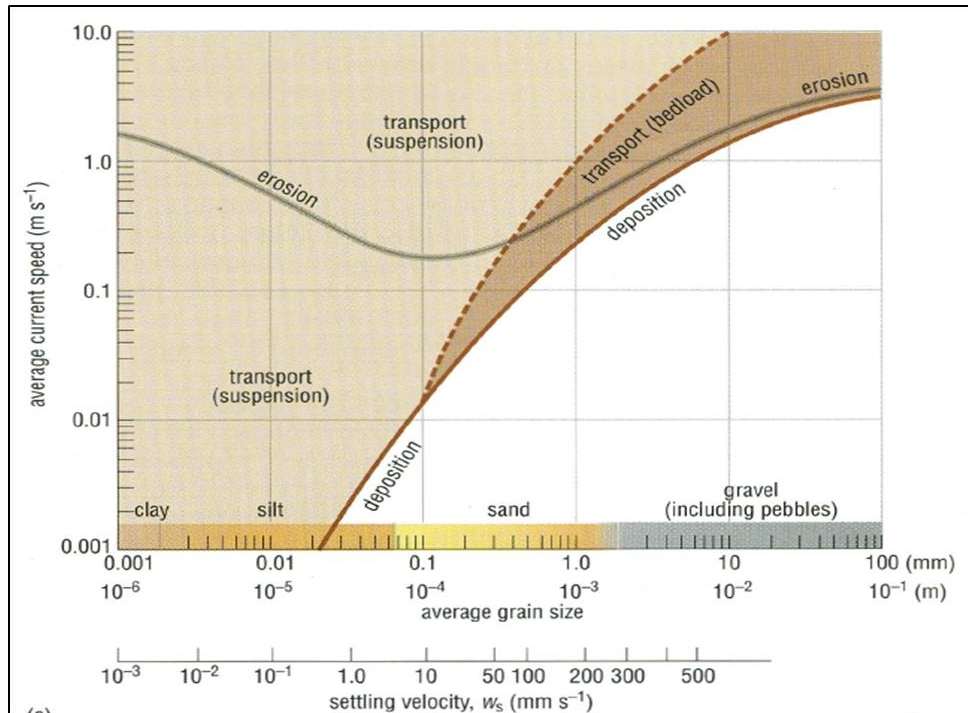
Figure 30: Range of average current speeds at which sediment particles of different sizes are eroded and transported. Broken line indicates the transition between bedload and suspension transport. Average settling velocities (W_s) for particles of different sizes deposited from suspension in still water are also illustrated (Adapted from Groud & Aubrey, 1985).

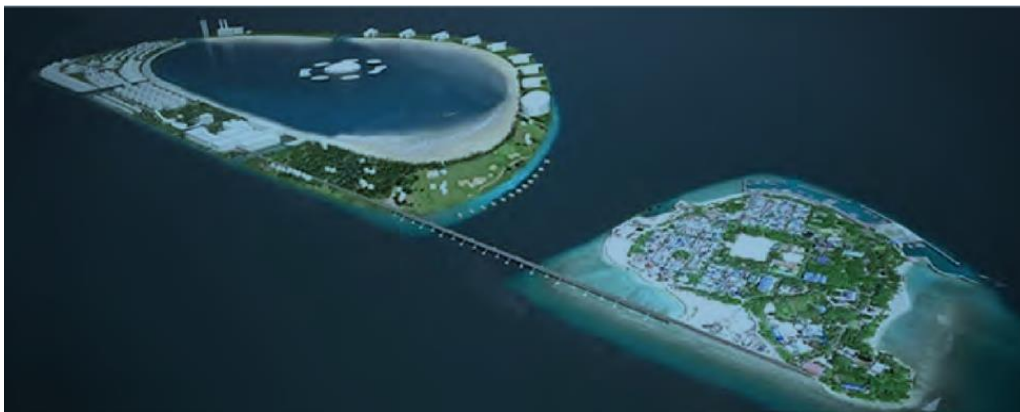
Figure 35: Eye of Maldives showing the link between Gulhi Falhu and Villingili Island (source: GAD International Ltd., 2011)
