# Coastal vulnerability, adaptation & resilience in local communities of North Ari Atoll

Dr Ahmed Shaig

**Authors:** Ahmed Shaig

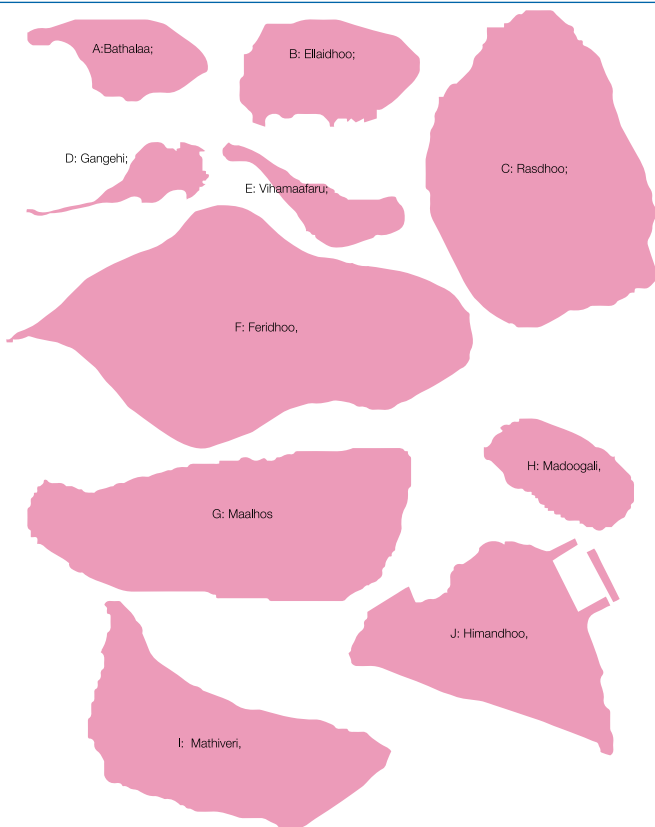
| Island Type | Description | Sketch | Islands in North Ari Atoll |
|---|---|---|---|
| B | Oceanward rim-perpendicular island | <p>A: Bathalaa;<br/>B: Ellaidhoo;<br/>C: Rasdhoo;<br/>D: Gangehi;<br/>E: Vihamaafaru;<br/>F: Feridhoo;<br/>G: Maalhos;<br/>H: Madoogali;<br/>I: Mathiveri;<br/>J: Himandhoo;</p> | A: Bathalaa;<br>B: Ellaidhoo;<br>C: Rasdhoo;<br>D: Gangehi;<br>E: Vihamaafaru;<br>F: Feridhoo;<br>G: Maalhos;<br>H: Madoogali;<br>I: Mathiveri;<br>J: Himandhoo; |

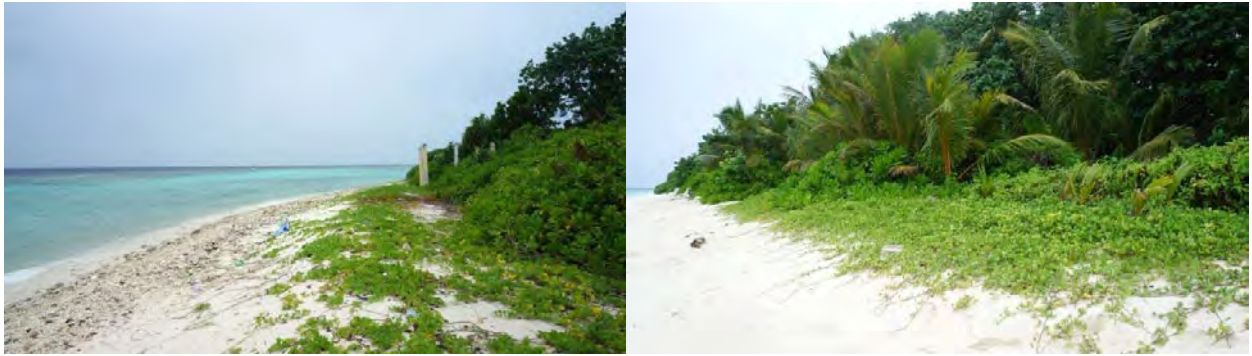
Figure 3.3 Beach pioneers and halophytes growing in stabilizing areas - Ukulhas

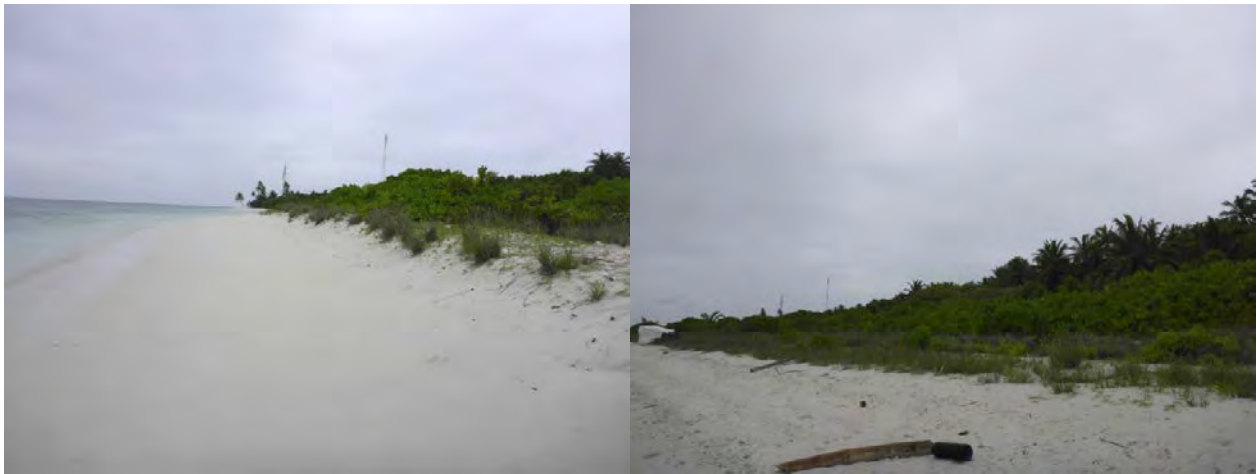
Figure 3.4 Accretion in Feridhoo

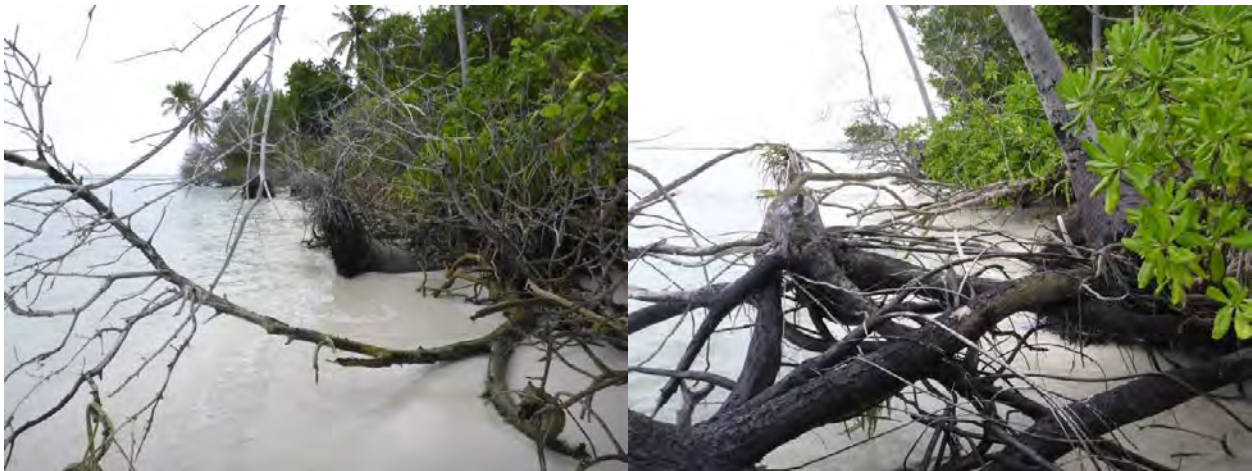
Figure 3.5 Severe erosion in Feridhoo

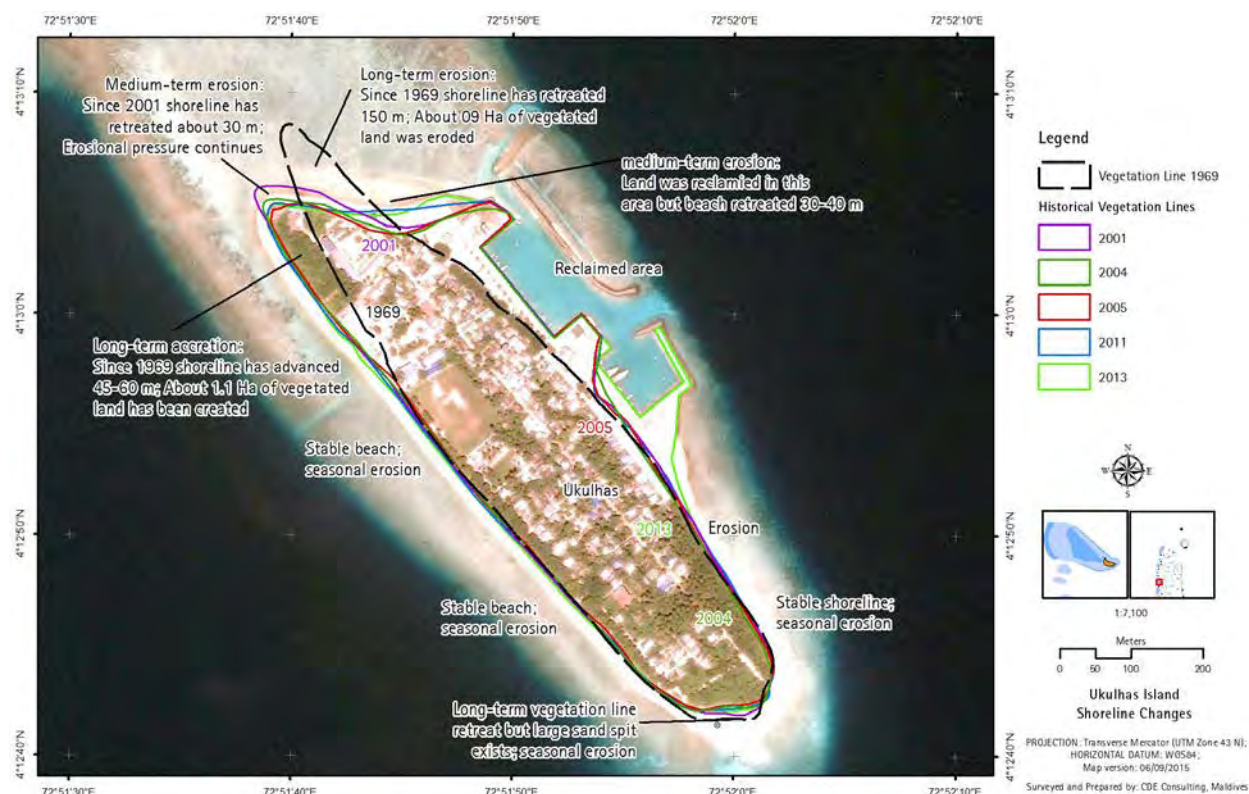
Figure 3.8 Ukulhas medium-term shoreline changes

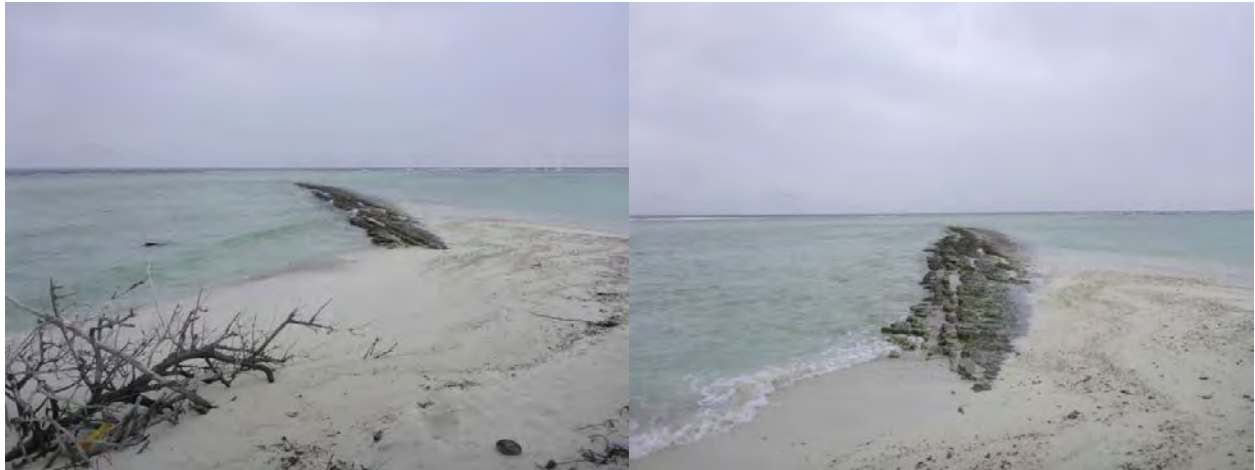
Figure 3.13 Beach rock plays a role in holding the sediments in place in Feridhoo

| Feature | Description |
|---|---|
| Beach Rock | <p>Beach rocks are consolidated sand and coral which forms where groundwater and seawater meets on the beach. Once the shoreline is eroded it is exposed and visible. Beach rocks are known to play a role in controlling beach erosion especially in high energy zones. There are well developed beach rock systems in Thoddoo, Mathiveri, Bodufolhudhoo, Feridhoo, Ethermadivaru, Maalhos and Himandhoo. All of these islands, except Bodufolhudhoo and Ethermadivaru are exposed to SW monsoon swells.</p> |

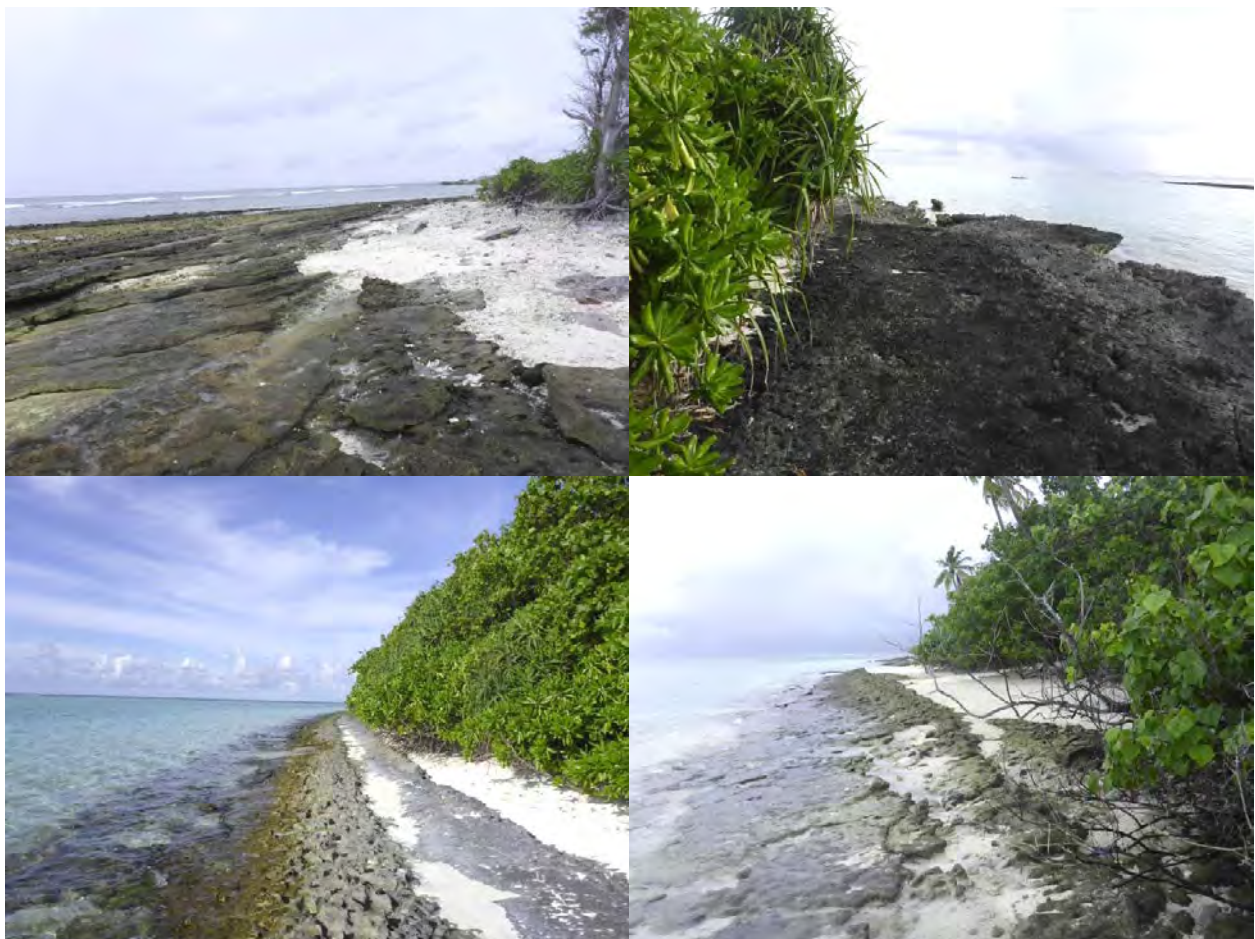
Figure 3.14 Beach rock as a natural revetment in strong wave conditions: (a) Maalhos; (b) Mathiveri (c)Thoddoo and (d) Himandhoo

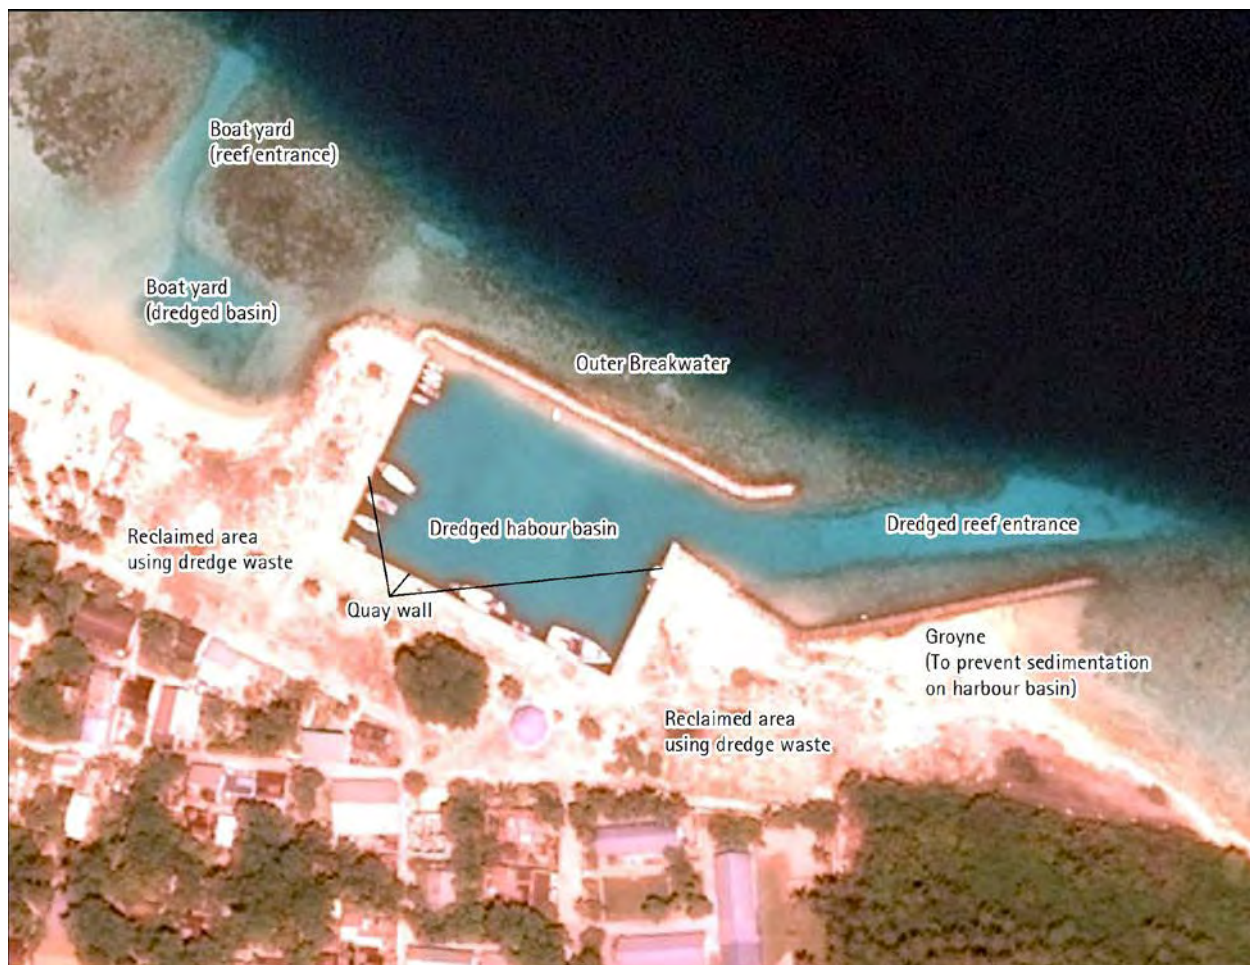
Figure 4.1 Basic elements of harbor infrastructure

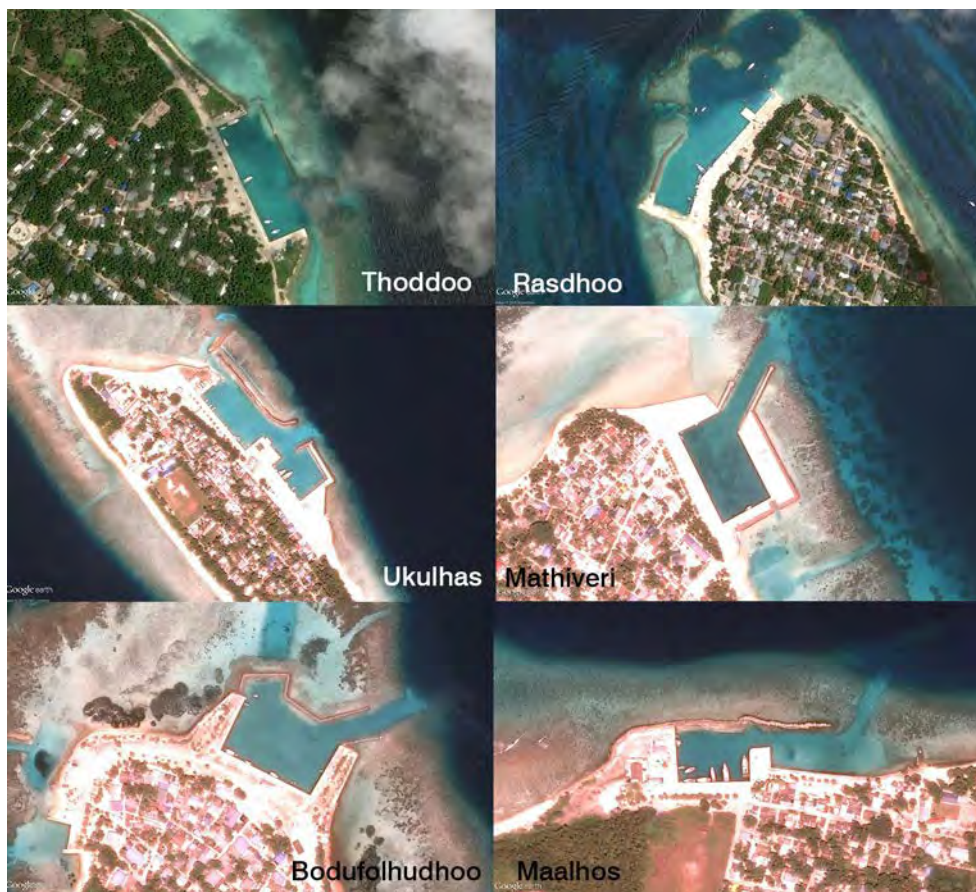
Figure 4.2 Harbour designs used in the inhabited islands of North Ari Atoll

Dredging reef entrances is part of the suite of facilities constructed with a harbor. It is also done separately to access the deep lagoon of a reef, to access a boat yard or as a separate access to the island which does not have a harbour. In North Ari Atoll, all inhabited islands, except Himandhoo have their reef entrances as part of the harbour. Himandhoo has two reef entrances – one on the south and one the north. Bodufolhudhoo also retains two channels with one for the existing harbour and one for the old access point on the western side of the island. Bodufolhudhoo was also forced to close down one of its dredged channels due to strong wave refraction within the harbour.

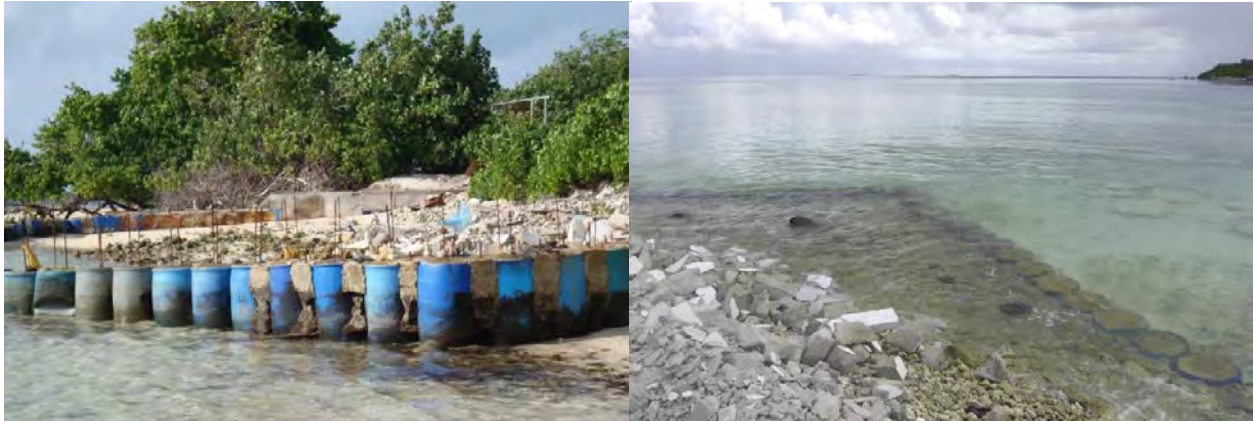
Figure 4.4 Example of improvised Seawall structures: concrete filled barrels in AA Bodufolhudhoo

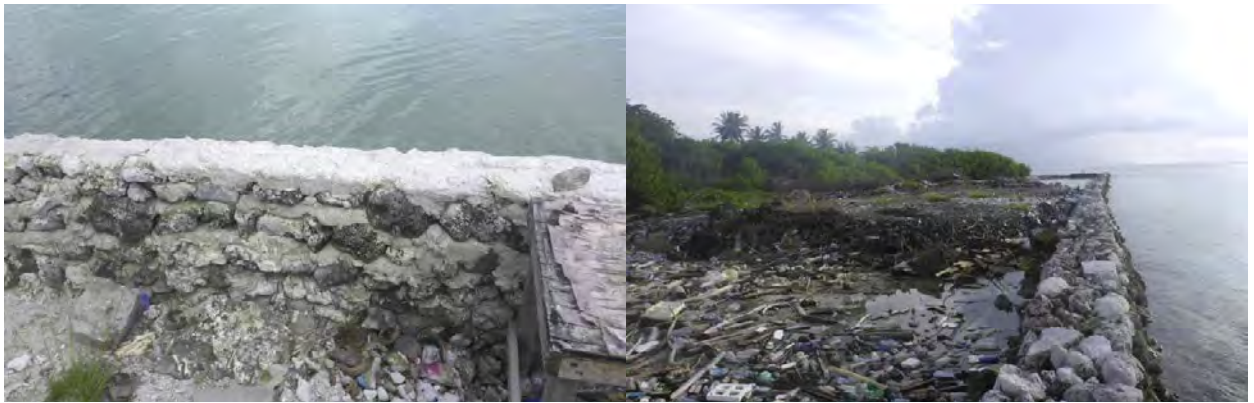
Figure 4.5 Examples of Seawall structures: semi-plastered coral mound seawall in Bodufolhudhoo and Mathiveri

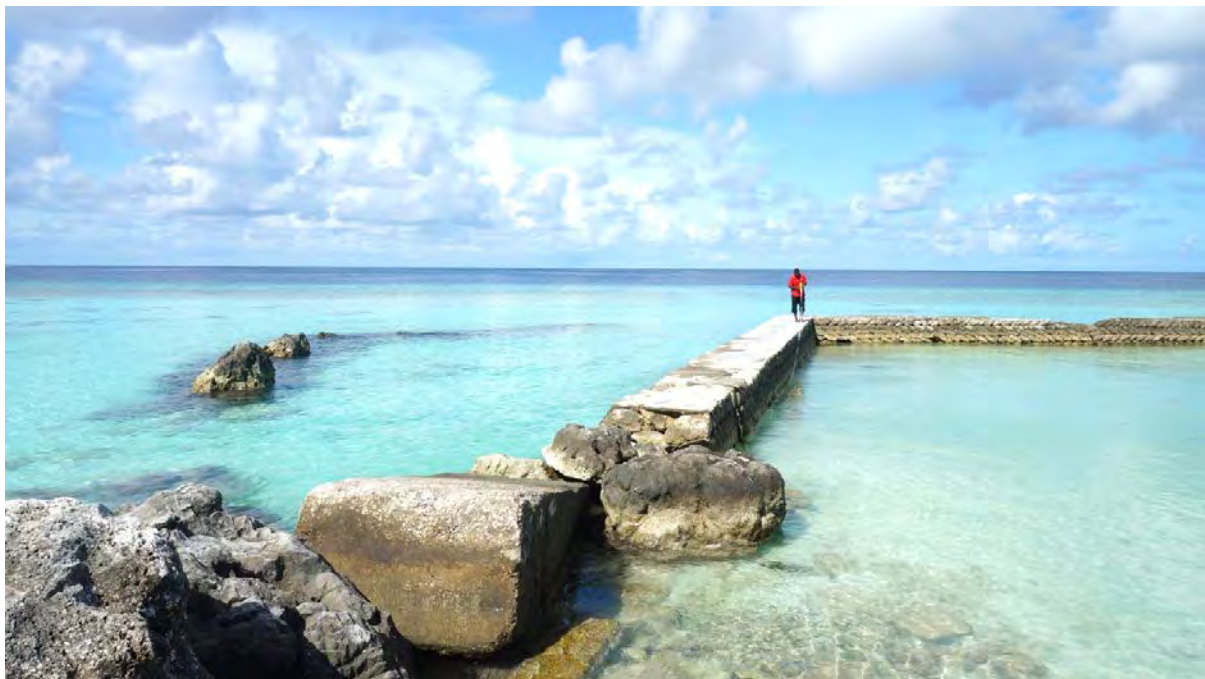
Figure 4.9 Break water design used prior to 2010s – sand cement bags from Thoddoo Island

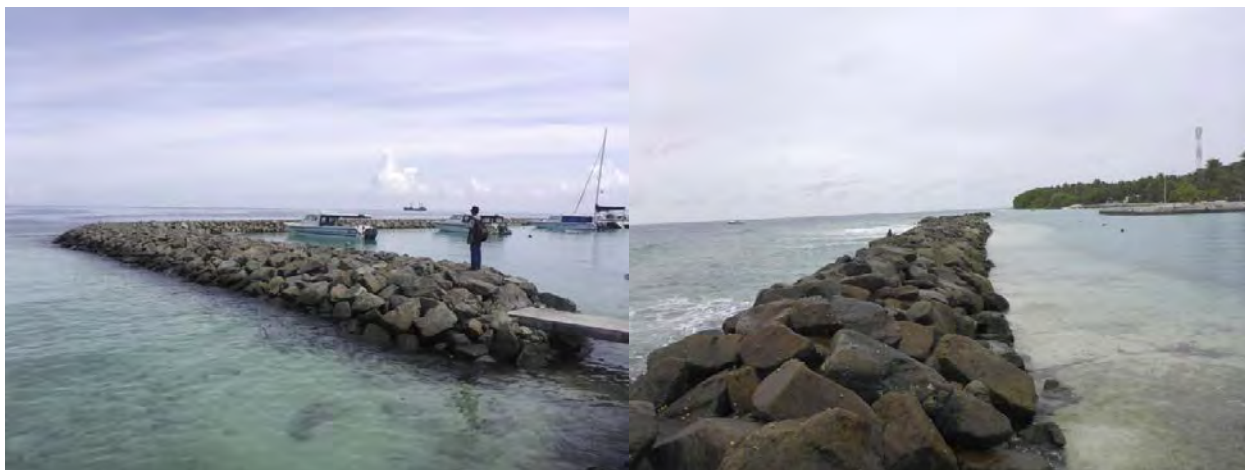
**Figure 4.10** Current break water design for harbours – Raised rock boulder breakwater in Rasdhoo and Maalhos

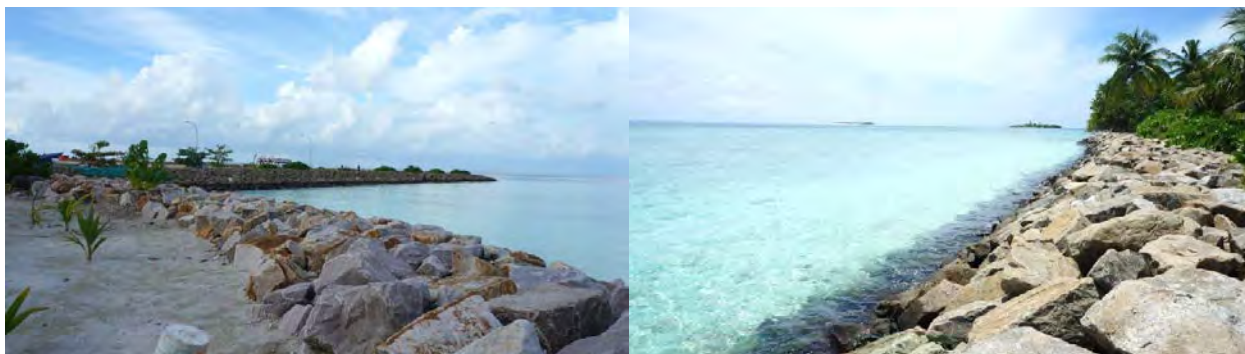
**Figure 4.11** Revetment – Armor rock structures in Mathiveri and Rasdhoo

Revetments in North Ari Atoll have been constructed mainly using armour rock. There is only one instance of the use of sand-cement bag revetments.

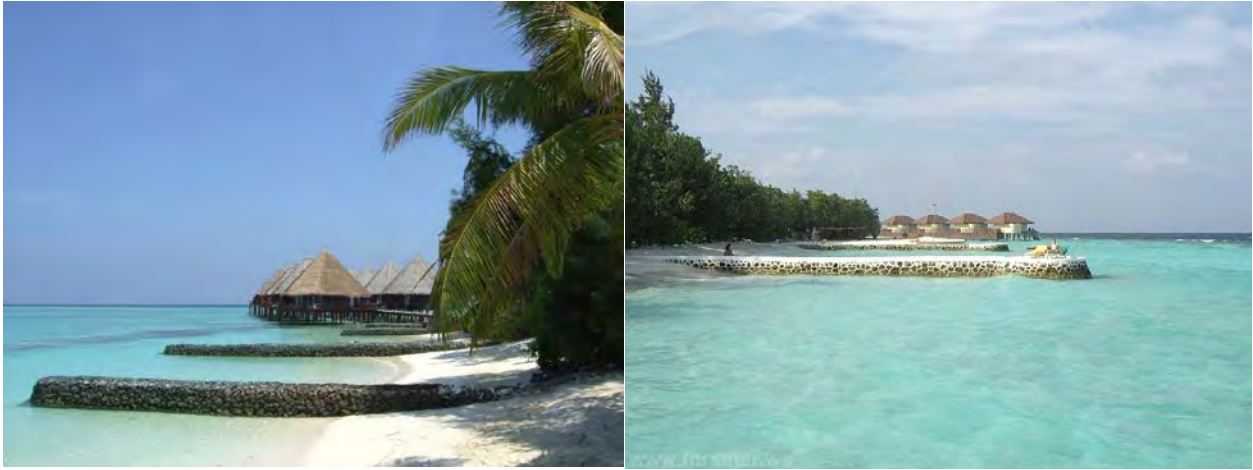
**Figure 4.12** Groynes used for erosion mitigation in Velidhoo and Mayyafushi

The basic design includes a structure extending into the lagoon above high water level. The length of the structures varies depending on the island used. The seaward end may be designed as a circular shaped structure for aesthetic purposes. It is usually constructed using sand-cement bags or coral mounds.

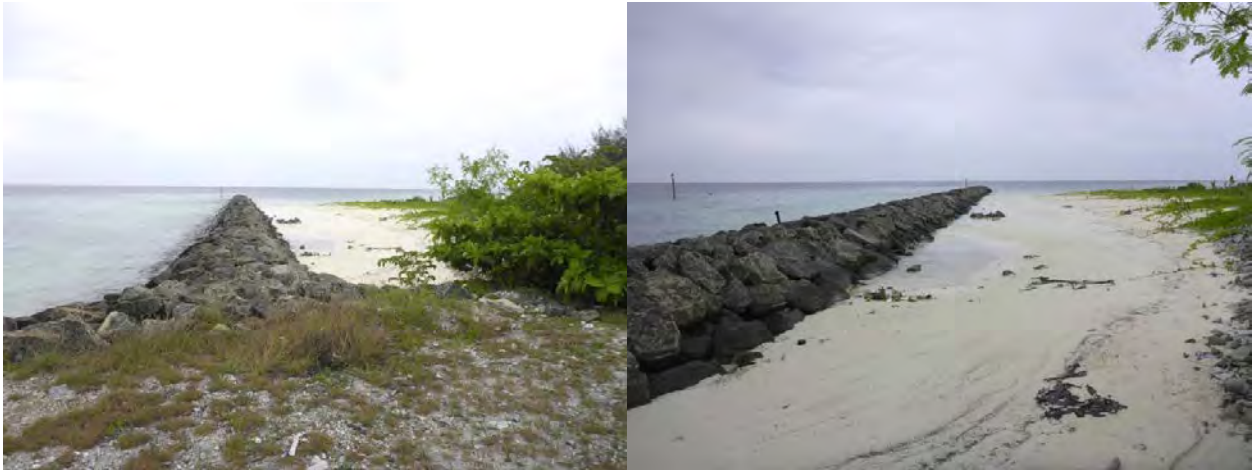
**Figure 4.13** Groyne constructed in Feridhoo to prevent sedimentation in harbor basin and to prevent erosion

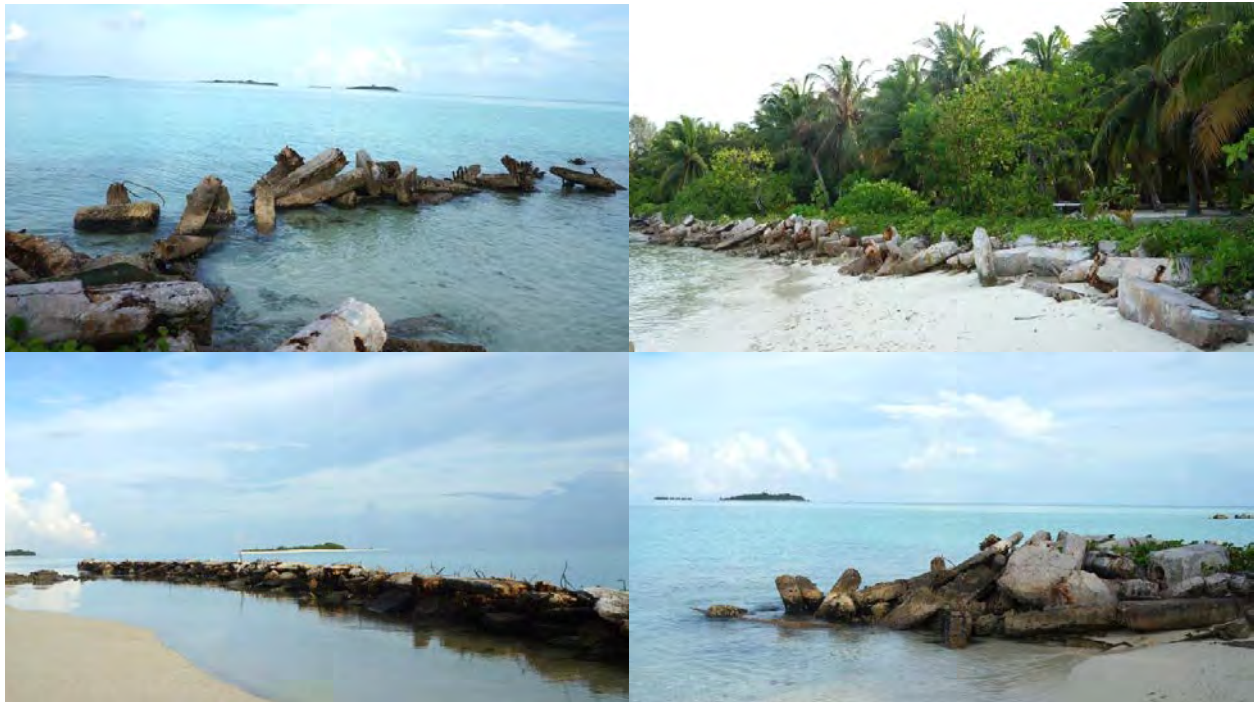
Figure 4.14: Ad hoc dumping of construction waste to mitigate erosion in Mathiveri Island. A range of measures including groynes, revetments and nearshore breakwater have been constructed using harbour demolition waste.

Construction debris has been used as a breakwater, particularly in Mathiveri Island. They used the debris from the old harbour demolition to create a makeshift structure.

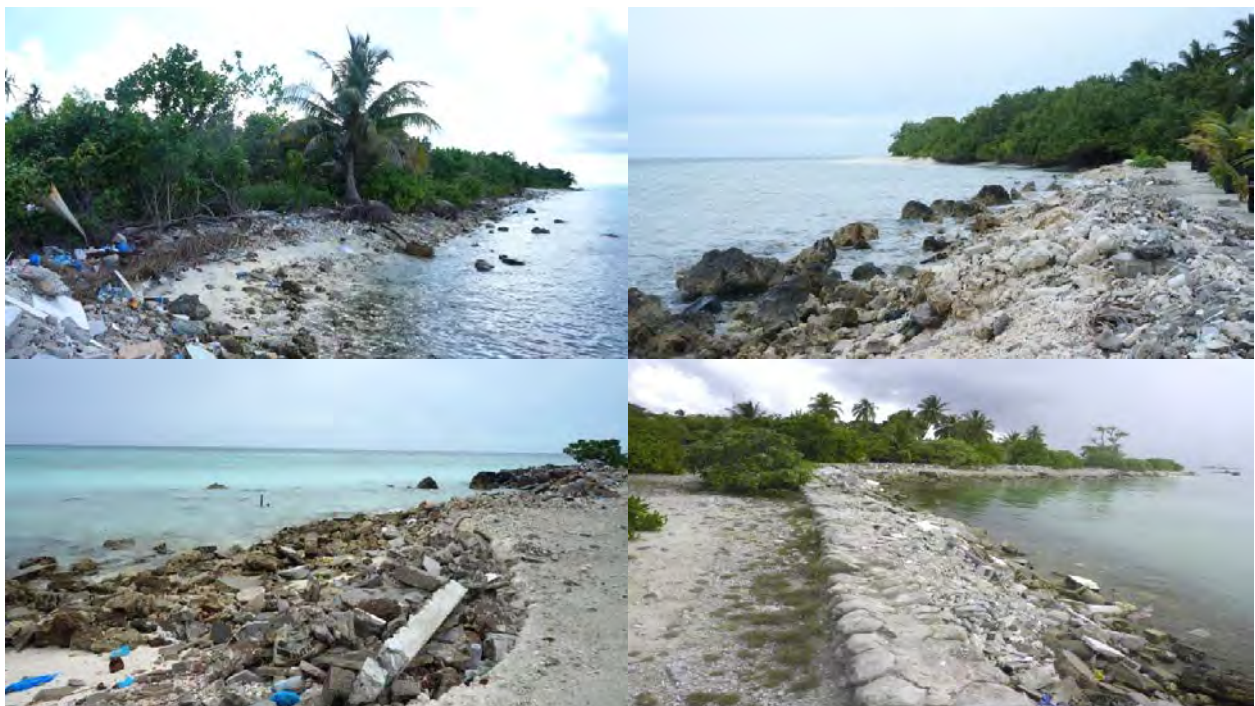
Figure 4.15 Construction waste used for erosion mitigation in (a, b) Thoddoo, (c) Ukulhas and (d) Bodufolhudhoo

Its effectiveness is poor. In areas of heavy erosion, despite the presence of the debris, erosion tends to continue leaving behind the debris in the lagoon.

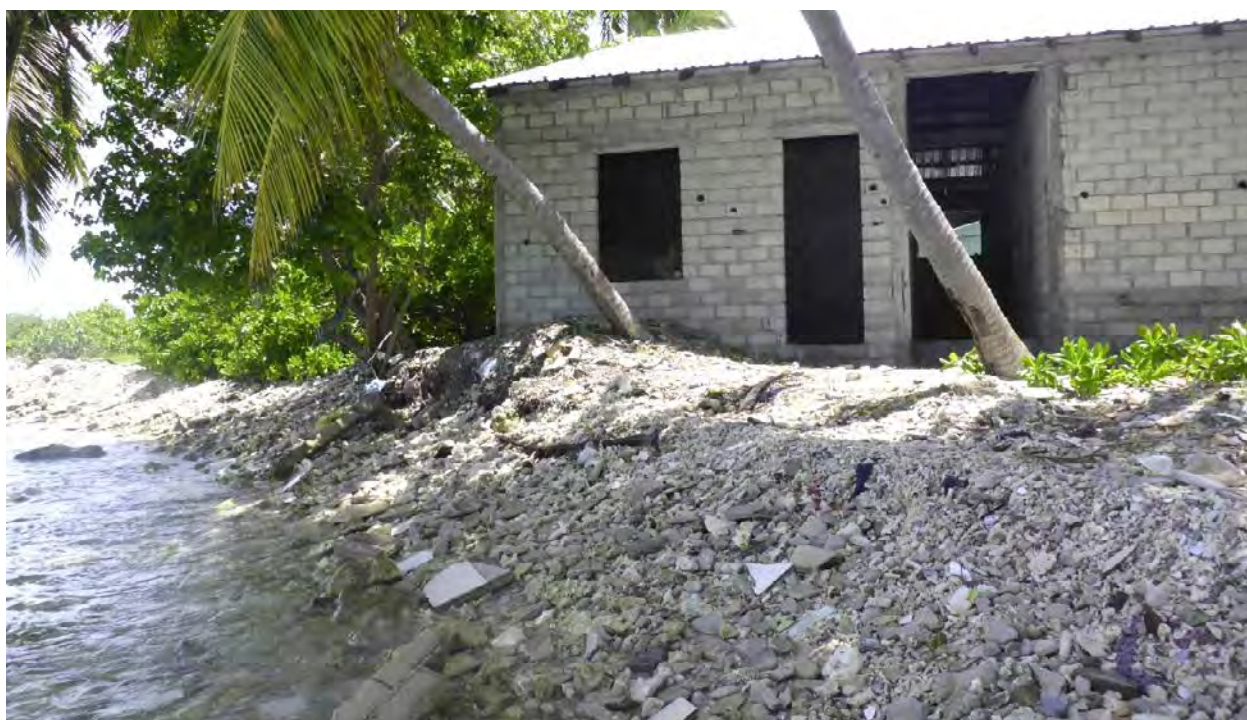
Figure 4.16 Building in close proximity to an eroding shoreline in Rasdhoo Island

Land-use setbacks provide the most environment friendly option against medium term-erosion. This method recognizes that certain areas of the island are volatile and exposed to periodic erosion and provision is given to facilitate these natural processes by avoiding construction in these zones.

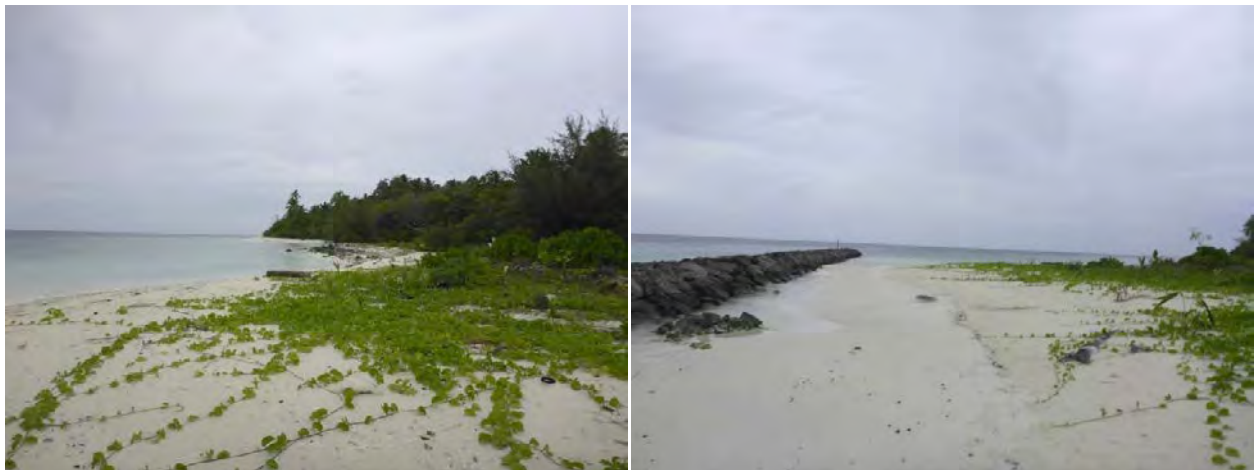
Figure 5.3 Accretion during NE monsoon on the eastern side of the harbour

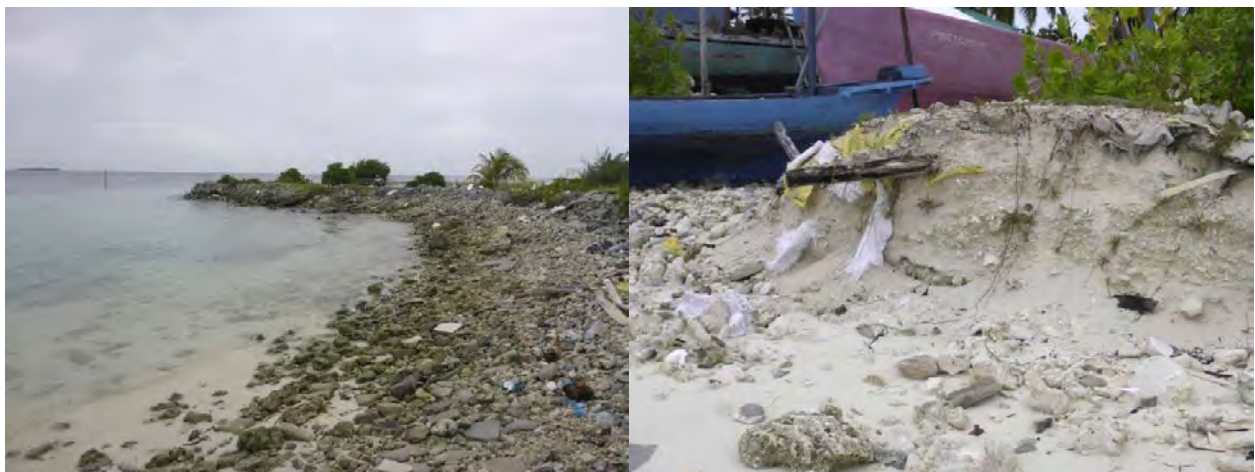
Figure 5.4 Erosion on the western side of the harbor
