FIRST ENVIRONMENTAL IMPACT ASSESSMENT ADDENDUM

Proposed Reclamation of Himmafushi, Kaafu Atoll, Maldives

Change of Borrow Area

Ministry of Housing and Infrastructure

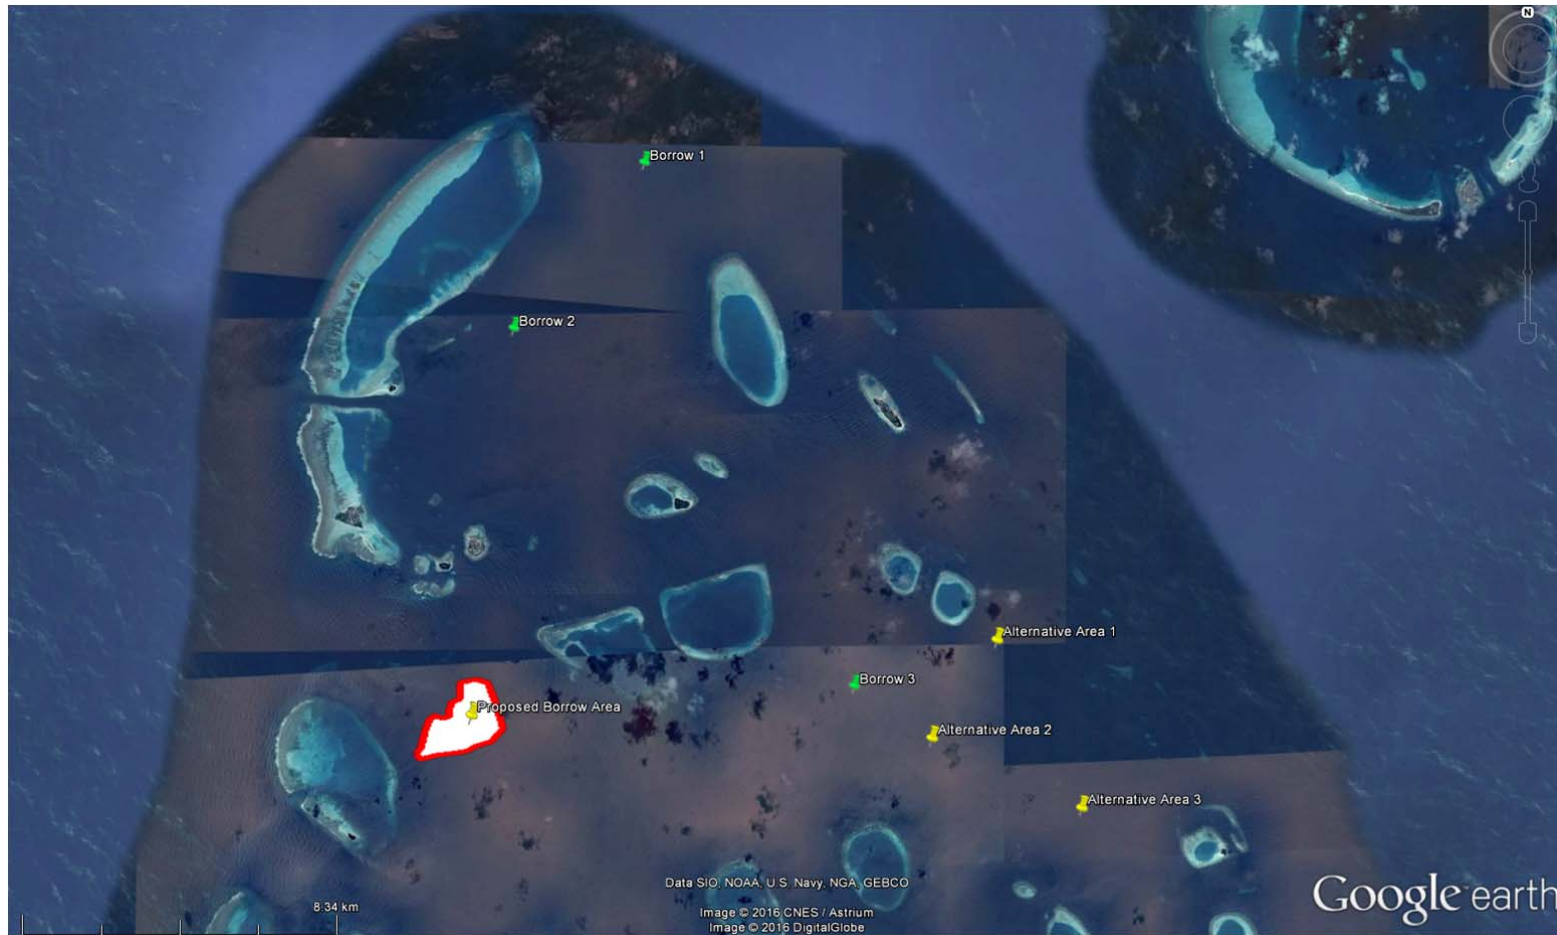
The originally proposed borrow areas as well as the final borrow area is shown in the figure below. The previously proposed borrow areas are circled in Yellow place marks and other borrow areas that were investigated in Ari Atoll are given in Green place marks.

Figure 1 Study area including the previously declared borrow areas and the final borrow area

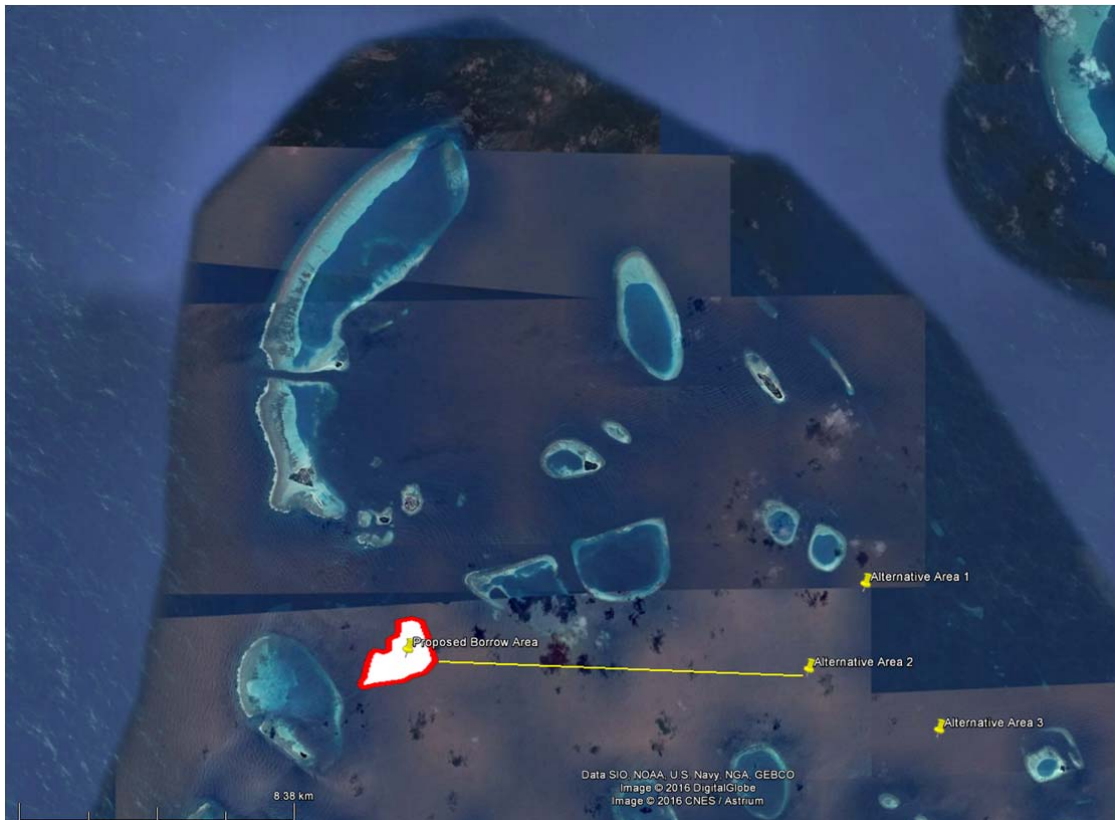
Figure 2 Proposed borrow area compared to areas provided in initial EIA

The GPS coordinate of the borrow centre of the borrow area as given in the above figure is 4°08'51"N - 72°46'26"E. Surface area of the entire area is 3,400,000 sqm. Minimum bottom depth of the area is 40m from MSL, while maximum bottom depth is at 50m from MSL. Average sand particle sizes found on site is 658mm. From this area, the sailing distance to the reclamation area is 126km.

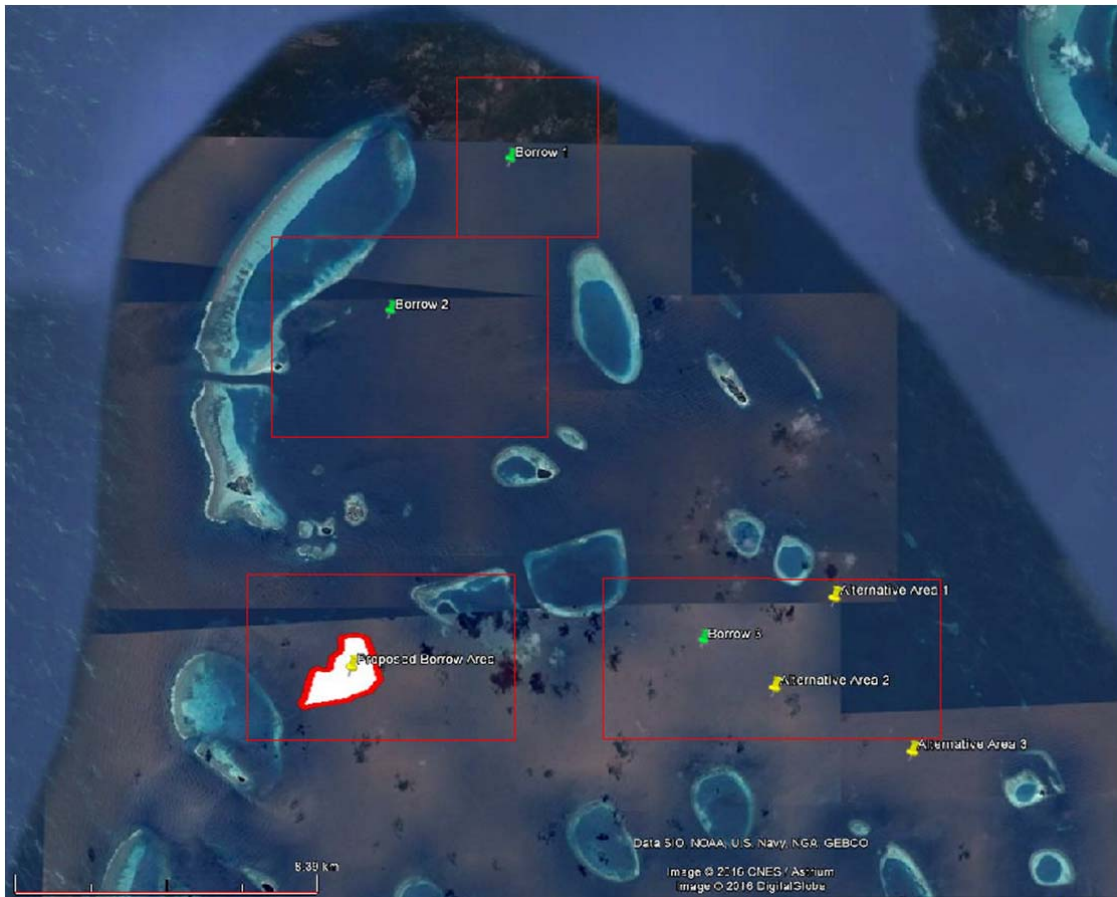
The Figure below shows wide areas that were studied as part of the sand search campaign. Four broad areas were studied, from which, only one area yielded sufficient quantities of quality sand required for the reclamation.

Figure 3 Locations studied within Ari Atoll for sand availability

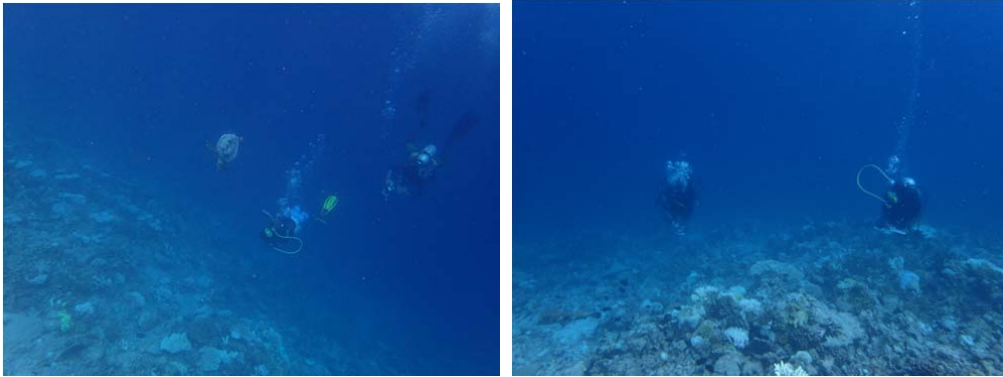
Figure 6 Marine environment survey photos

Marine Environment was investigated by observing biodiversity check using line transects. The divers took notes along the transect regarding Fish species, Invertebrates and Coral cover. The results are currently being processed and will be provided to EPA once finalised.

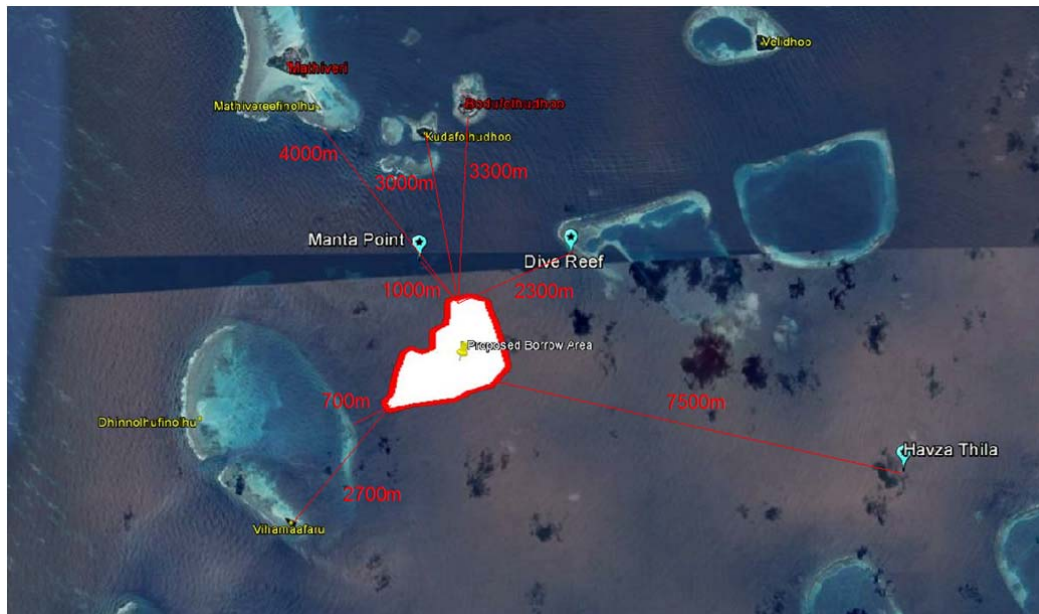
It's important to note that the initial EIA had proposed several borrow areas that were in similar proximity to sensitive areas as shown in the figure below.

Figure 7 Distances from the project area to the sensitive areas

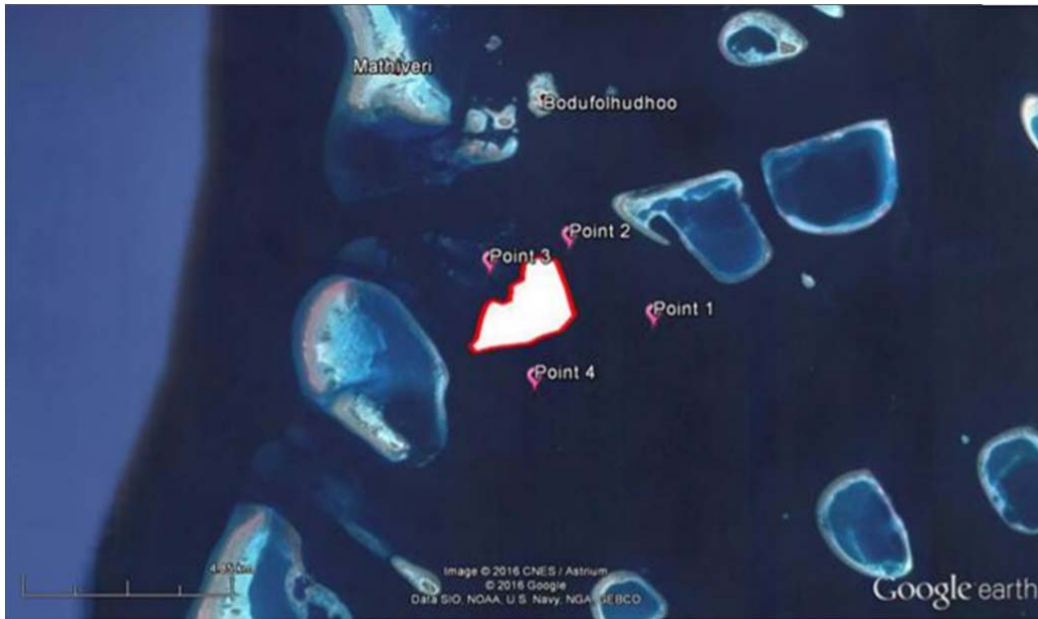
Figure 12 Proposed points for water quality monitoring in North Ari Atoll borrow area

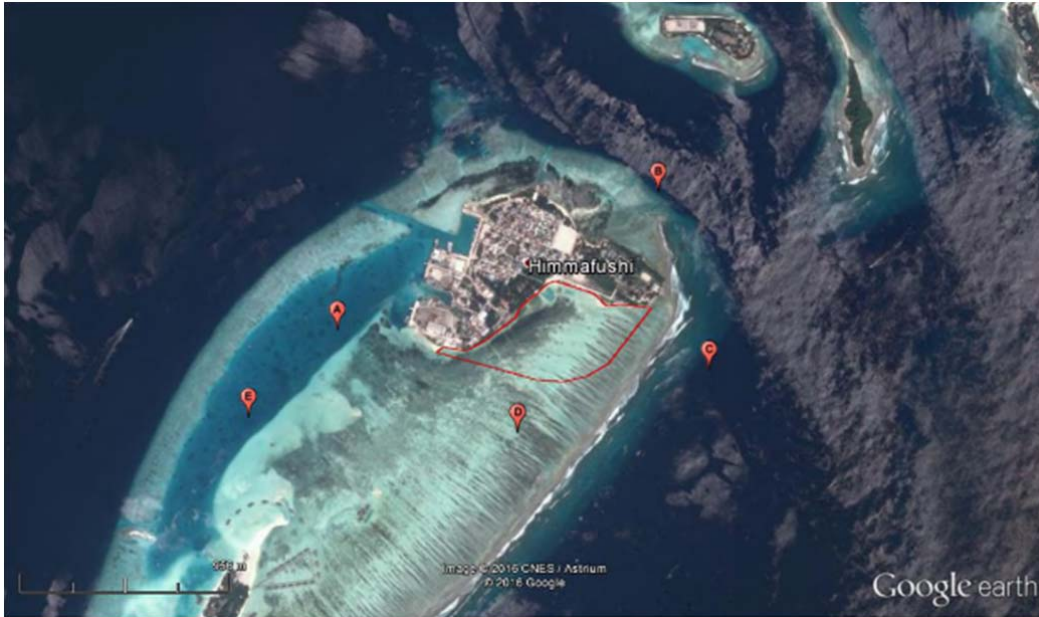
Due to the limited water depth at the house reef of Himmafushi it is not possible to access the water by boat during low tides and thus to perform water quality monitoring. Therefore it is proposed to shift the water quality monitoring points which are given in the Water Quality Monitoring Plan of Van Oord to areas which are accessible, these new points are shown in the Figure below. In this way the monitoring can be executed more frequently and without any safety issues.

Figure 13 Proposed points for water quality monitoring at Reclamation site

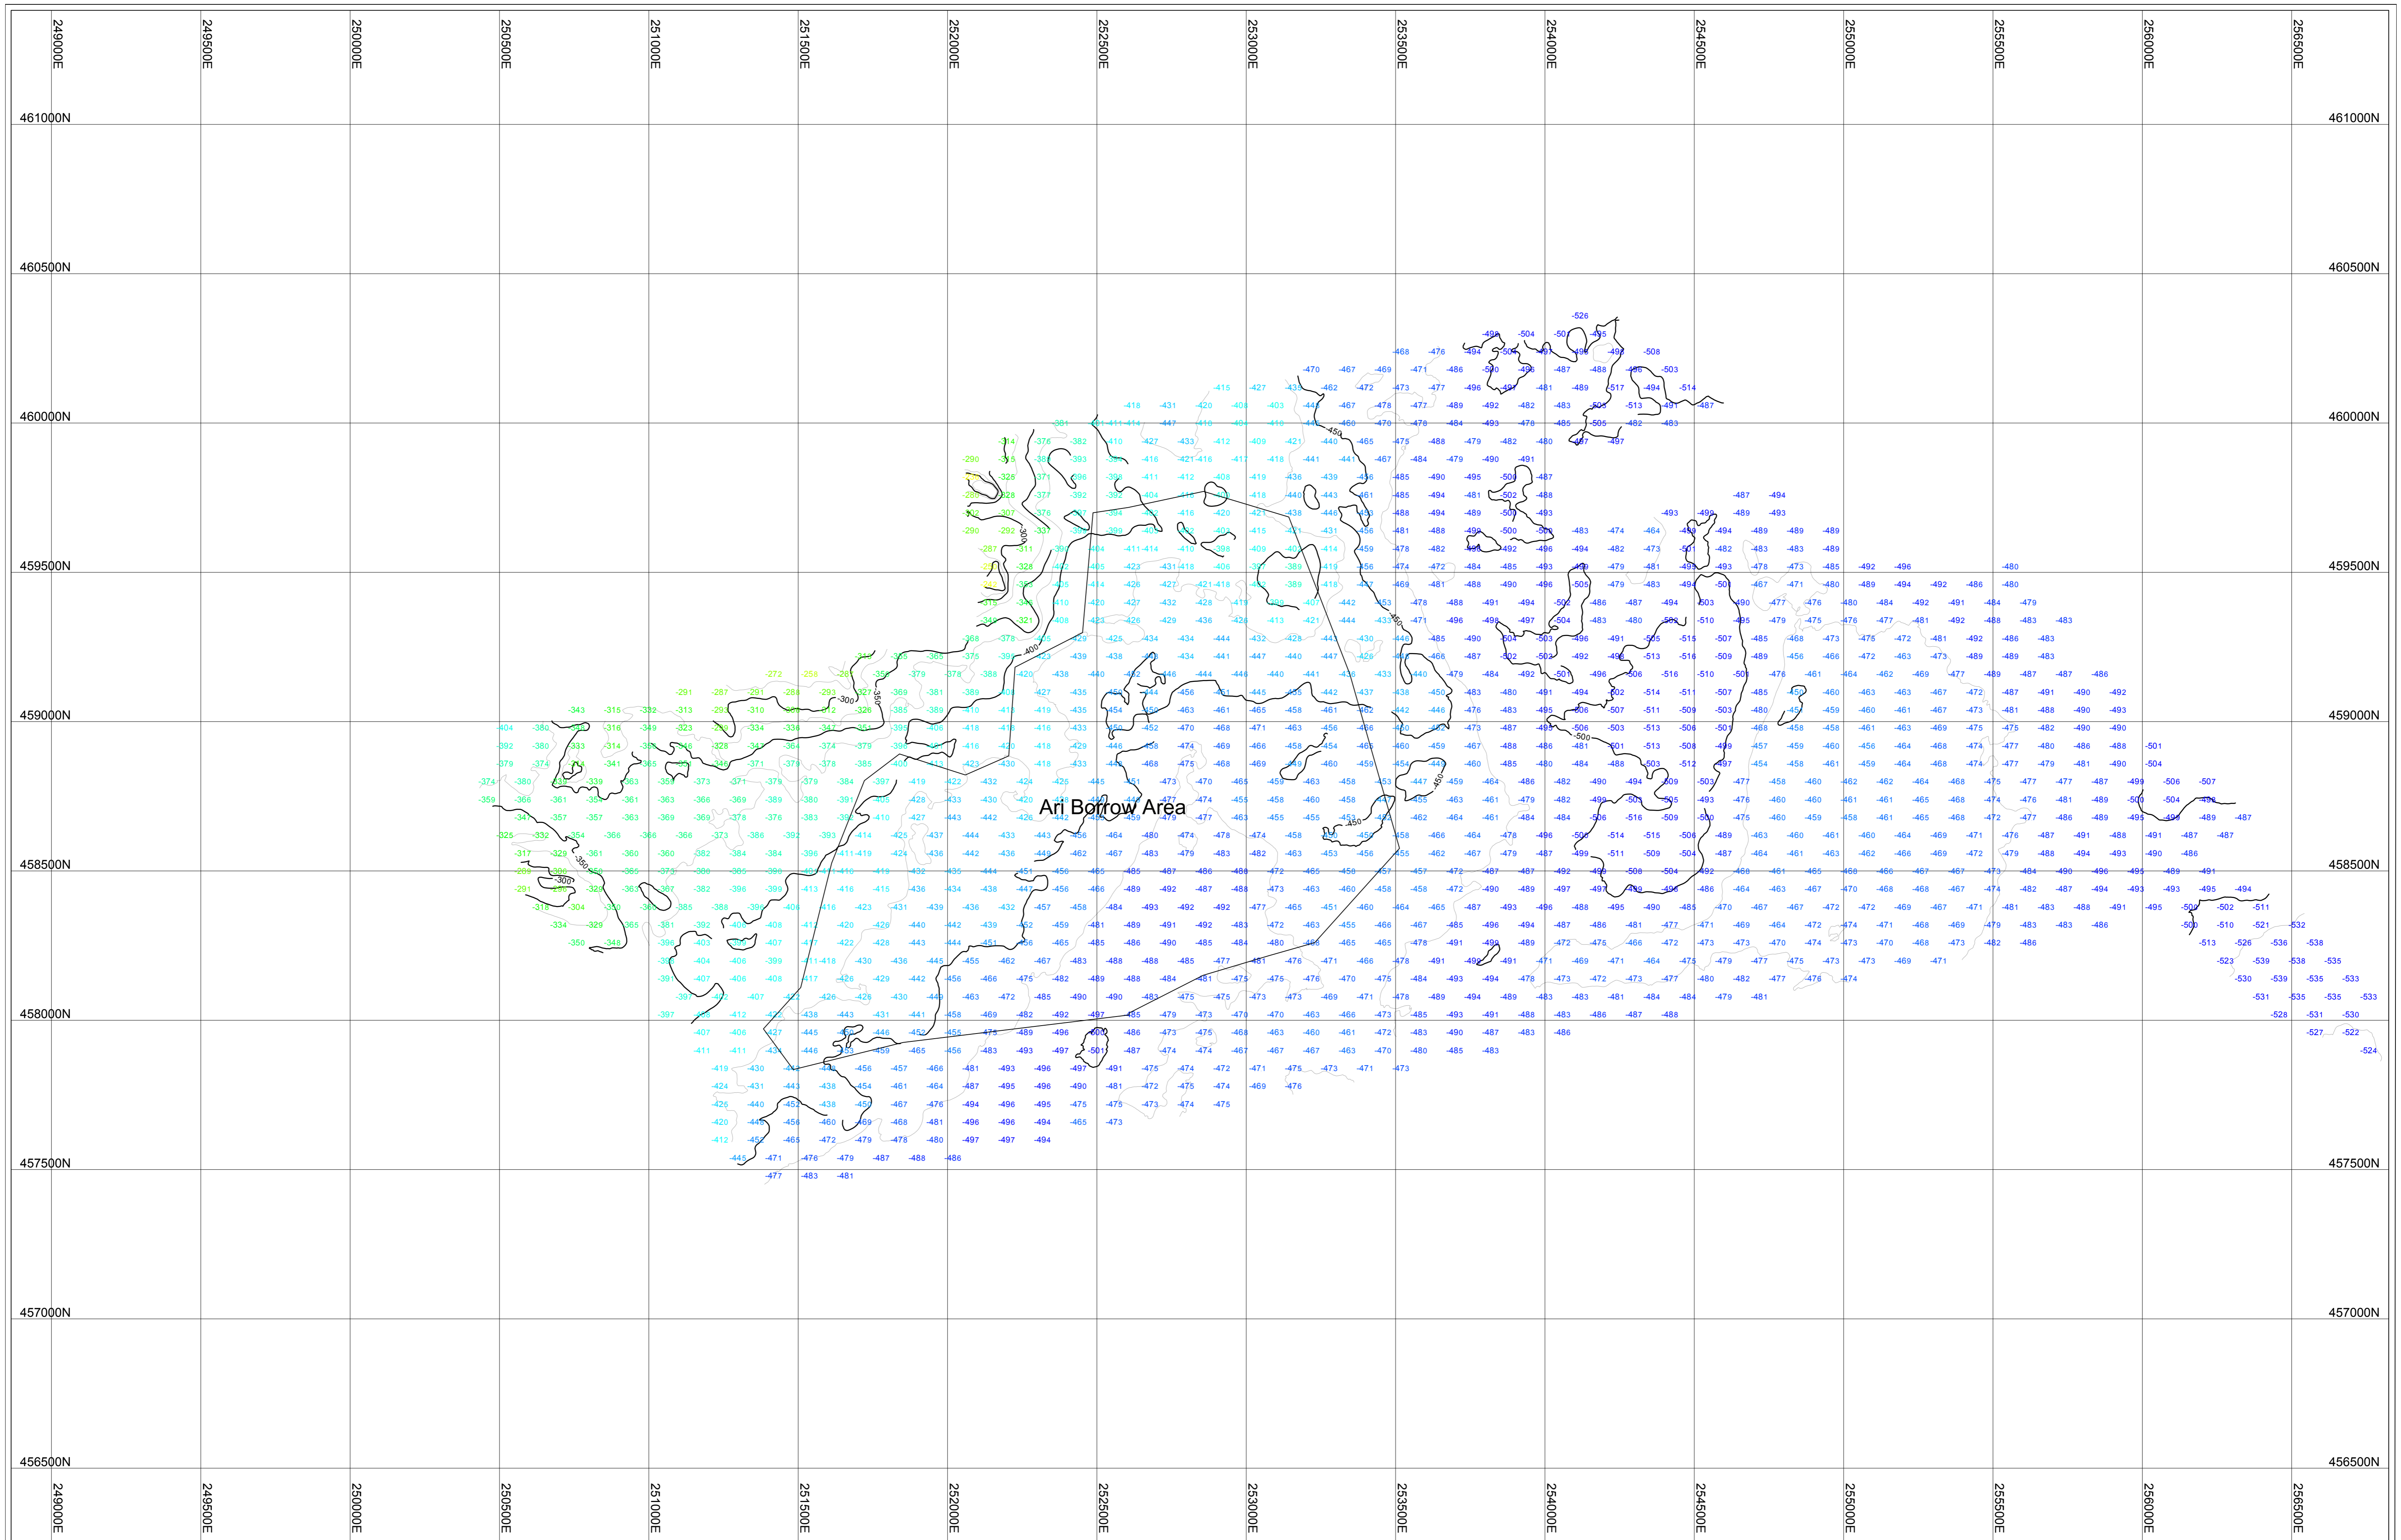
Annex 5 – Bathymetry

Depths and dimensions in m
 Navigational Water Depths are related to CD
 Reclamation Depth are related to MSL (CD + 0.66m)

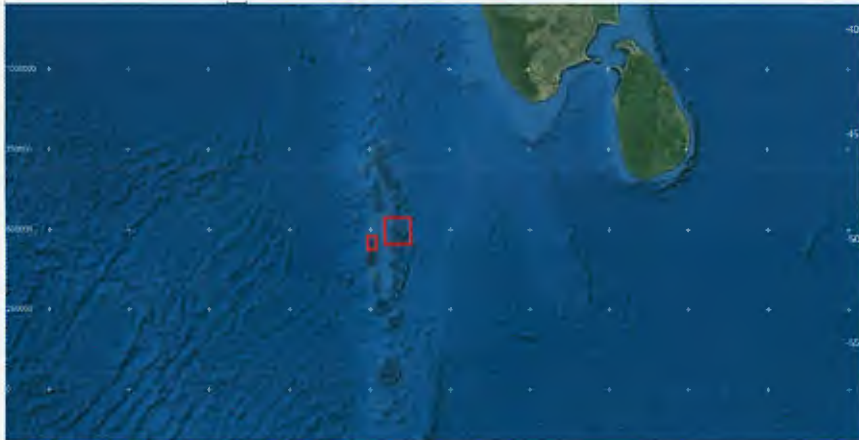
Figure 1. The red squares indicates the location of the Ari Atoll (west) and Male Atoll (east).

Himmafushi Island is part of the Male Atoll which is located in the central part of the Maldives. The island is located approximately 17km north of the capital Male. For a reclamation on the north-east side of Himmafushi approximately 600.000m³ of sand is required. Between 15-03-2016 and 28-03-2016 Van Oord conducted a sand search campaign to find a borrow area containing the required amount of suitable sand. The primary objective was to locate sand in the Ari Atoll as extensive dredging took place in Male over the last years and sand resources will likely be depleted. As requested by the client an extensive sand search was also conducted in male in order to verify if any suitable material still remains close to the project location.

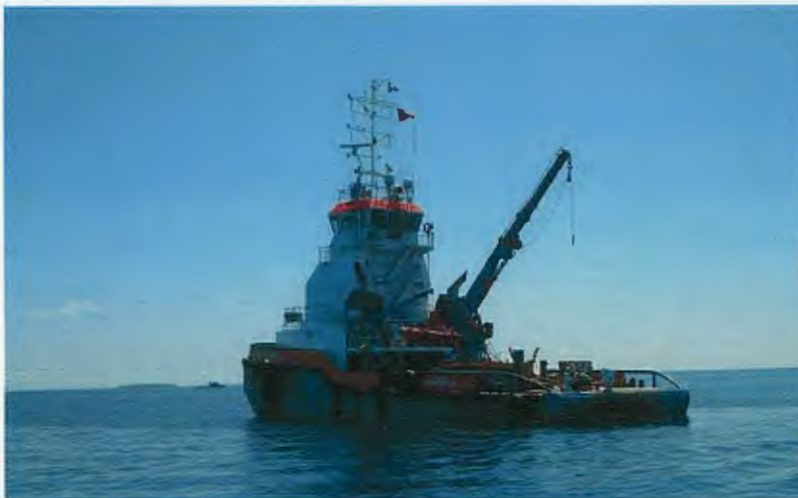
Figure 3. The Van Oord pushbuster "Blackbird"

The vessel used for the Sand search was the Blackbird, a Pushbuster type vessel belonging to Van Oord, see Figure 3. Initially the inside of the Ari And Male atolls were surveyed using a SES 2000 Standard, a parametric echosounder produced by Innomar. Based on this data borrow areas were selected. For obtaining samples in the borrow area the crane of the blackbird was used to deploy a high power electric vibrocorer constructed and operated by Marine Sampling Holland (Figure 4). The retrieved material was logged and selected samples were sent to the Fugro lab in Dubai for lab analysis.

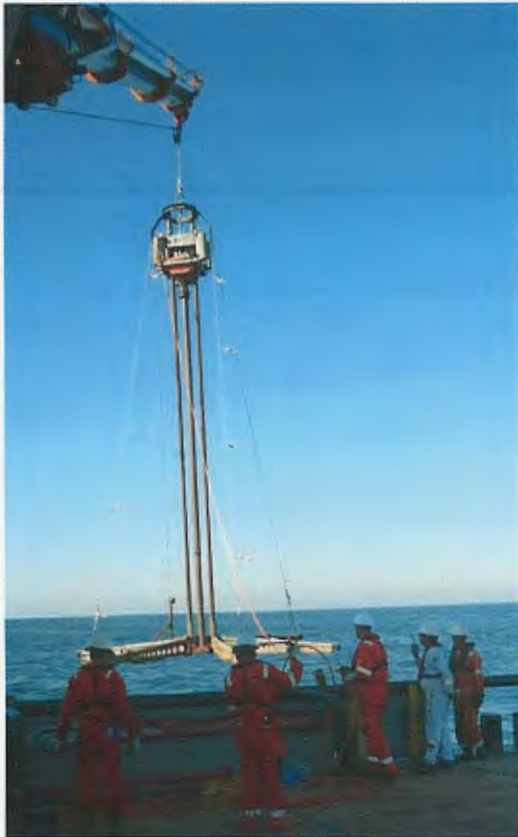
Figure 4. High power electric vibrocorer being deployed.

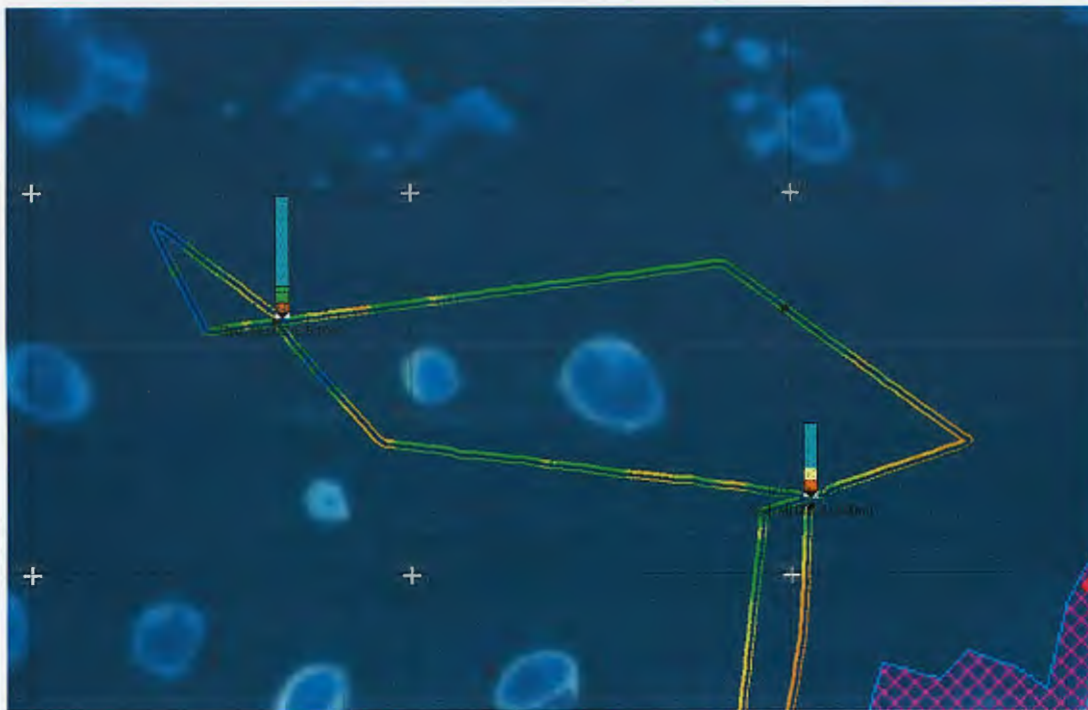
Several exploration lines were sailed in area 1. The pes profiles clearly show the presence of a thick sedimentary layer on top of what appears to be bedrock. In order to test the nature of the sediment layers two vibrocores were deployed. Both returned unfavorable results as the sediment are fine grained and consists of SILT.

Figure 6. Sailed lines in area 1 and vibrocore locations both cores recovered a thick layer of medium dense SILT.

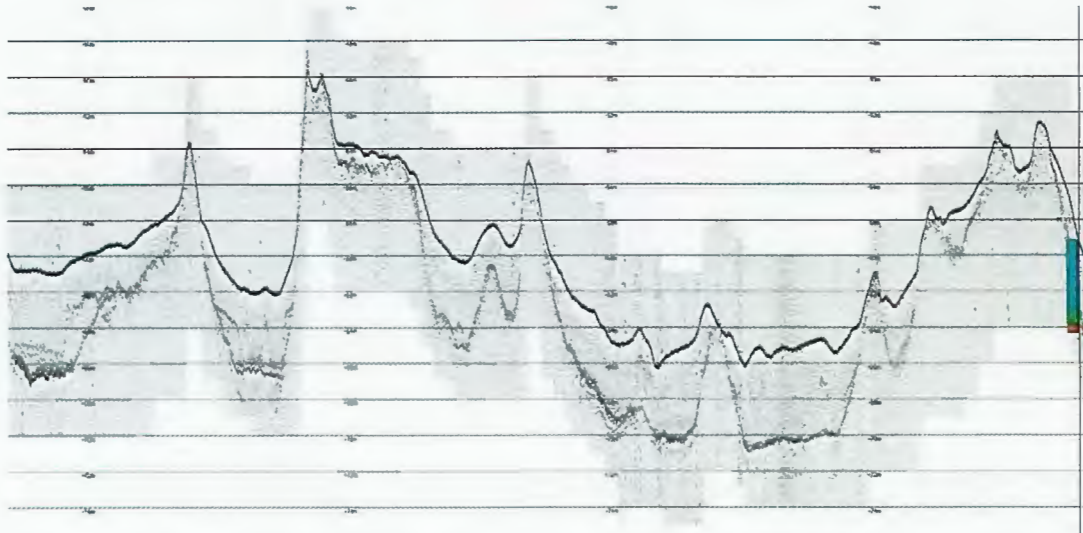
Figure 7. Typical Pes profile area1. Clearly visible is the bedrock which is covered by a thick "blanket" of silt

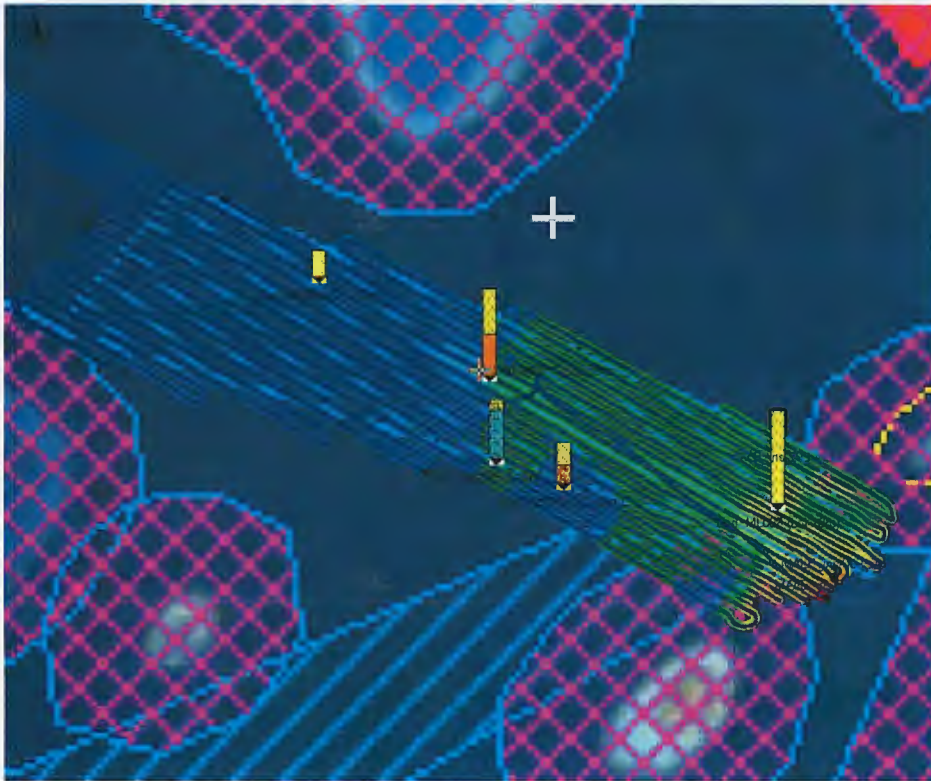
Figure 10. Sailed lines in Area 1. Vibrocores showed small sandbar in the east and central part.

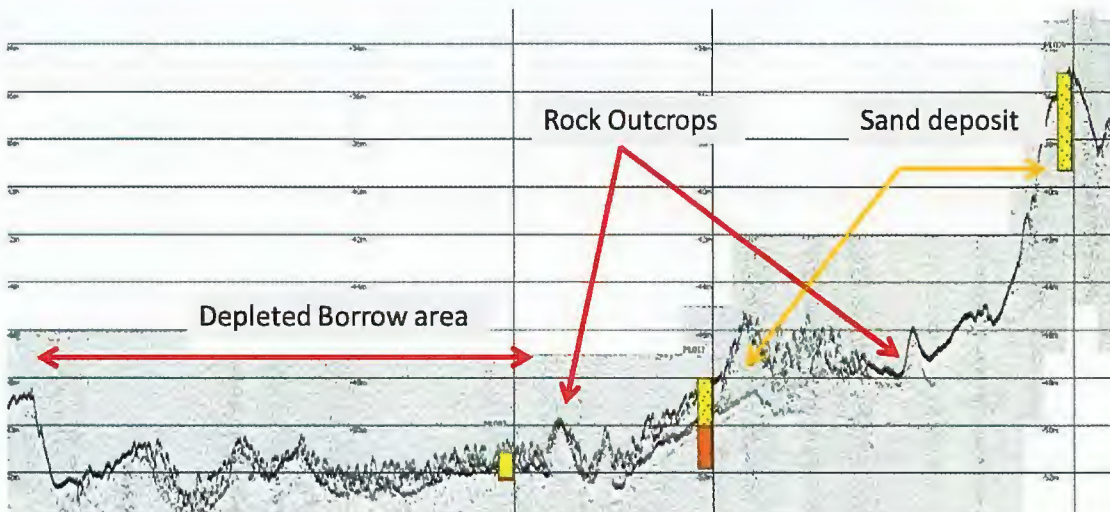
Figure 11. Pes profile across area 2 clearly shows the depleted area in the west, some small pockets of sand remain in the east

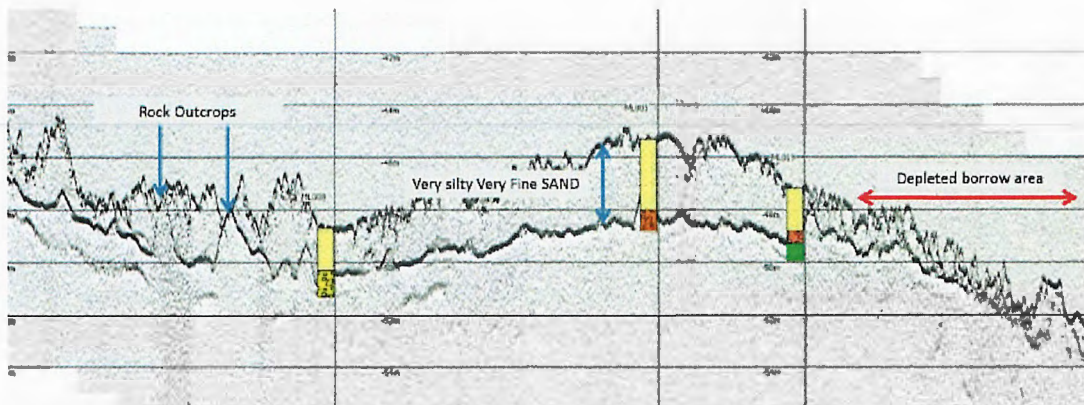
Figure 14. Pes and vibrocores show very fine very silty sediments in the central part of the former Leiv Eriksson Borrow Area.

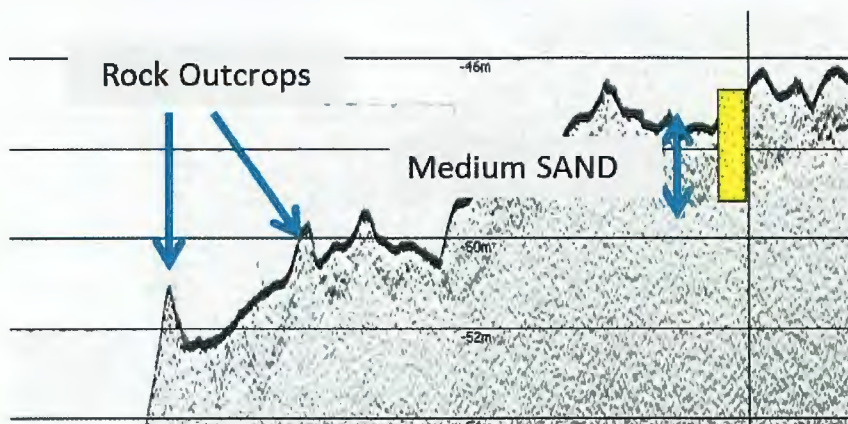
Figure 17. Pes profiles show a sediment layer of between 0 and 2.6 meters in thickness.

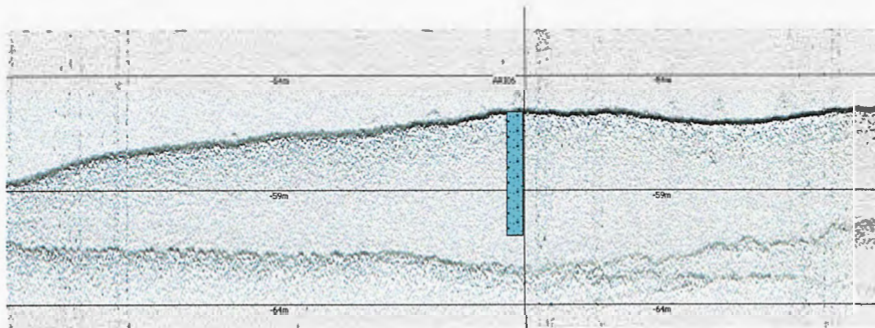
Area two and three are located more inward of the Ari Atoll. The PES profiles in these areas revealed a thick sedimentary deposit up to 10 meters in thickness. Two vibrocores were deployed to determine the nature of the deposit and returned thick SILT layers. The areas were not further investigated.

Figure 22. Profile in Area 2.

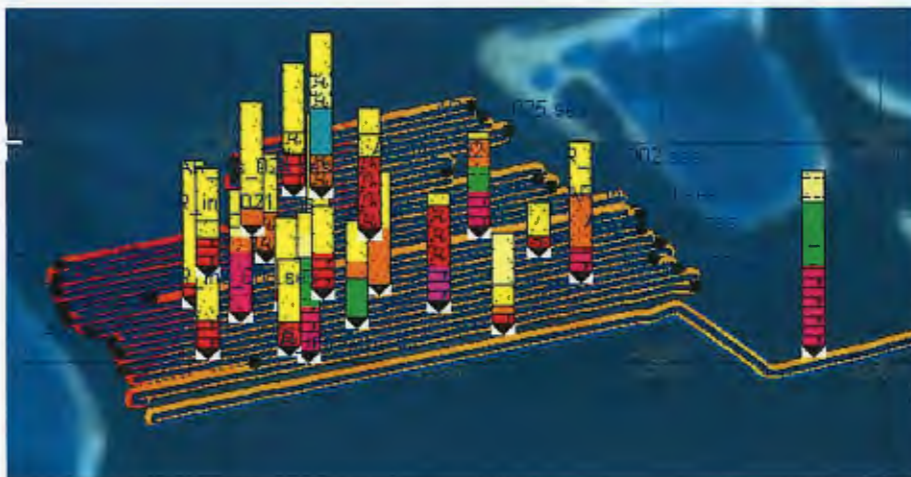
The sedimentary deposit was mapped in detail with a PES survey and extensive Vibrocore Campaign. Sailed lines and Vibrocore locations are displayed below. Vibrocores deployed in the area recovered yellowish white medium to coarse SAND.

Figure 25. Sailed Pes lines and vibrocores area 4.
