Environment Impact Assessment Report

Development of Holiday Inn Geoenvironmental and Geotechnical Aspects, Ameeneege, Male` Maldives, (Part I).

Male' Hotel Associate Pvt. Ltd.

November 2007

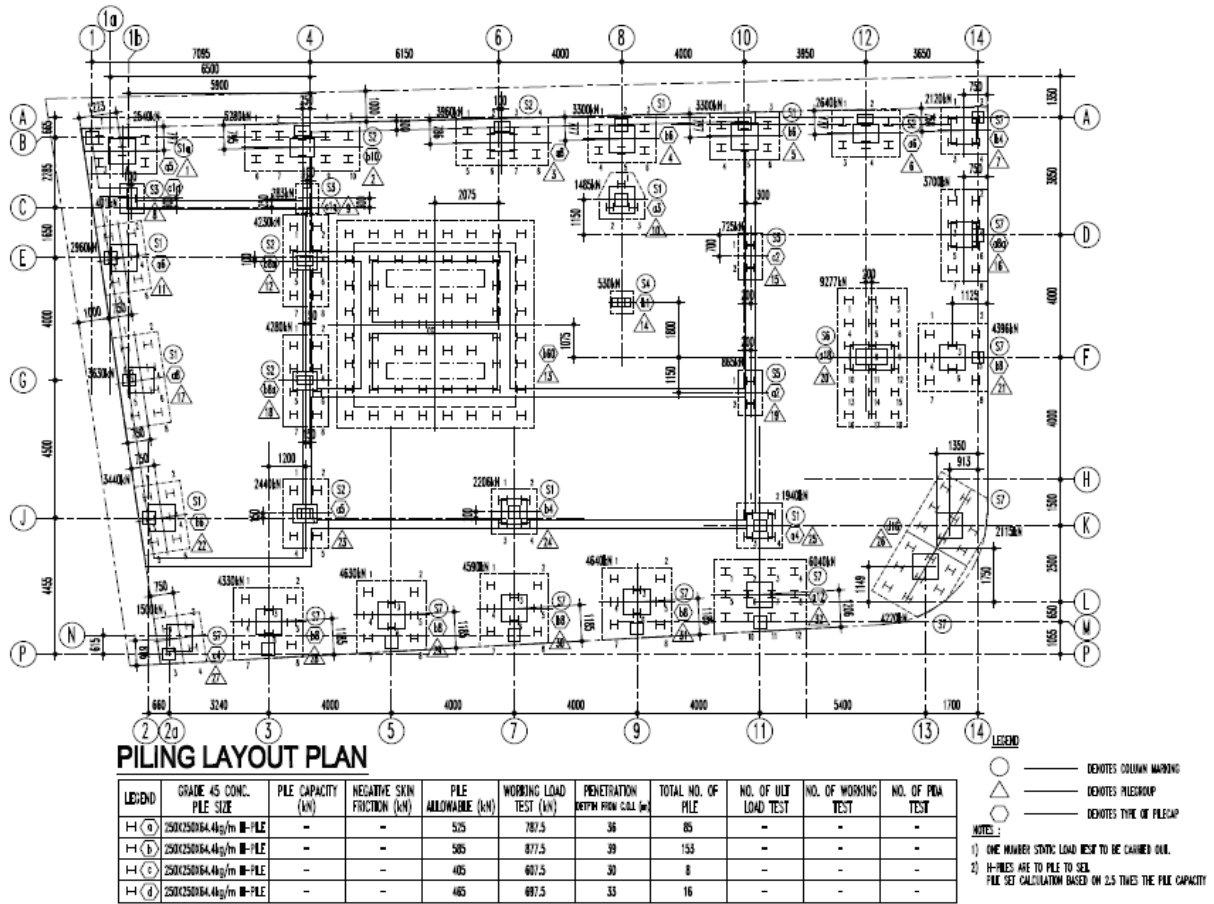
Fig 3. Pile layout plan, a total 256 steel H-piles will be driven into the ground.

The project involves building a 15-storey hotel, (Holiday Inn) in Ameeneege, and operate it at international 4-star standard hotel. The proposed building consists of RC (Semi-Basement & 1st Storey) System & Steelwork System (from 2nd Storey to Roof) with profile steel slab construction. The building will be sitting on a Steel, 'H' pile of 250 x 250 x 64.4 kg/m, foundation system. The pile capacity is estimated to be 405 kN, 465 kN, 525 kN and 585 kN with corresponding pile depth of penetration of 30m, 33m, 36m and 39m (Fig 2). A total of 85 piles will be penetrated to 36m depth, 153 piles to 39m, 8 piles to 30m and 16 piles to a depth of 33m, making the total number of piles that will be derived into the ground 256 H pile (Fig 3).

As mentioned in the structural details of building the whole building will be standing on a pile foundation. A total of 256 piles, 250x250mm steel H piles, will be driven into the bed rock, 85 piles will be penetrated to 36m deep, 153 piles to 39m, 8 piles to 30m and 16 piles to a depth of 33m. The piles shall be driven with a hydraulic drop hammer. The drop hammer has a 3-tonnes ram and ram stroke of up to 1m shall be used for driving the piles.

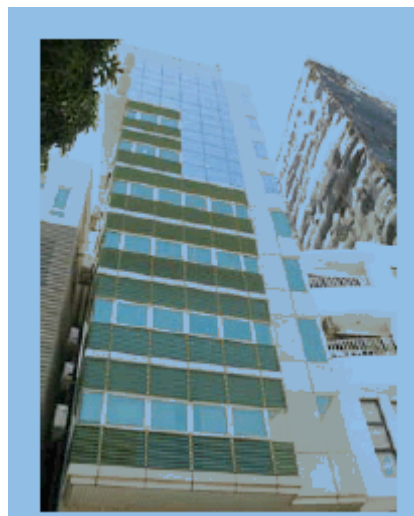
Fig 7. ADK tower 12-30m west of the site.

ADK tower building, shown in (Fig 7), is built to 10 storey, constructed with reinforced concrete frames as primary structure on raft foundation. Exterior cladding was masonry walls, glass curtain wall, aluminium framed glass windows and solid timber doors. This building is approximately 12-30m west of the site.

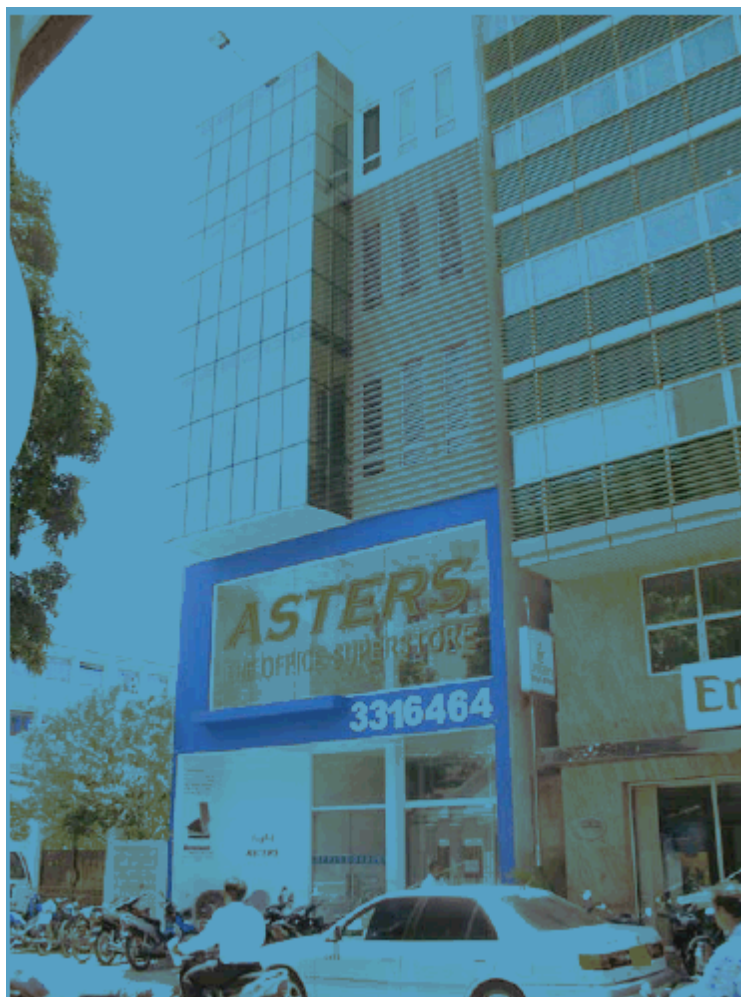
Fig 8. Asters building 10-25m away from the site.

Asters building (Fig 8) is generally built to four storey blocks with one block with two storey constructed with reinforced concrete frames as primary structure and exterior cladding with masonry walls, aluminium framed as well as timber framed glass windows and doors. This building is 10-25m west of the site.

Table 6 . Distribution of locations of defects compared for floor levels Asters building.

Floor level	Locations of defects	%
Level 1	19	12.9%
Level 2	15	10.2%
Level 3	26	17.7%
Level 4	20	13.6%
Level 5	44	29.9%
Level 6	23	15.6%

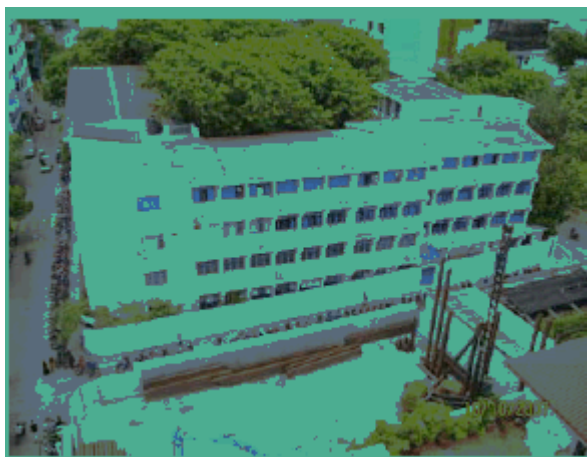
Fig 10. Dharumavantha school 50m east of the site

Dharumavantha school (Fig 10) is generally built to four storey blocks with one with one block with two storey constructed with reinforced concrete frames as primary structure and exterior cladding with masonry walls, aluminium framed as well as timber framed glass windows and doors. The school is located 50m east of the site.

Table 8. Distribution of locations of defects compared for floor levels Dharumawantha School.

Floor level	Locations of defects	%
Ground floor Level	75	46.3%
First floor Level	37	22.8%
Second Floor Level	30	18.5%
Third Level	15	9.3%
Terrace/roof Level	5	3.1%

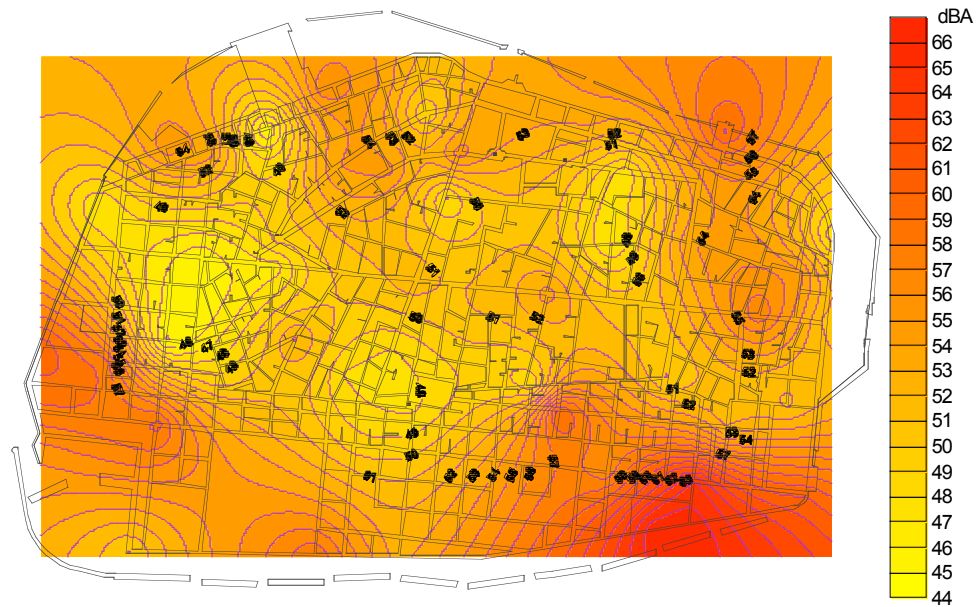
Fig 12. Countours of ambient noise level at night time in Male`

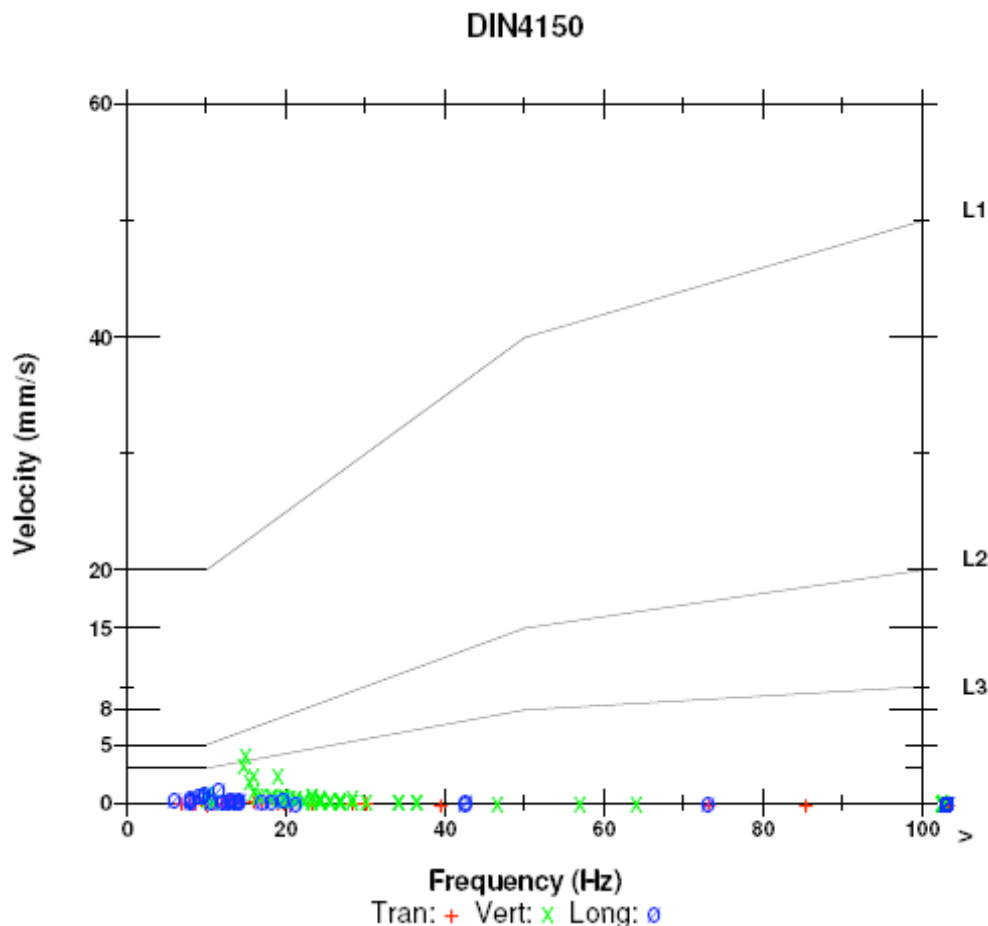
Fig 13 . Vibration level recorded at ADK tower at the time of test piles driving, vibration levels PPV are as low as 2mm/s.

During the SPT test pile driving on the site, vibration were measured using a minimate® Vibration and Overpressure Monitor, placed at the top floor of some of the aforementioned buildings on the 20th 2nd and 23rd of September 2007. Maximum Peak Particle Velocity PPV recorded was 2.98mm/s and the maximum frequency recorded was 18Hz. Sample vibration record obtained from the site during the test pile driving operation, compared with standard DIN 4150-3, is shown in (Fig 13).

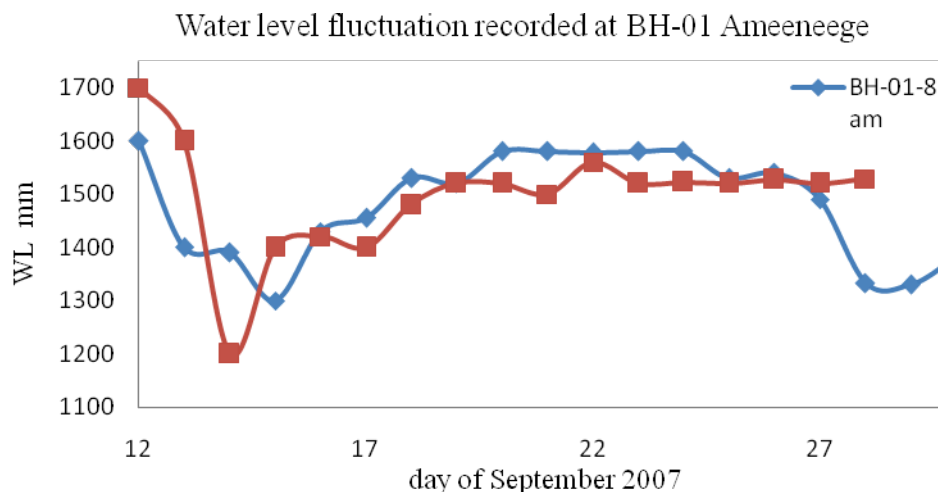
Fig 14. Ground water level fluctuation recorded at BH-01, project site from 12-30th September 2007

The primary groundwater system in Male consists of a shallow, unconfined aquifer island water lens. Information regarding groundwater levels at the site was obtained from previous subsurface investigations. In general, groundwater has been reported at about 1.57m below the ground level. Ground water fluctuations have been monitored in three boreholes, water level was recorded in the evening and morning every day. The graph in (Fig 14) shows typical ground water fluctuation recorded in borehole 1 (BH-01) recorded from 12-30th September 2007 twice a day at 8am and 5pm. The graph shows that ground water level was generally high at 5pm and has a water level difference between morning and evening within a range of 13-190mm during the recording period.

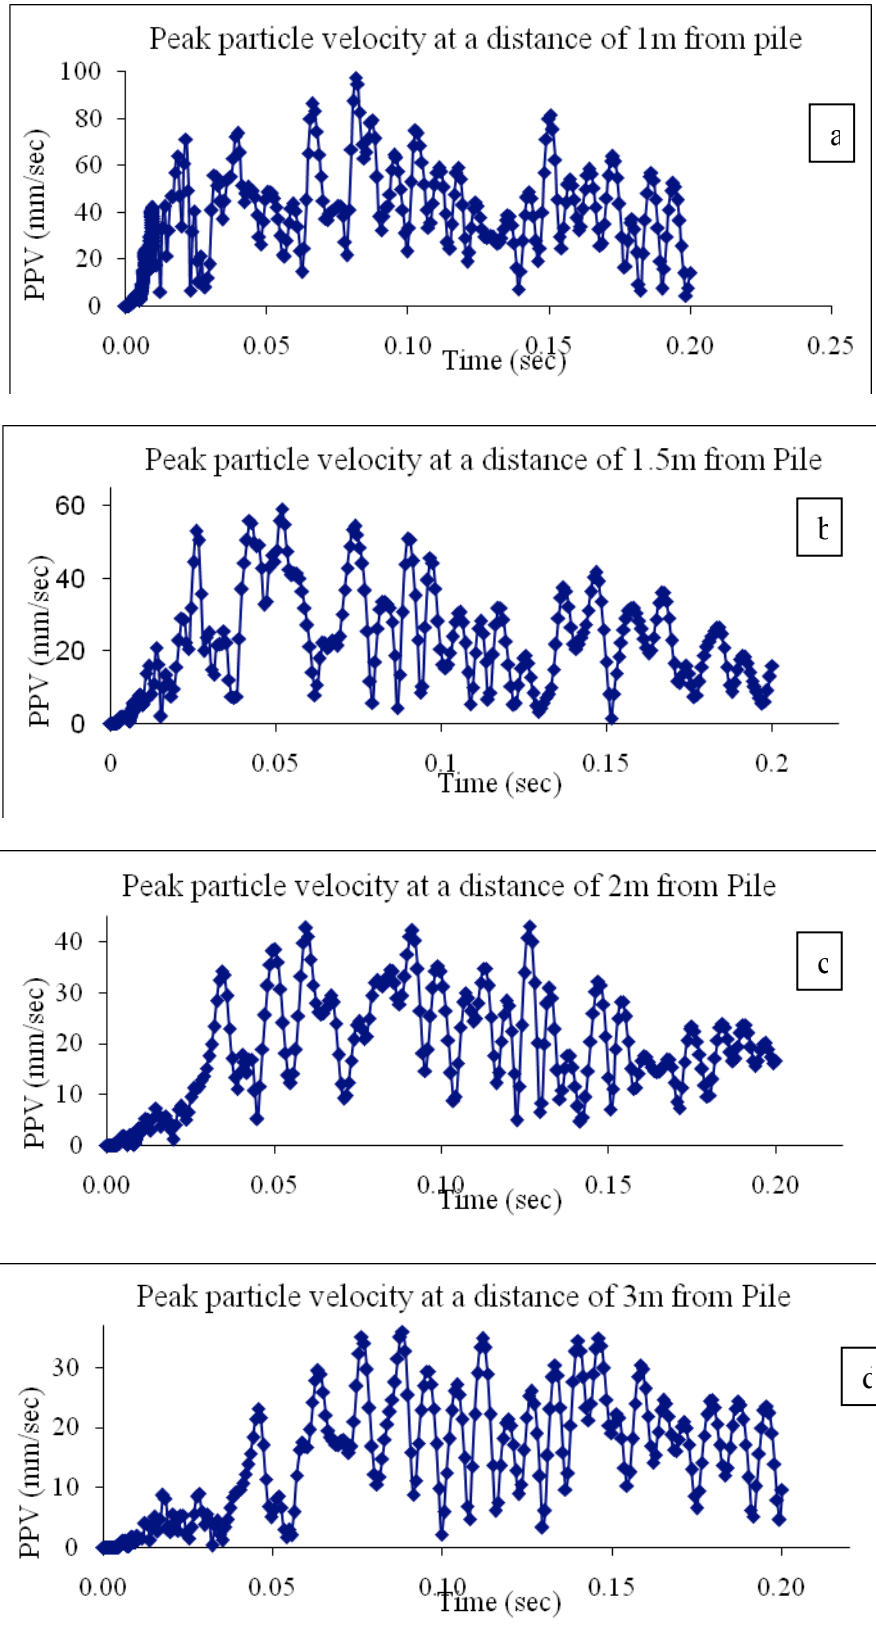
Fig 15. Graphs a-d shows modeled peak particle velocity, Ameeenge development, at different distances from pile tip. The figures shows that the safe distance for vibration is more than 2m, if less than that PPV reaches 50, DIN limits, potential risk of damage for nearby structures.

In the case of Ameenege vibration modeling at various depth found that PPV reaches to 50 PPV at distance less than 2m (Fig 15a-d). Therefore it is possible to impact buildings that are closer than 2m from pile tip (example Athiriveli) to be effected from pile driving. Athiriveli is less than a pile length from the pile driving area on the western side. At this stage we are not about the magnitude of impacts, could be number of hair-crack, or even more, surely the building needs to be monitored during the pile driving process.

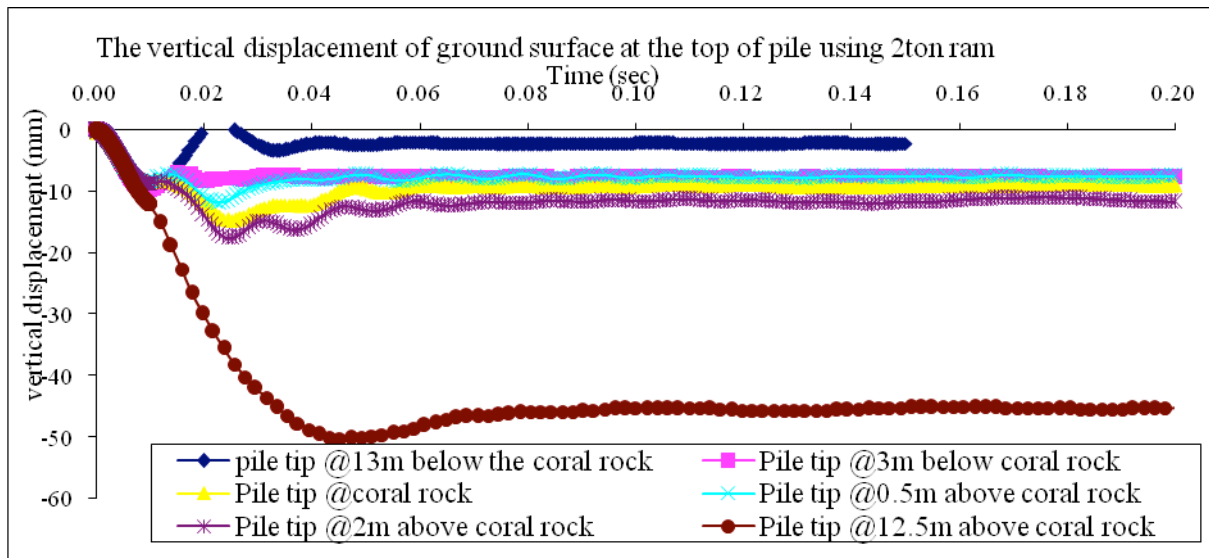
Fig 16 .Showing the time taken by 2 ton ram to drive the pile in various depths.

The second option to minimize the vibration and noise level would be to minimize the hydraulic hammer ram from 3 tons to 2 tons or less. However modeling the hammer ram with Plaxis ® show that 3 tons is the right size. If the ram is reduced to two tons time taken to drive a pile is extremely long (Fig 16).

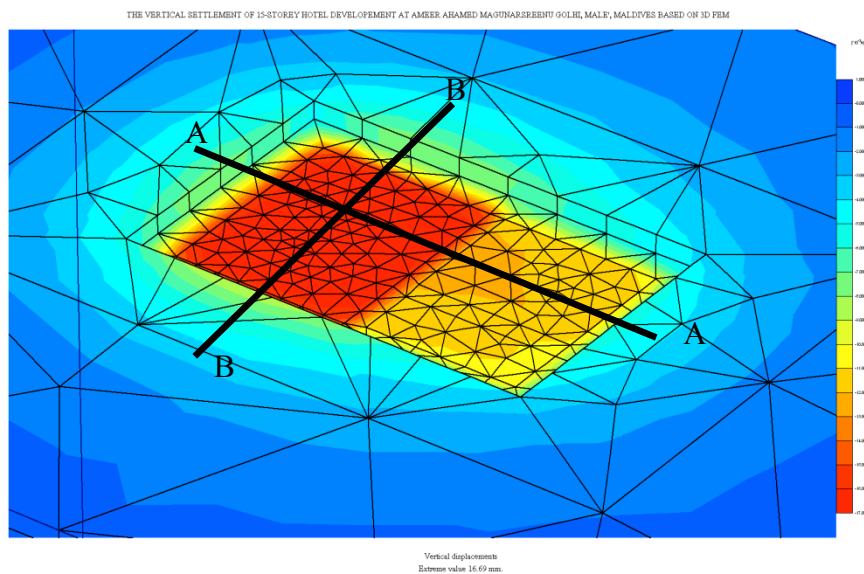
Fig 18. 3D Plaxis ® image showing the vertical settlement from Ameenege building (top) and cross sections A-A and B-B (bottom), the amount of settlement will not exceed 17mm.

Impacts: Pile driving and construction of the 15 storey building at Ameeneege would cause ground settlement, and lateral movement to some degree. So far the calculated values of settlement are within allowable limits. For the purpose of this EIA ground settlements near the proposed 15-strey hotel was modeled in Plaxis® software. The model shows ground settlement within the range 0f 12-17mm (Fig 18).

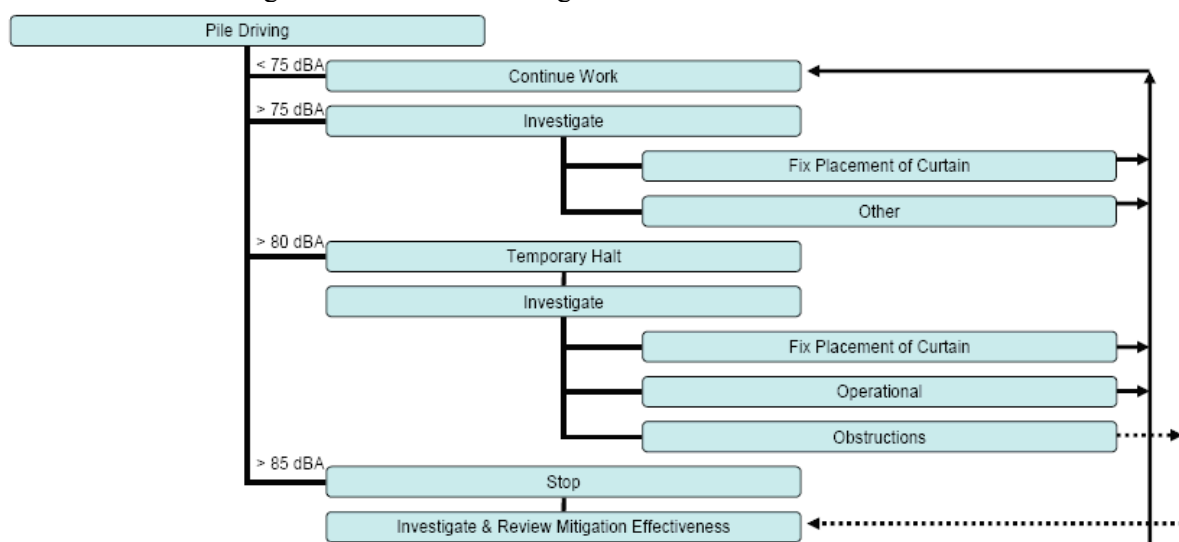
Fig 19. Noise mitigation action flow chart.

Mitigation: Workers operating equipment that generate noise should be equipped with noise protection gear. Workers operating equipment generating noise levels greater than 80 dBA continuously for 8 hours or more should use earmuffs. Workers experiencing prolonged noise levels of 70 – 80 dBA should wear earplugs. Apart from this there are available technologies to reduce the sound such as, fence- acoustic insulation, moveable sound barrier curtain and temporary sound barriers. If the sound emission is higher than 80dBA f at 50m radius from the source such option could be considered. Figure 19 shows noise mitigation action flow chart.
