# ENVIRONMENTAL IMPACT ASSESSMENT

Existing Desalination Plant

Chaaya Lagoon Hakuraa Huraa Resort, Meemu Atoll, Maldives

## Environmental Audit Report 2010

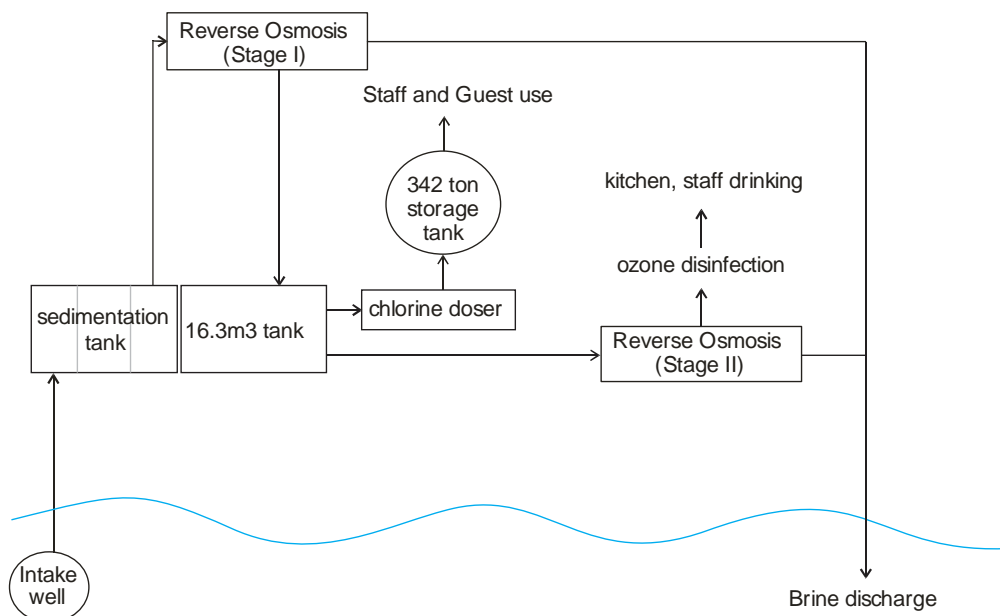
**Figure 2-2: Schematic illustration of the desalination plant facilities**

Feed water is drawn from the southern side lagoon. There are two intake wells. First well is about 120m from the beach near to the reef and second well is 100m from the beach and at a shallower length. The well near the reef is used during the low tide since it is in deeper waters and the other well is used only when the tide is high. The area where the second well located was quite shallow and the well can be approached by walking during the low tide.

Seawater from intake pipe is connected to sedimentation tank through a pump well. The sedimentation tank consisted of 3 chambers which has total capacity of 16.3m<sup>3</sup>. There is also a product water receiving tank adjoining the sedimentation tank as an annexe to the sedimentation tank. The capacity of this product water receiving tank is also 16.3m<sup>3</sup>. The product water receiving tank is also open (without cover) just like the sedimentation tank.

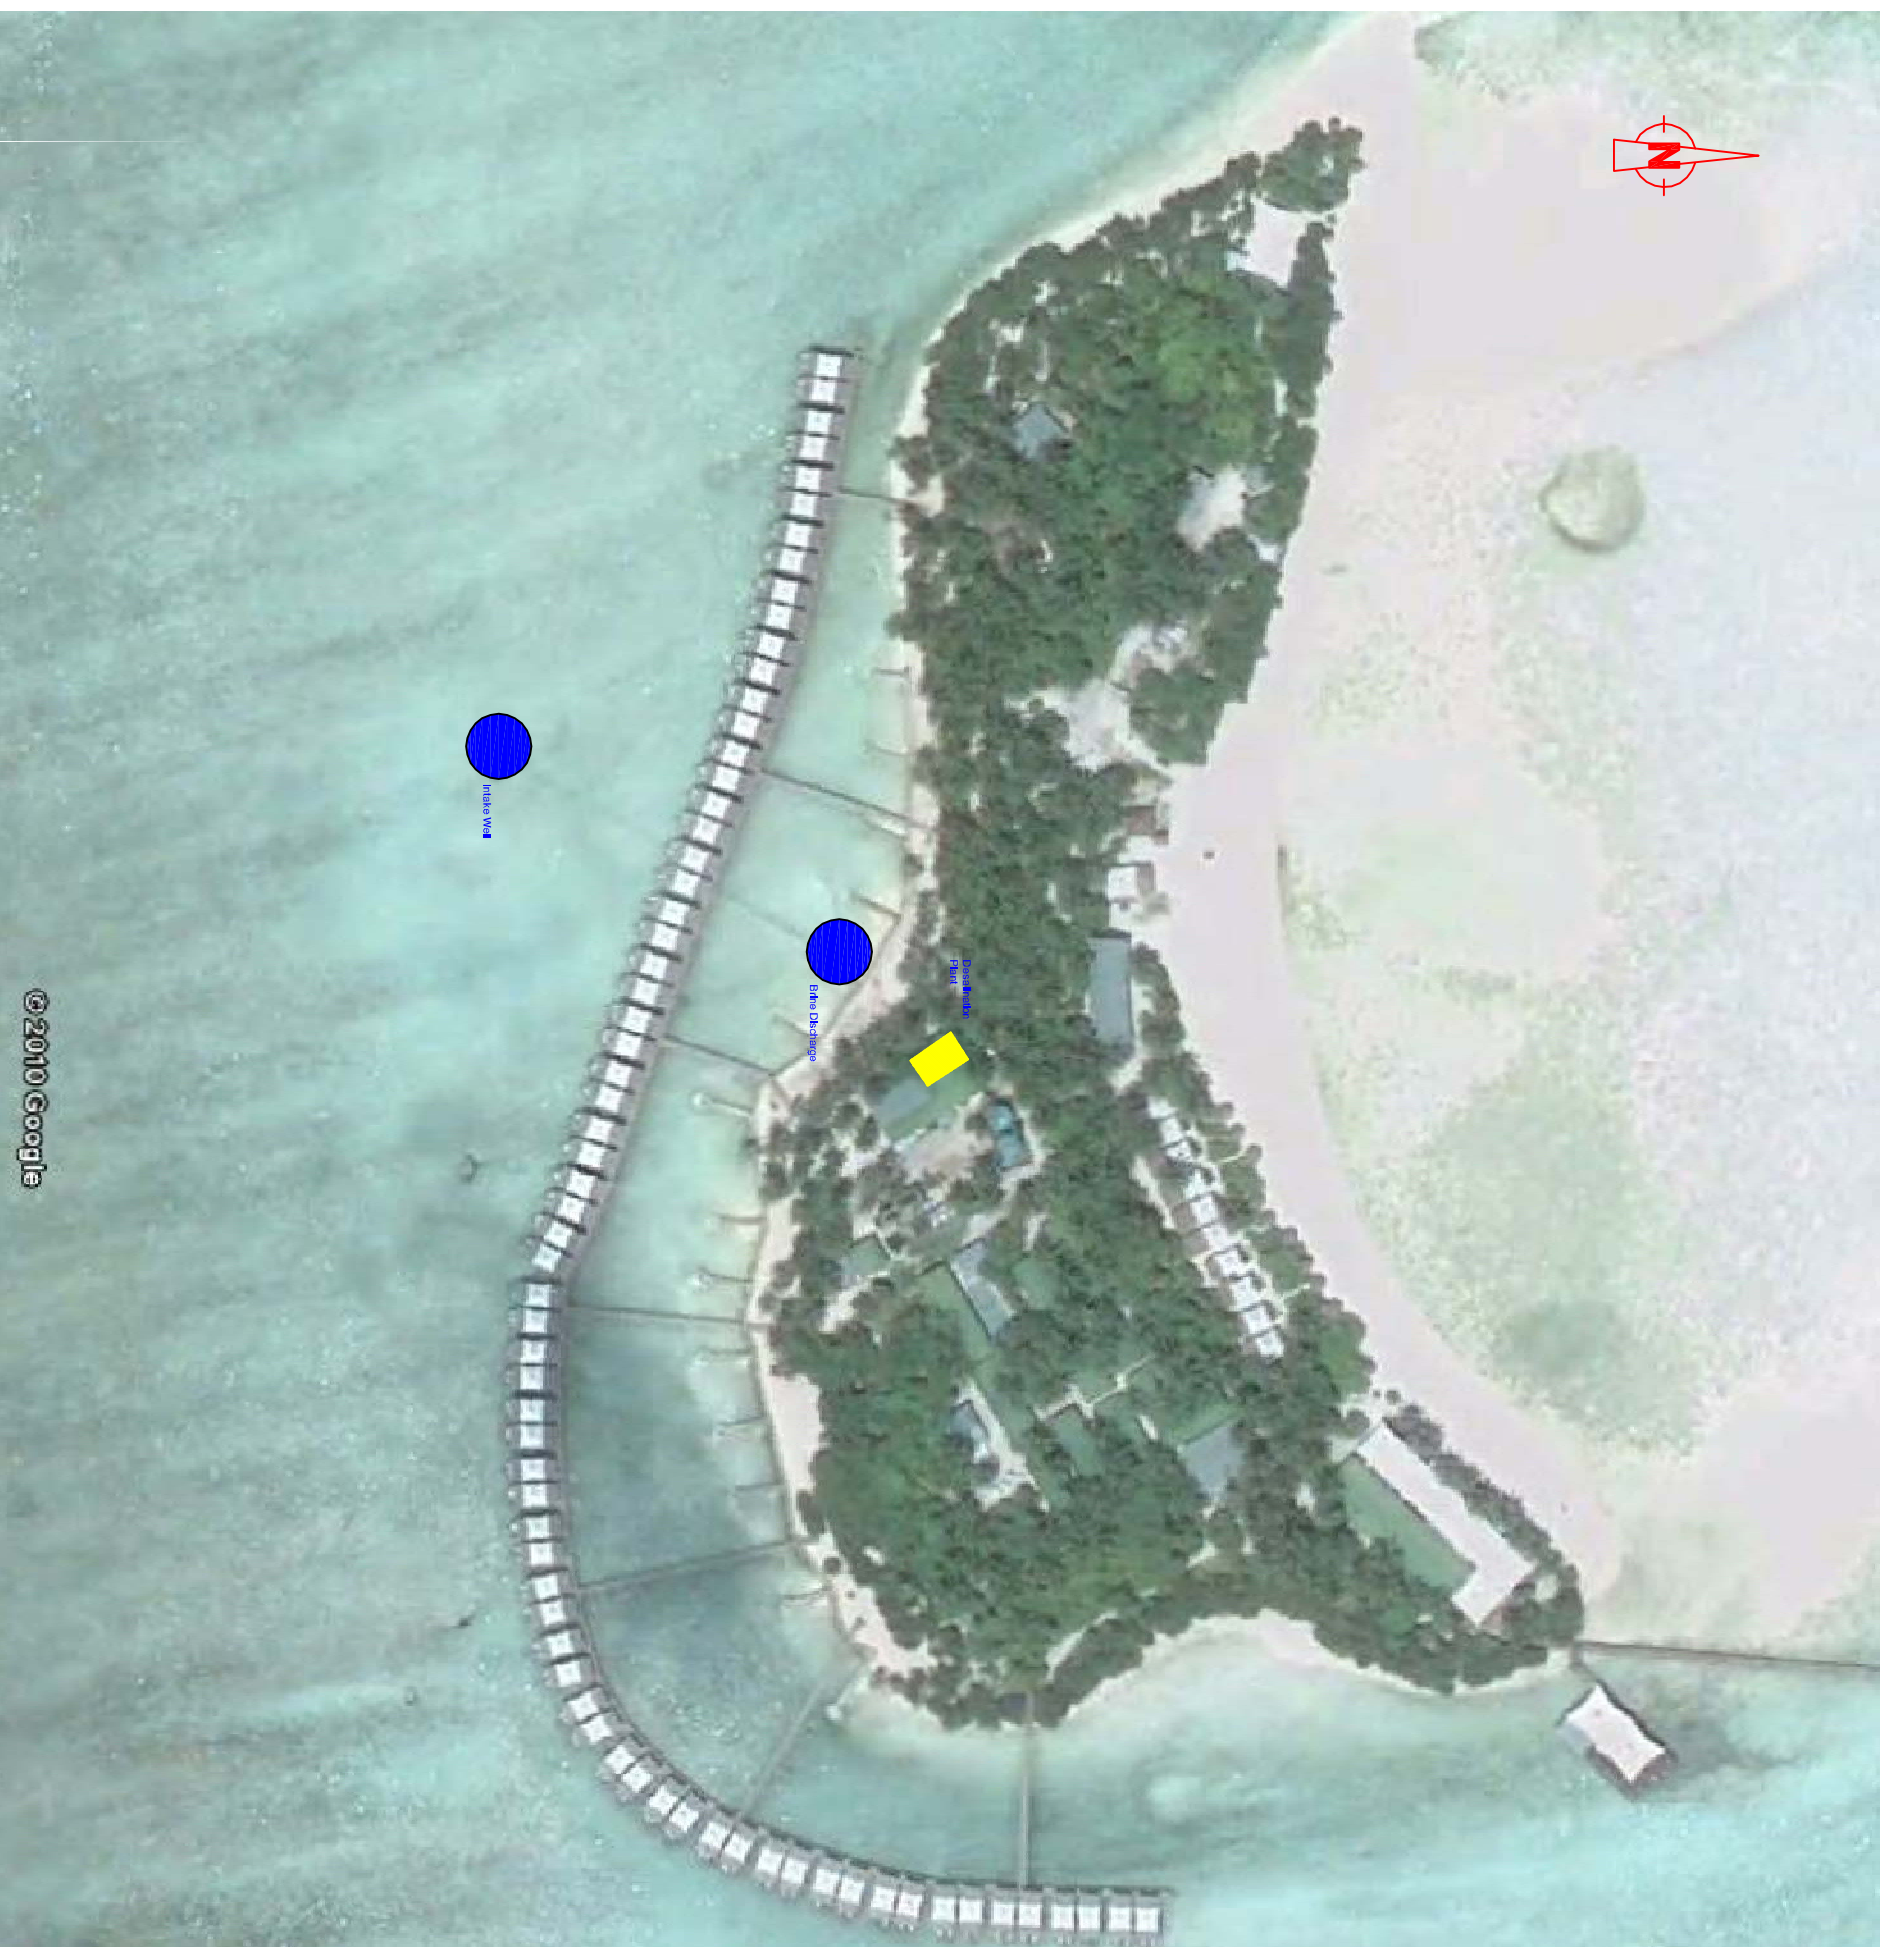
Figure 2\_3: Site Plan indicating the desalination plant facilities

Noise and Lux meter parameters.

Outside RO Plant Noise Level :72.4

Intake well Details

Type: Concrete  
 Intake Well: 4 Feet  
 Distance from Beach: 150m
