Environmental Impact Assessment for the proposed channel and harbor development at Full Moon Tourist Resort

Submitted by: Fullmoon Resort Maldives

July 2008

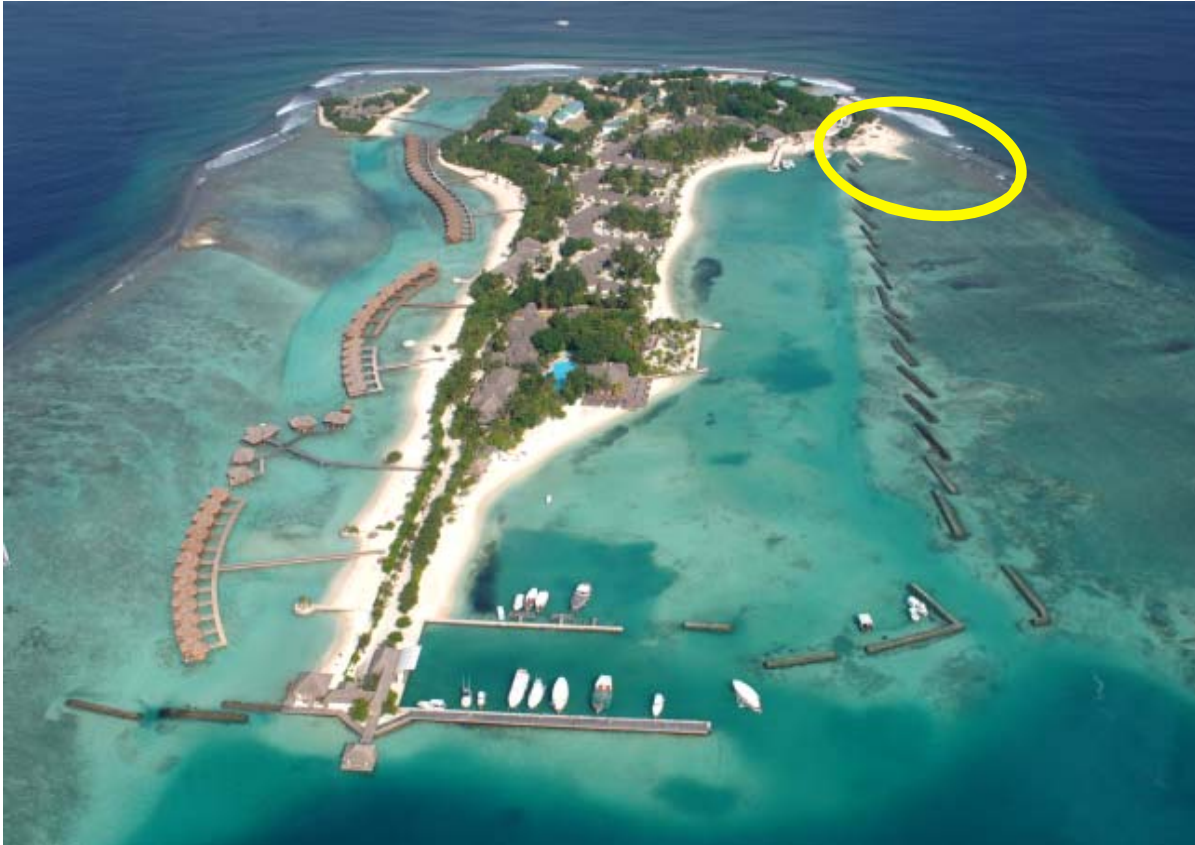
Figure 1: Over view of Fullmoon resort looking from western side towards east. The main features of the Fullmoon Resort – the breakwaters are seen. The circled area is the project area.

The proposed harbor area is located just right of the existing harbor area. The area would technically be the southernmost corner of the island (cf. Figure 1, Figure 2 and Figure 11).

Carefully looking at the Fullmoon resort one would immediately notice there are few choices for practically locating supply jetty and harbor (cf. Figure 1). The western end of the arrival jetty and the northern side of the island has water bungalows which is most important asset of the island.

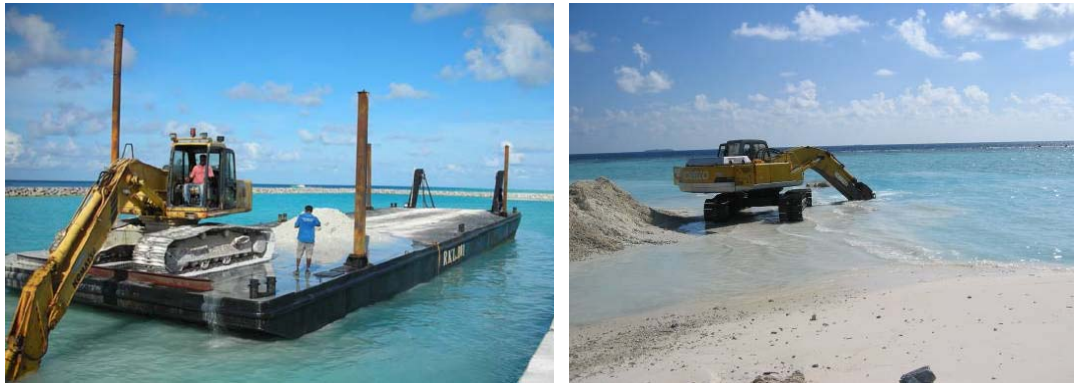
Figure 3: During the excavations works the dredger may be loaded onto a shallow draft barge (for deep harbors) or excavator sits on the site itself and works from the far end move to beach.

The proposed method of the deepening is by use of an excavator (Figure 3). It is proposed that the excavator works from deep end and work its way towards the shore. The various alternatives and options of the exactly doing this is given in Evaluation of Alternatives

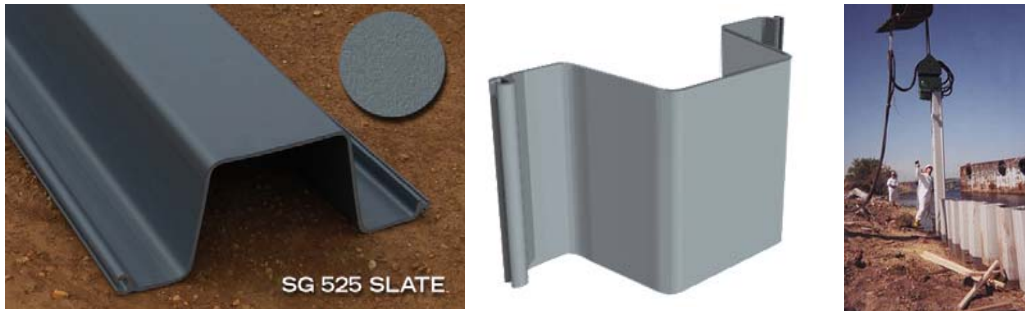
Figure 4: Typical sheet piles that will be used in Fullmoon Resort (0.609m wide). The sheet piles will be driven by vibration method (image on the left).

It is proposed that sheet piles will be driven using the vibration method (Figure 4). This has proven to be by far effective than driving them by hammering. The sheet piles will be driven to a maximum of 5m.

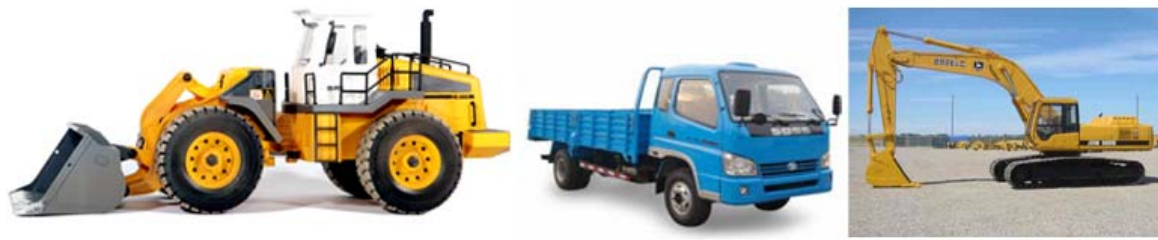
Figure 5 Construction equipment that will be used on the site.

The main equipment mobilized to the site will be an excavator, a barge and a loader (Figure 5). Materials mobilized to the site will consist of rock boulders for construction of breakwaters, cement,

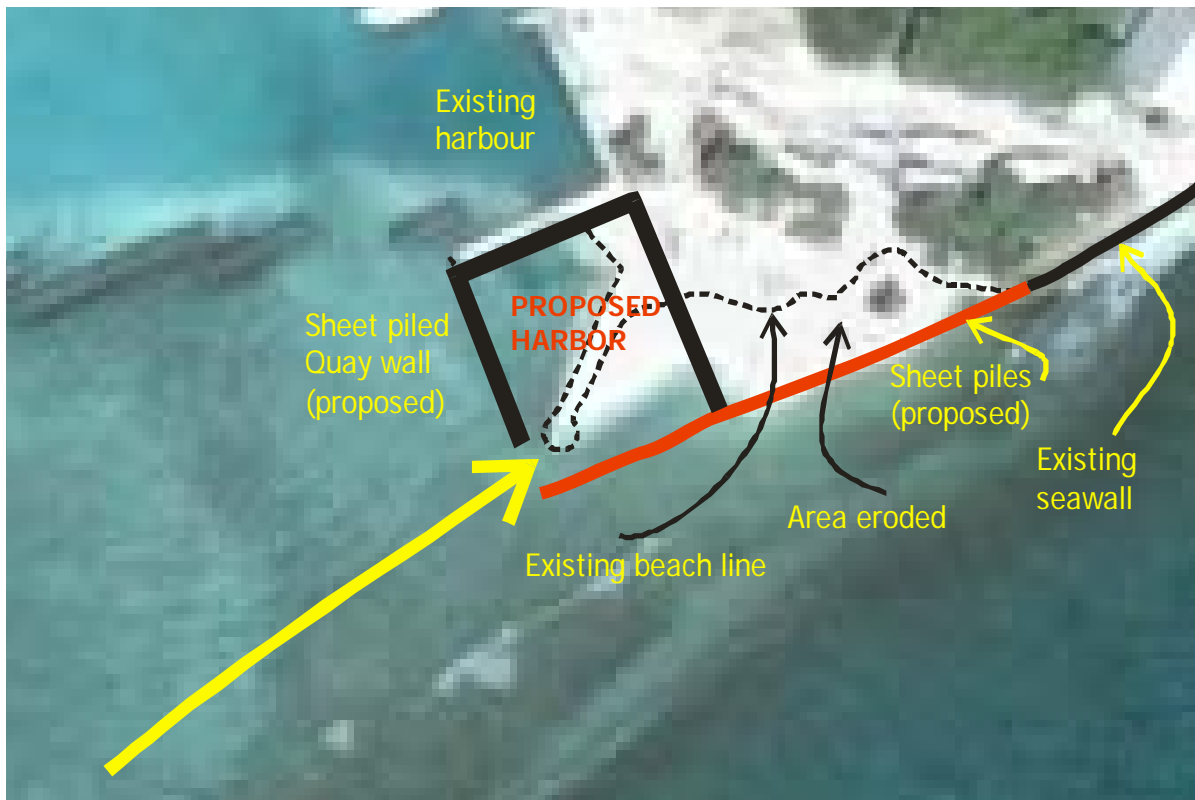
Figure 6: Details of the southeast corner of Fullmoon to show the existing the proposed structures. Note the area eroded and the existing the seawall which terminating at the corner.

The redevelopment activity shall takes place on the southeastern corner of the island (Figure 6). The management has a plan for undertaking the project whilst the resort is in operation. The project shall be fenced off which will be about 20,000 sq m. Most of the work shall take place the shallow reef flat in the project area. A biophysical description of the area is given in the section on Existing Environment.

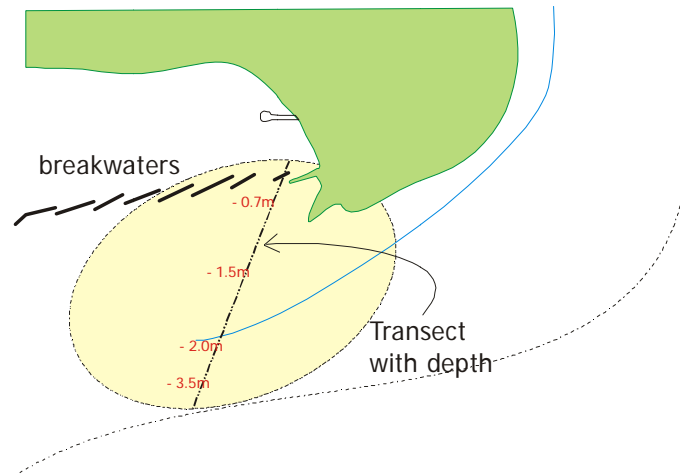
Figure 7: Survey area showing the depths the project development area.

Results: The time of observations was at low tide. The depth of the reef flat ranged from about 1.5 – 3.0 on the reef flat (Figure 7). The area was virtually denuded of live coral. It is a fair assessment to say that < 1% of unit area is covered by live coral. The coral in these cases were isolated colonies of Porites (< 50 cm diameter). Loose rubble, often consolidated with overgrowth of encrusting coralline algae was dominant feature of the substrate. It was obvious that herbivory (fish feeding on the algae) are keeping the area relatively 'clean' of algae. Scarid (parrot fishes) feeding marks on the rock laden with algae were seen. Although relatively few, there were small areas where sand dominated the bottom. These areas would experience high energy (local hydrodynamics) making it difficult for consolidation to occur.

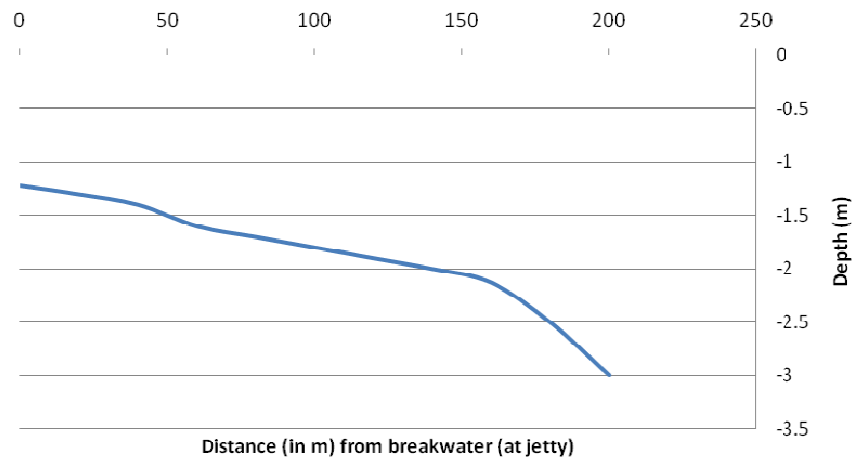
Figure 8: Profile of reef slope at the study site (see Figure 7).

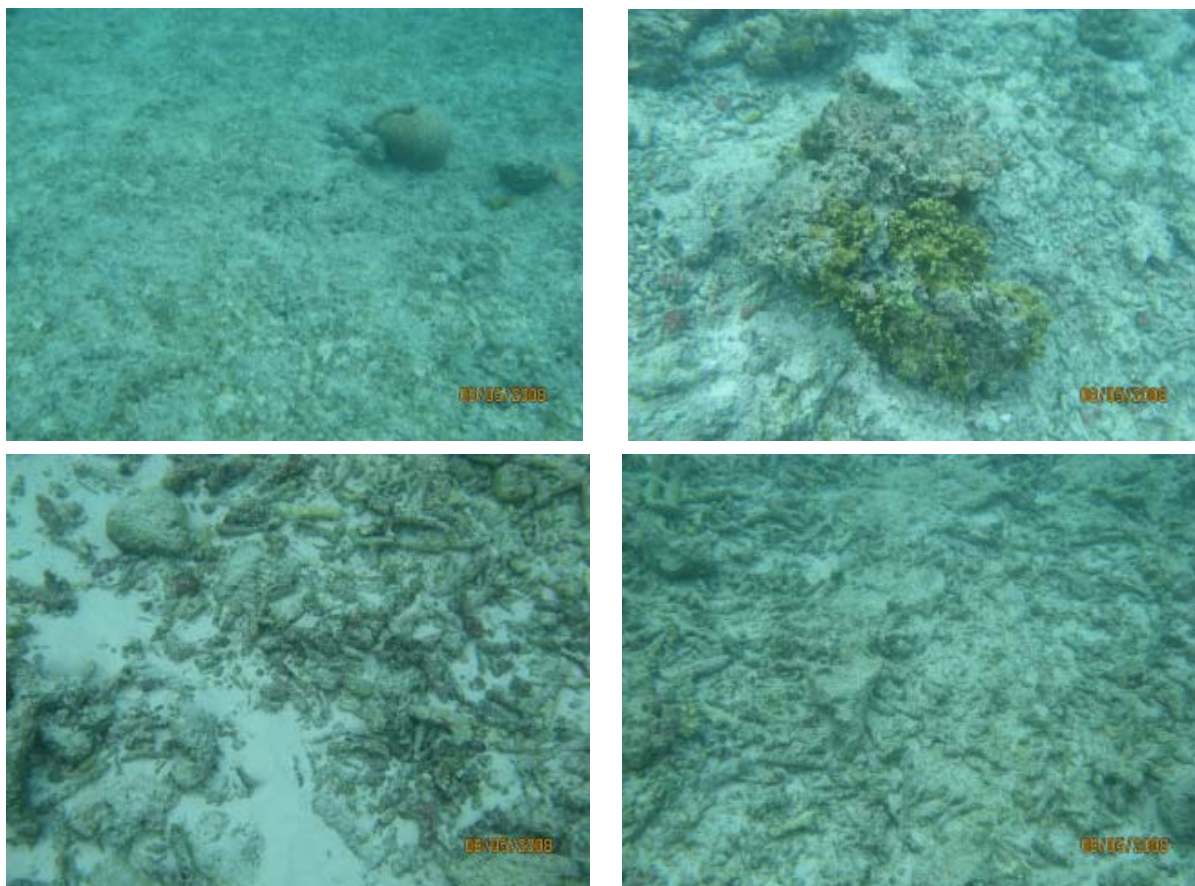
Figure 9: A sample of the bottom substrate at the survey area

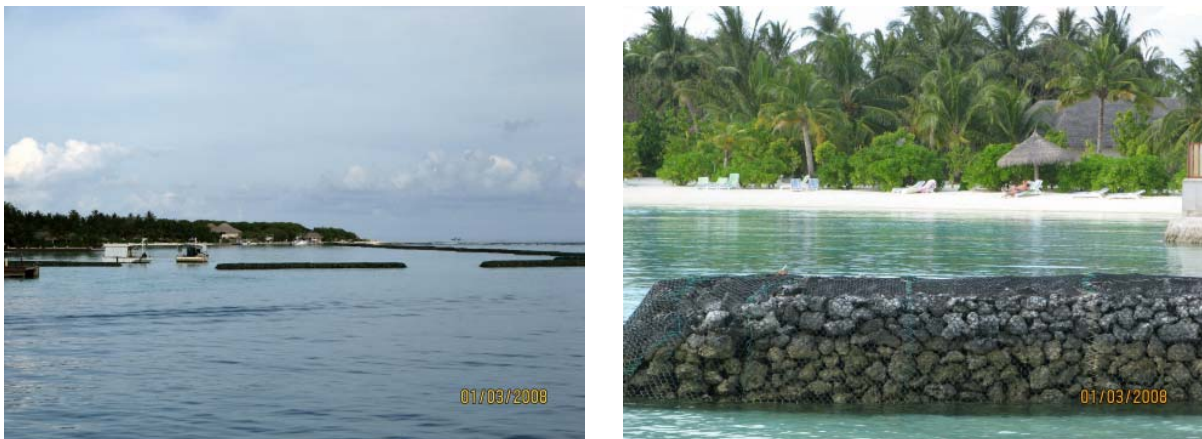
Figure 10: The beach on the southern side (right) is maintained regular 'beach replenishment' using 2 sand pumps (right) which are placed in the lagoon.

The beach area is maintained by constant repair of the breakwaters and replenishment of beaches by the sand pump (Figure 10). Fullmoon keeps records of the maintenance works done on the breakwaters. From the dates of the invoices made to the contractors it was estimated that minor maintenance area made once every three months and major repairs are made once every six months.

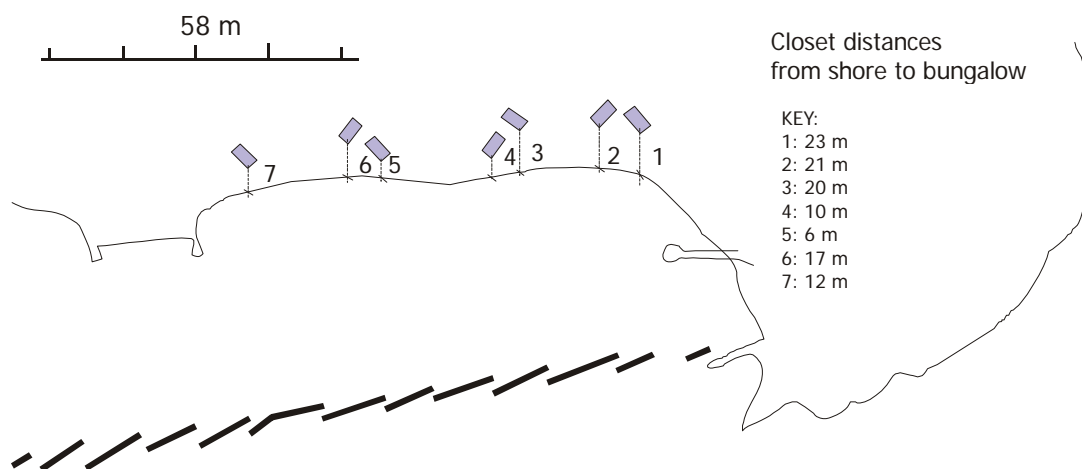
Figure 11: Scale sketch to shows the distances from the beach lines to the 7 bungalows located on the southern side of the island.

The distances from the seven beach bungalows to the beach line were made for a baseline references (Figure 11). Beach profiles were not takes here. As mentioned earlier, the beaches are maintained regularly through beach replenishment works. The estimated beach profiles were about 20-25 degree slopes from the vegetation line to the beach toe.

1. Changes in wave strength and current (no baseline data). An indirect way of measuring the change would be noting the frequency of repair of the breakwater, particularly ones close the channel. At present major repairs are made on average once every 6 months and minor repairs once every 3 months. This may be monitored for the next 10 years.
2. Shore line changes (no baseline data): Given that the beach is continually replenished by pumping sand it may not be worth taking detailed profiles of the beach. Instead a rough overall measure would be to take perpendicular distances from the beach to the near-corner of the 7 bungalows on the southern side of the island. (cf. Figure 11). This measurement should be taken twice a year for 5 years.

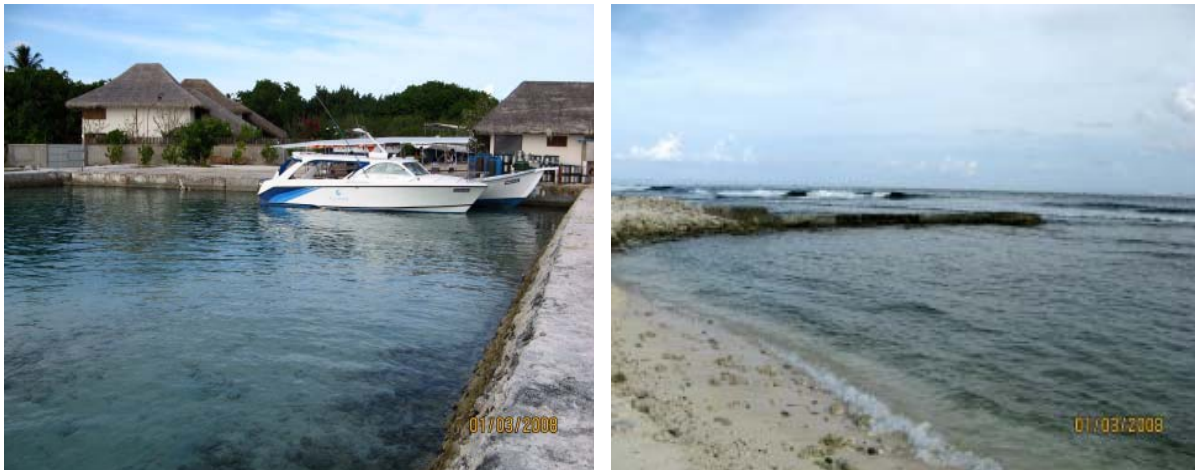
Figure 12: Existing harbor (left) is located very close to the prime beach bungalows. The new harbor will be just right off the existing harbor (right panel).

As have been mentioned the existing supply jetty and harbor is on the eastern section of the lagoon. Not only it requires the supply vessel to steam inside the lagoon close the beach, the harbor itself is located too close the prime beach bungalows (Figure 12). Guests occupying the water bungalow (see in the image in Figure 12) regularly complain of the noise during early hours of the morning and night. Normally, unloading of fuel and loading of trash and solid waste that requires to be taken to Thilafushi are loaded at times when guests would not be in the room. But these constraints have been too difficult and costly for the resort to bear in the long run.

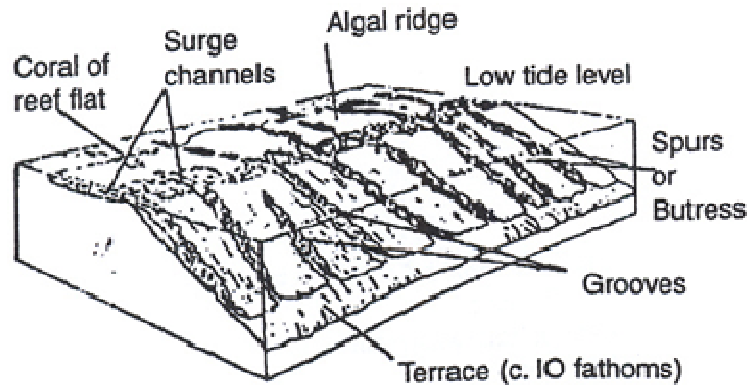
Figure 15: Reef slope structure – showing the spur and grooves.

The deepening of the relatively narrow channel on the reef flat/reef slope may have the same effect as spur and grooves. Most reefs have a spur and groove system which extends along the reef flat and some distance down the reef slope. This system is often extensively wide and long, depending on the reef slope.

The spur and groove system appears to be formed by erosion reinforced by the prolific seaward growth of corals on the groove. The overall result of this spur and groove system is self-reinforcing. Incoming waves cause extensive surges along the groove resulting in the re-suspension of sediment and the continual movement of reef rubble prevents effective coral growth. Less turbulent waters experienced in the spur region allow coral growth which reduces turbulence further.
