Environmental Impact Assessment

**For the proposed renovation,
refurbishment and addition of overwater
villas and spa complex at Laguna Island
Resort, South Malè Atoll**

**Proponent:
Universal Enterprises Pvt. Ltd**

August 2008

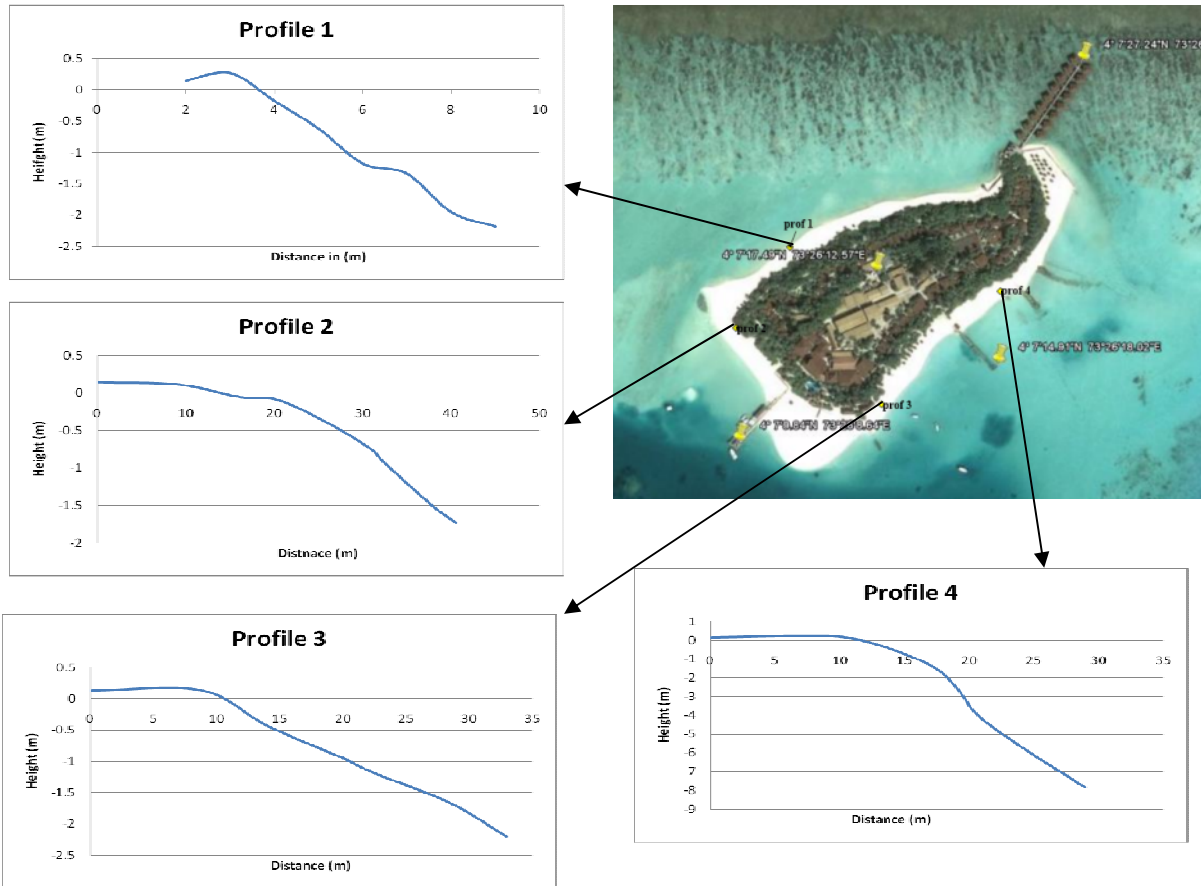
Figure 9. Location of beach profiles taken from the island, related to sea level showing the elevation of the beach.

Beach slope is fairly gentle on the northern part but relatively steep on the southwestern part of the island. Four beach profiles were taken from the island, their location and beach profiles are shown (Figure 9).

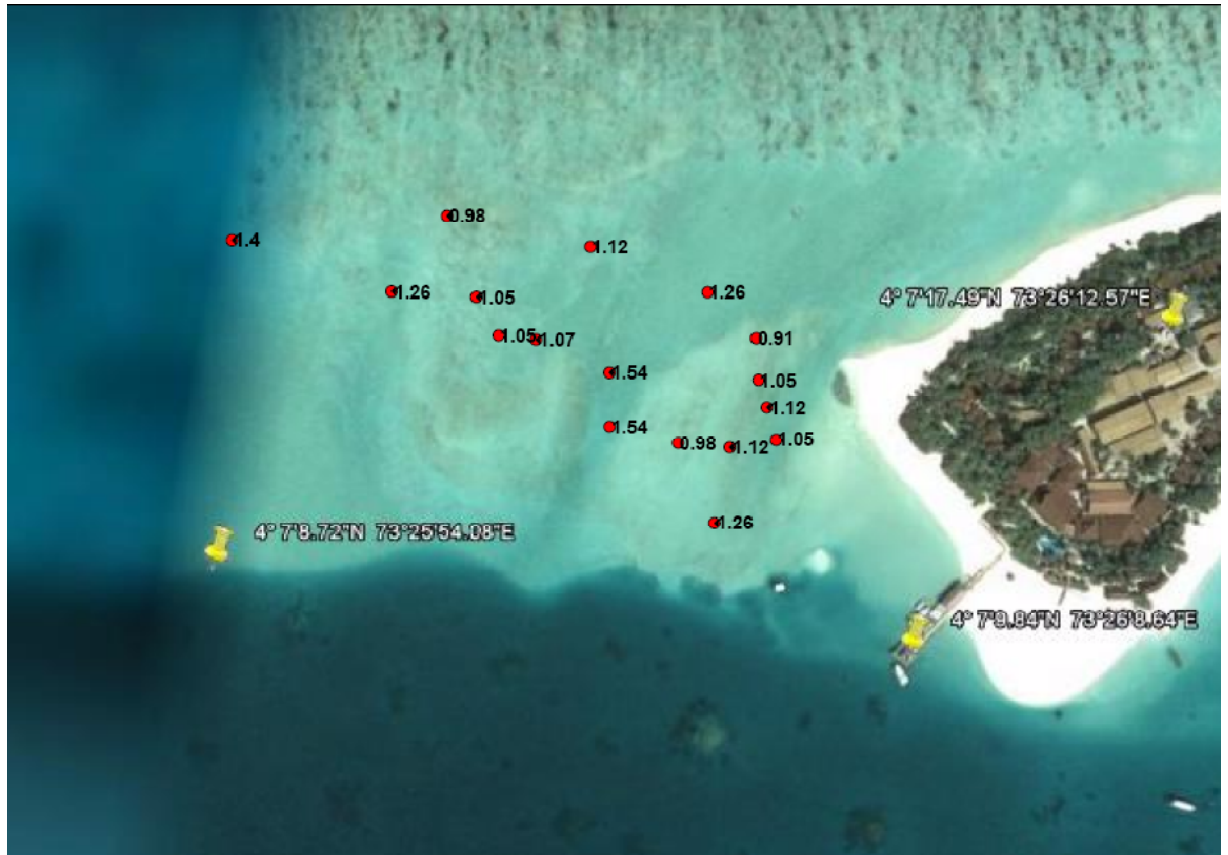
Figure 11. Shows the calculated maximum wave height in (m) that will be expected in the area proposed for overwater villa and spa complex development. The black dot marks the location of S4 current meter was deployed for current measurements.

Laguna being located at the NW rim corner of the South Malé Atoll it is exposed to direct oceanic swells from the western side during the SW monsoon. Being located at the corner of the atoll two it is exposed to wedge waves that passes through the channel between Laguna and Vaadhoo. These waves are very much limited in their height and energy by the depth of water over which they travel before reaching the shoreline of the island. Surf waves breaking into the reef flat were observed on the western side of the island and this type of waves will continue to break into reef flat during the SW monsoon. However due to the large distance between the reef edge and the island shoreline the wave energy is significantly reduced by the time it reaches to Laguna shoreline (Riyaz et al 2008). Calculated maximum wave height, based on water depth, for the proposed overwater villa development area is shown in (Figure 11). The observed wave height on the south and western side of the island is between 0.3-0.7m with a period of 5-12seconds.

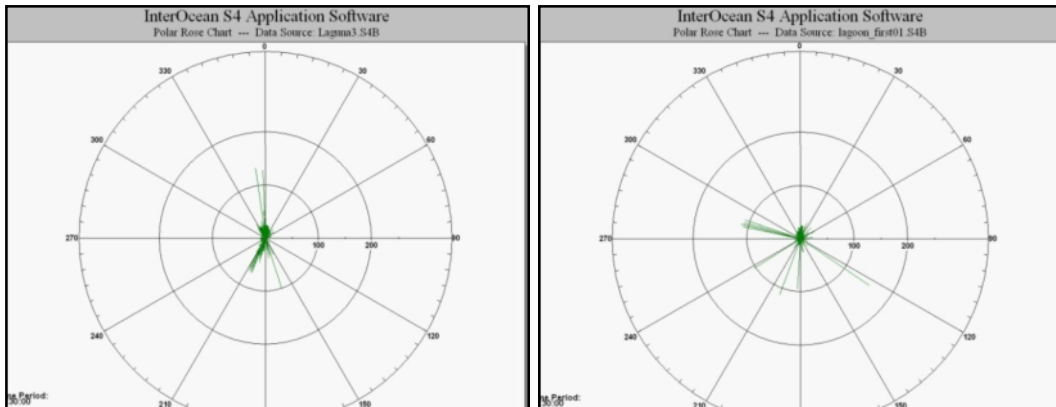
Figure 12. Polar Rose Chart current measurements obtained from S4 current meter deployments. The chart on the left is the results of measurements obtained from 3-13 April and the left is obtained from 14-31 April 2007.

During the design period of over water villas, current measurements were obtained from the lagoon of the proposed overwater villa development area. S4 current meter was deployed in two occasions in April 2007. The first deployment was from 4-13 and the second was from 14-31 of April 2007. Current measurements both the velocity and direction was obtained by using S4 current meter. Figure 12 shows the velocity and direction of lagoon current in Laguna Island. The maximum velocity obtained during the period was 150cm/s. During the first deployment period the dominant direction was SW but the strongest were northerly with a speed of 120cm/s and southeasterly with a velocity of 100cm/s. During the second deployment 14-31 April 2007 the velocity was more or less north and north easterly. And the strongest current speed was observed on the easterly direction with a speed of 150cm/s.

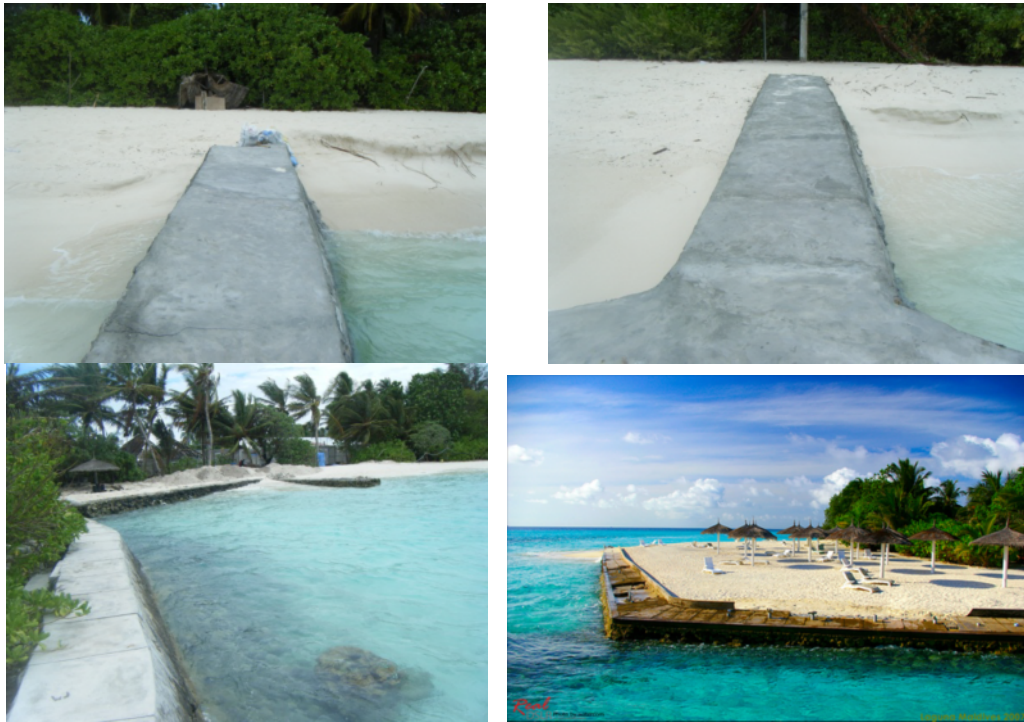
Number of groynes (shoreline perpendicular coastal structures) is constructed around the island to maintain the white sandy beach. A seawall (shore parallel adjacent coastal structures) is constructed on the northern tip of the island adjacent to the existing overwater villas (Figure 13). From a coastal engineering point of view these coastal development are haphazard and has been developed without much thought on the coastal and hydro dynamics of the island. Particularly, the extremely long, solid jetty (the main jetty on the southern side), which acts as a terminating groyne. This jetty has been constructed at the initial stages of resort operations in Laguna Island. Initially it was a continuous solid jetty but later the management made an opening at the center of jetty to pass sand through it. This solid jetty prevents sand movement from North to south, a large amount of sand is accumulated on the northern side and sand starvation is on the western side of the jetty. Pile of sediments accumulated on the northern side is making the lagoon shallower also blocks the opening at the center of the jetty. According to locals in the island last couple of years a very large amount of sand has accumulated and kept on piling up on the northern side of the jetty. Large amount of sand brought by the tsunami of 2004 accumulated never returned back causing sand starvation in various parts of the island. Apart from this long solid jetty, there are 4 groynes on the north eastern side of the island. Existence of these structures function to trap sand in between but as usual sand accumulation on one side and sand starvation on opposite side of all groynes were observed. Some of these structures are not properly aligned and therefore ineffective in achieving the desired objective. They are also esthetically unattractive.

Interaction of various existing coastal structures contributed to the unbalanced sediment distribution around the island. Due to the extreme length of some of the main jetty back-and-forth movements of sand has been blocked and the natural sediment balance was prevented.
