ENVIRONMENTAL IMPACT ASSESSMENT

FOR THE REMOVAL OF SEAGRASS AND BEACH
REPLENISHMENT ACTIVITIES IN HERATHERA ISLAND
RESORT, ADDU ATOLL, MALDIVES

*Maldives Tourism
Development
Cooperation*

CDE Consulting

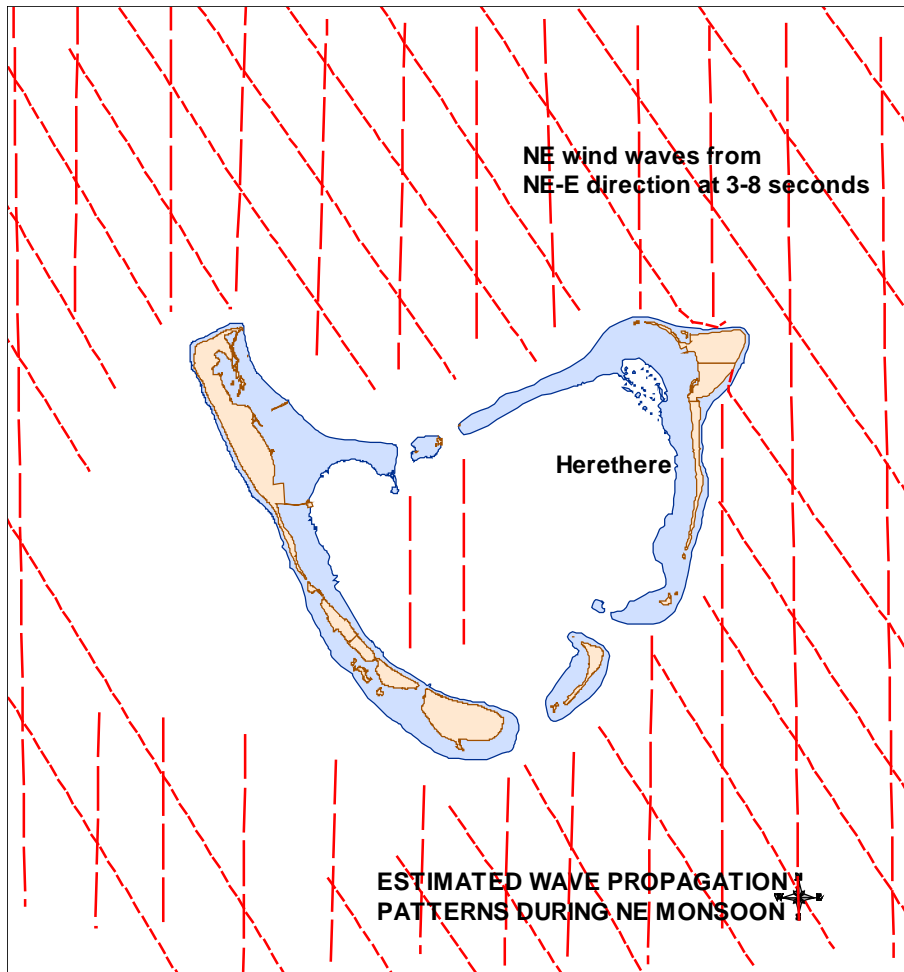
Figure 4.6 : Estimated wave propagation patterns during NE monsoon

The local monsoon waves generated mainly during the NE monsoon affects the eastern coastline of the island. These waves are generally with a period of 3-8 seconds and some time at 1.5 m high in open ocean. The estimated wave propagation pattern is plotted in the map below.

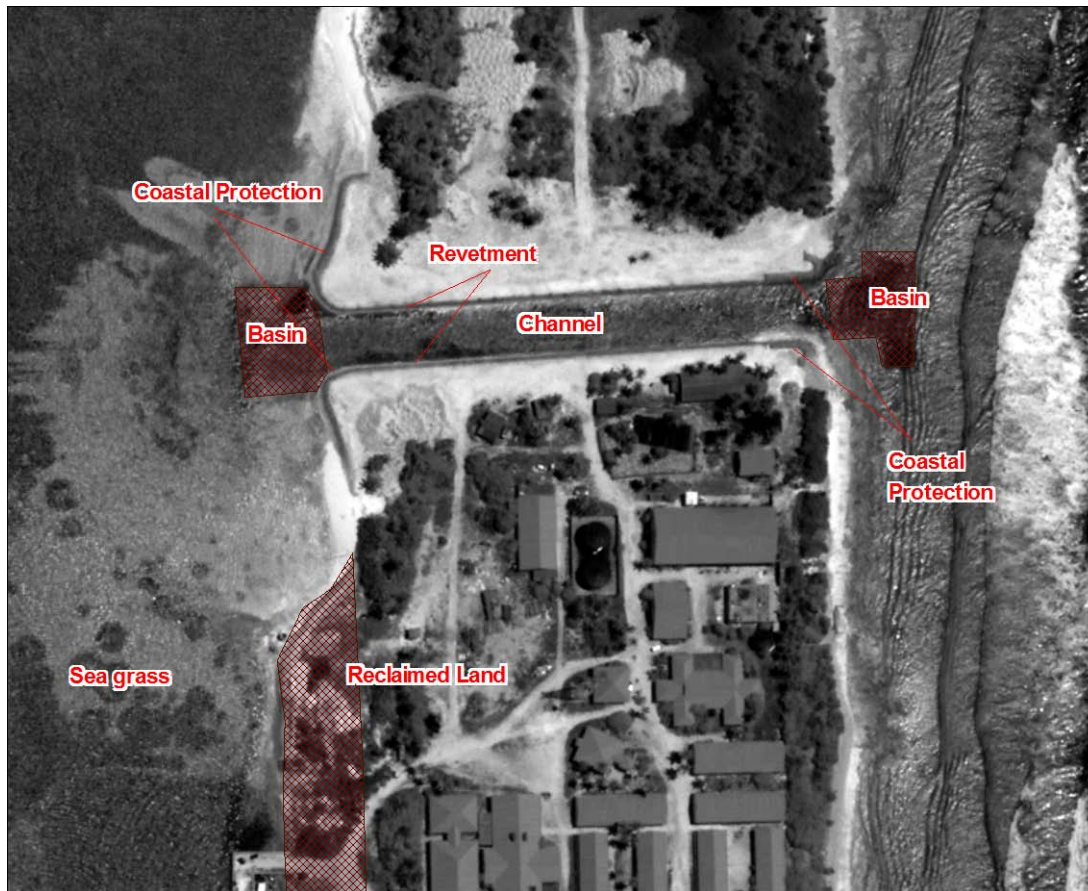
Figure 4.12: Characteristics of Zone A

Zone A is characterized by the following extensive coastal modifications.

- The dredged channel and its associated protection infrastructure (breakwaters, revetment and basins)
- Land reclamation around the harbor area.
- The ocean ward side is undergoing erosion following the construction of the breakwater.
- There is an extensive sea grass bed.
- The presence of the deep basins is preventing the desired effects on sea grass overgrowth.
- The channel is presently experiencing severe flooding events during the high tides and udha season – some elements of the design may be causing overtopping.
- The area should be treated as a low priority for beach management as there is no merit in preserving or developing a beach in this zone.

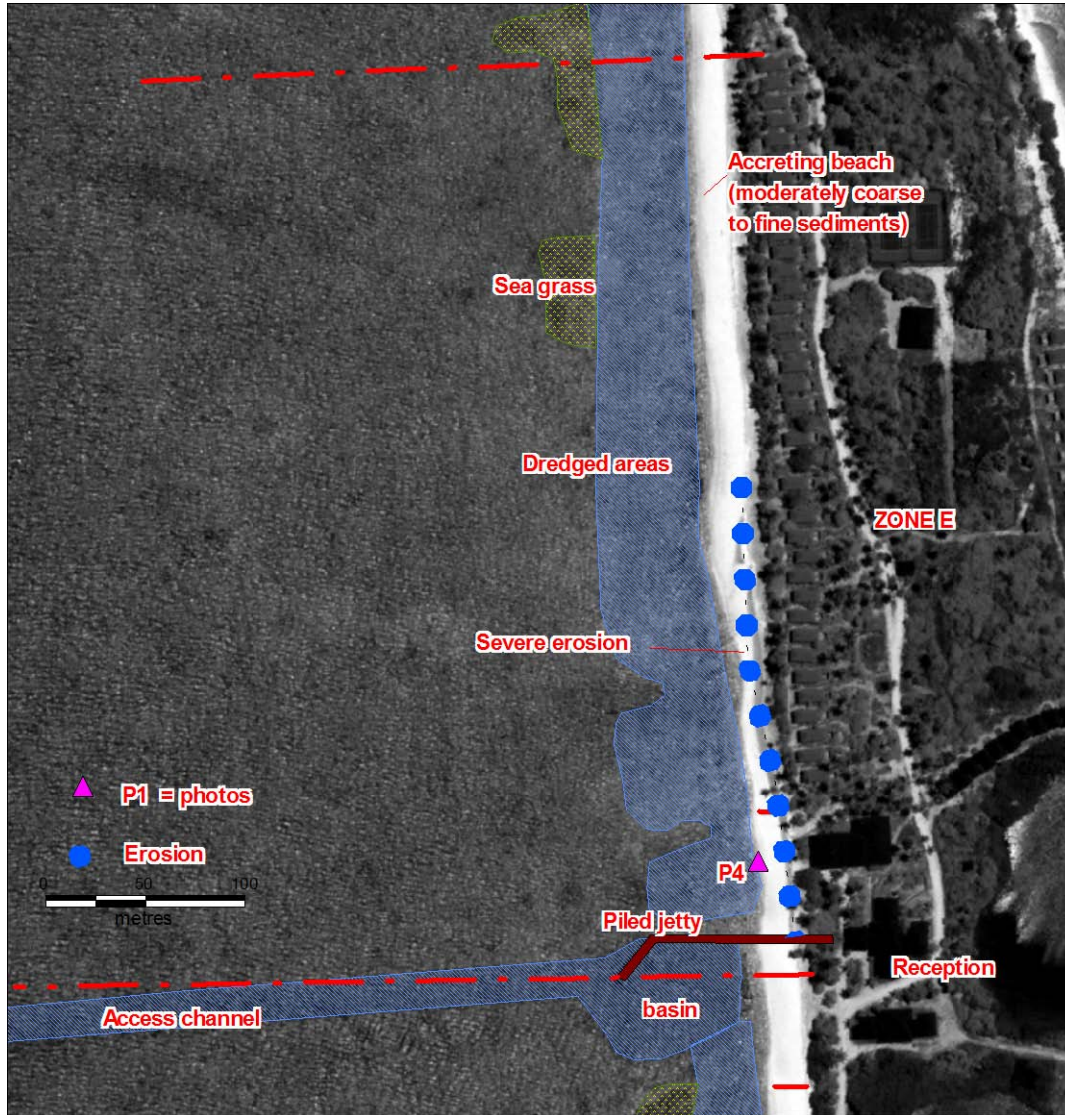
Figure 4.20: Characteristics of Zone E

- Zone E is one of the most crucial beach areas of Herathera: it is the arrival area of the island which provides the first impression of the beach system. Unfortunately, this area is characterized by severe erosion towards the jetty (see figure 4.21 below). The northern half is relatively healthy with coarse to moderately fine sediments. The area north of the arrival jetty is unsuitable as a tourism product.
- The most likely cause of severe erosion in this area is the presence of dredged basin and a groyne (under the jetty) which is blocking the sediment flow.
- There is dead sea grass littered along the entire stretch.

- Erosion mitigation and beach cleaning required in this zone.

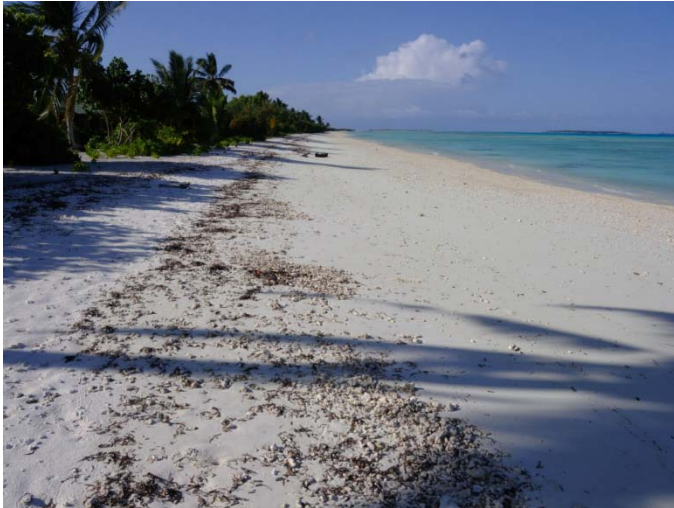
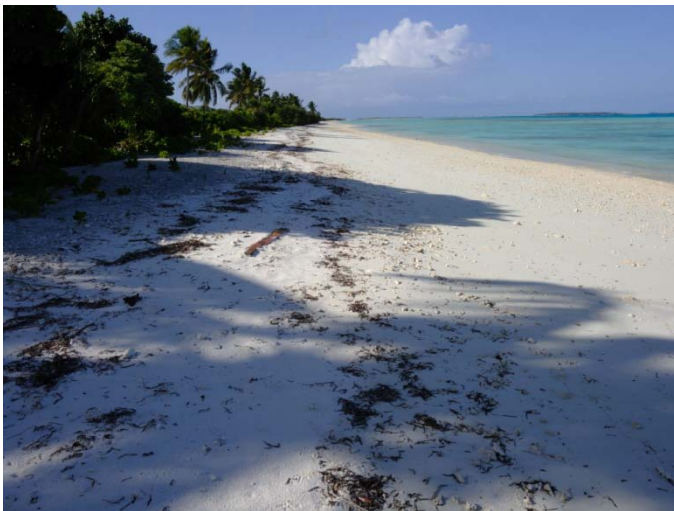
Figure 4.23: Beach conditions at survey point P5 (see map Above)

Figure 4.24: Beach conditions at survey point P6 (see map Above)

- Zone F is the most stable beach area of Herathera, at the time of the survey. The beach area immediately south of the jetty comprise of fine sand. Sediment quality decreases towards south (see figure 4.23 and 4.24 below).
- Sediment flow is prevented in the area due to the dredged basin and a groyne (under the jetty).
- There is dead sea grass littered along the entire stretch.
- Beach cleaning required in this zone.

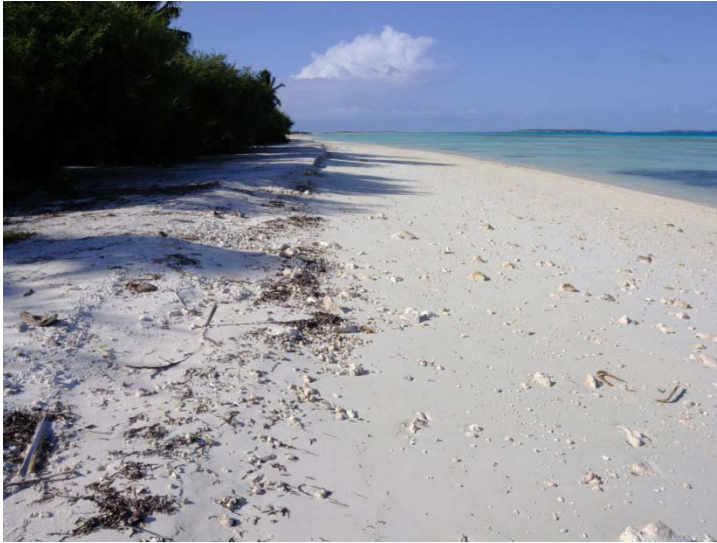
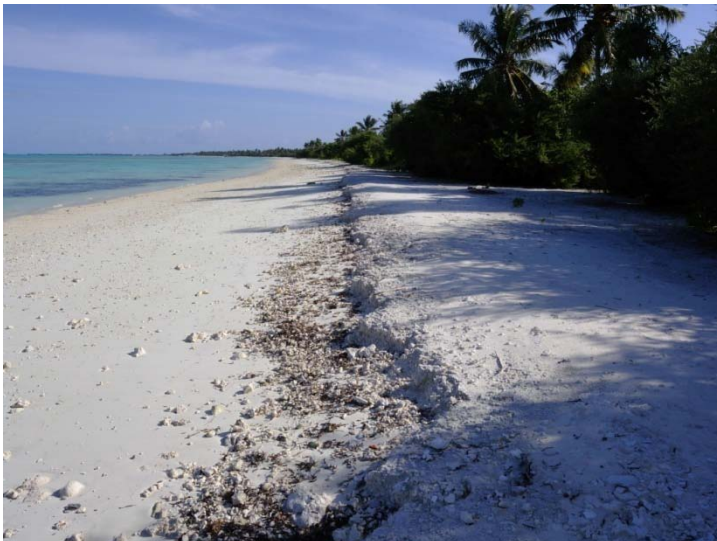
Figure 4.26: Beach conditions at survey point P7 (see map Above)

Figure 4.27: Beach conditions at survey point P8 (see map Above)

- Zone G has moderate levels of erosion, increasing in severity towards south (see figure 4.26 and 4.27 below).
- Beach composition is moderately coarse in the north and coarse in the south.
- There is dead sea grass littered along the entire stretch.
- New sea grass patches are growing in the dredged area.
- Erosion mitigation and beach cleaning required in this zone.

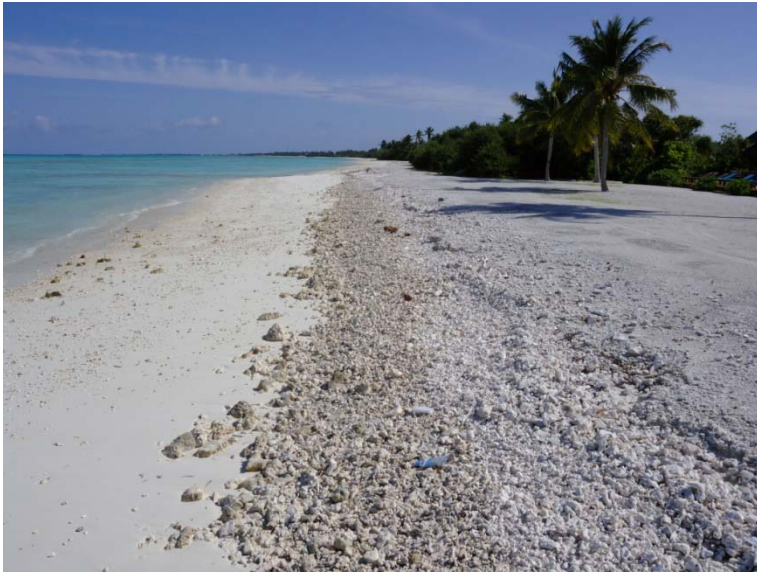
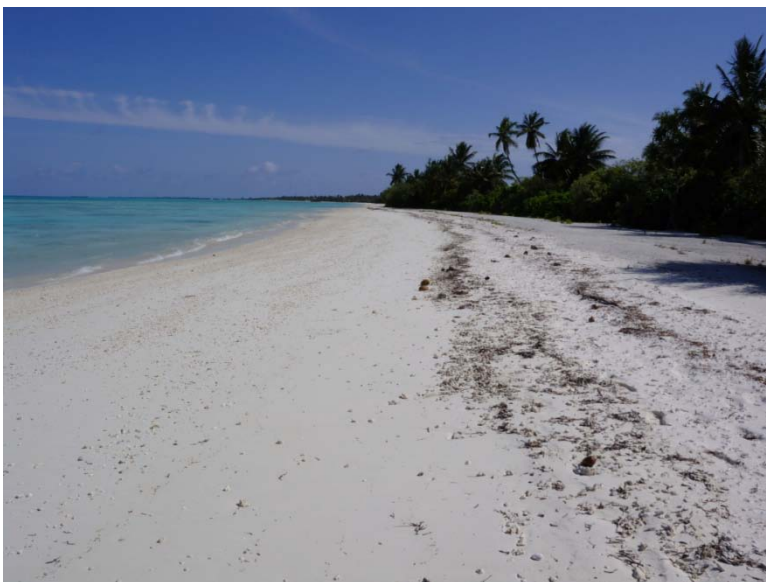
Figure 4.29: Beach conditions at survey point P9 (see map Above)

Figure 4.30: Beach conditions at survey point P10 (see map Above)

- Zone H has moderate to high levels of erosion with area of coral rubble (see figure 4.29 and 4.30 below).
- Beach composition is moderately coarse in the north, fine in the middle and coarse in the south.
- There is dead sea grass littered along the entire stretch.
- Erosion mitigation and beach cleaning required in this zone.
- Zone I is not developed but has undergone beach replenishment.

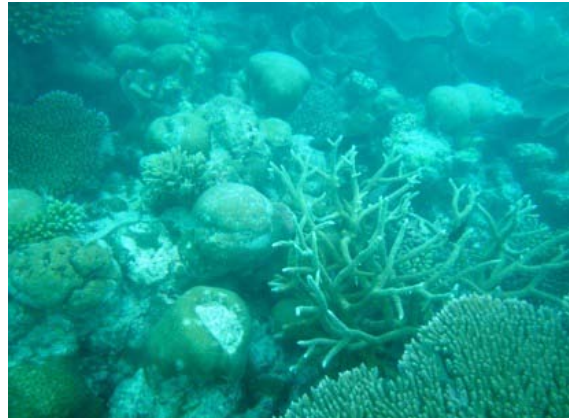
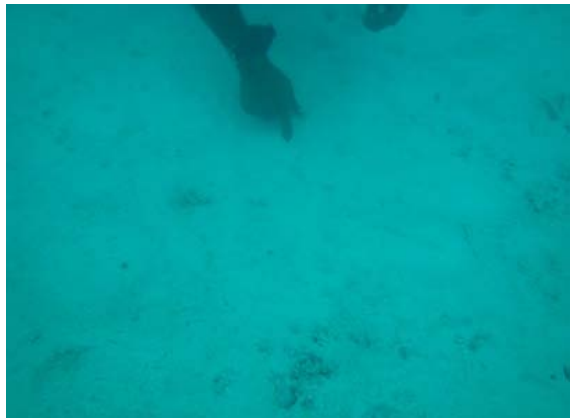
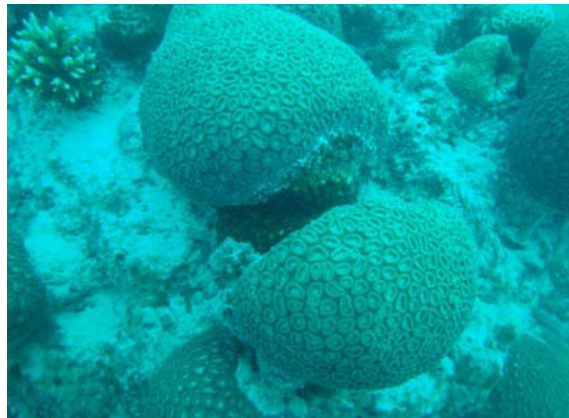
Solitary corals

Varieties of corals

Fine sand (at 9m depth)

Massive corals (Favids)

Figure 4.33 Benthic substrate observed at site D1

The coral reef at D 1 area is relatively well developed with about 20 to 50 percent live coral cover at the observed areas. The bottom of reef edge was dominated by coral rock followed by *Acropora* table, and branching corals plus *Goniastrea* sp and *Echinopora* sp. The reef on the western side forms a somewhat steep slope with very good live coral cover. A sandy terrace was observed at the D 1 area (Figure 4.33). The depth of this sandy area is about 8-10m. Considerably large amount of fine sand can be extracted from this region.

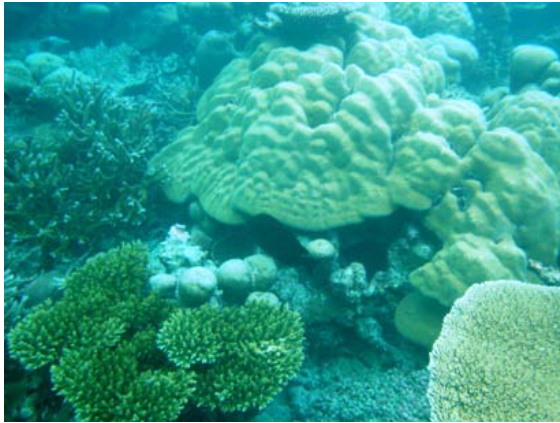
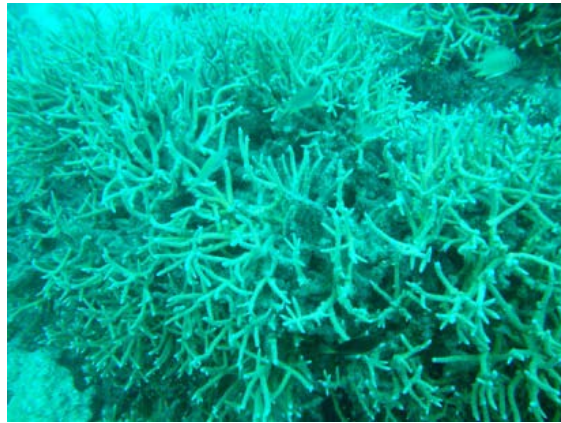
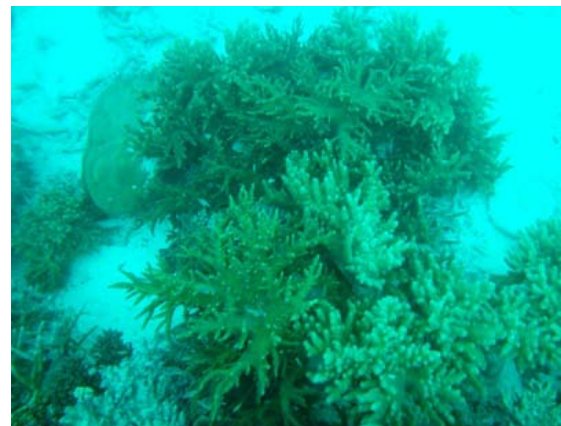
Varieties of corals

Fine branching coral (*Acropora*)

Favid (*Diploastrea*)

Soft coral

Figure 4.33: Benthic substrates observed at the site D 2.

The coral reef at D 2 area is also well developed with about 30 to 50 percent live coral cover at the observed areas. The bottom of reef edge was dominated by coral rock followed by *Acropora* branching and massive forms of *Porites* and *Echinopora* sp. No sandy areas were present at the deeper reef slope at this site. The coral genera found at this site is rather similar to site 1.

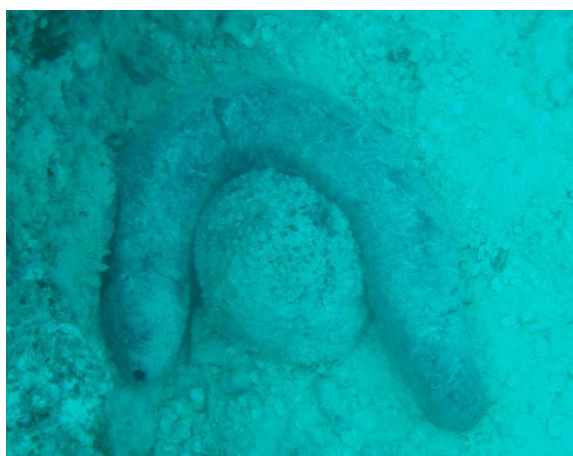
Sea cucumber

Feather star

Figure 4.35 some of the invertebrates encountered at site D 2

Only a few species of mollusks and echinoderms were encountered in these 2 sites (see Table 4.6). This may be due to the nocturnal nature of mollusks and echinoderms. What was observed during the timed swims is presented in the table below.

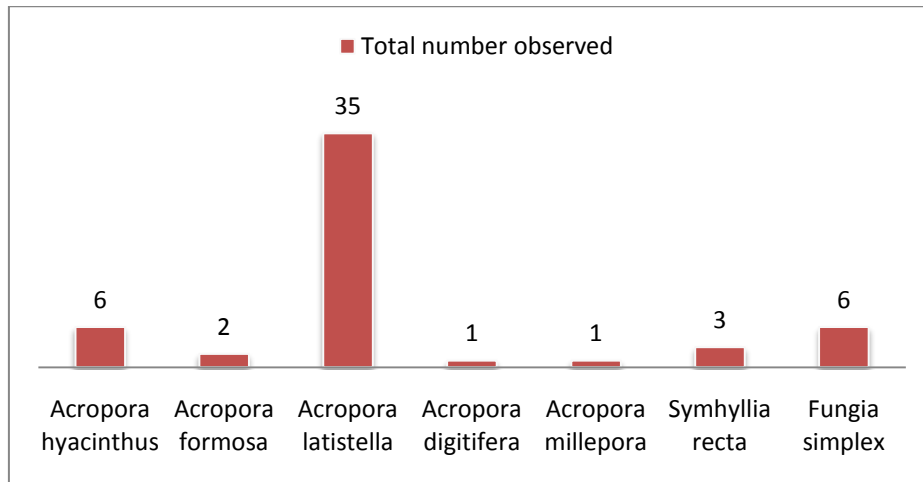
Figure 4.40 Species composition and population at transect 2

As observed in station 1, the predominant coral genera observed in this station is also Acropora. As shown in figure 10, percentage live coral cover at this station is approximately 9%. Large portion of this transect was covered with sand and rubble.

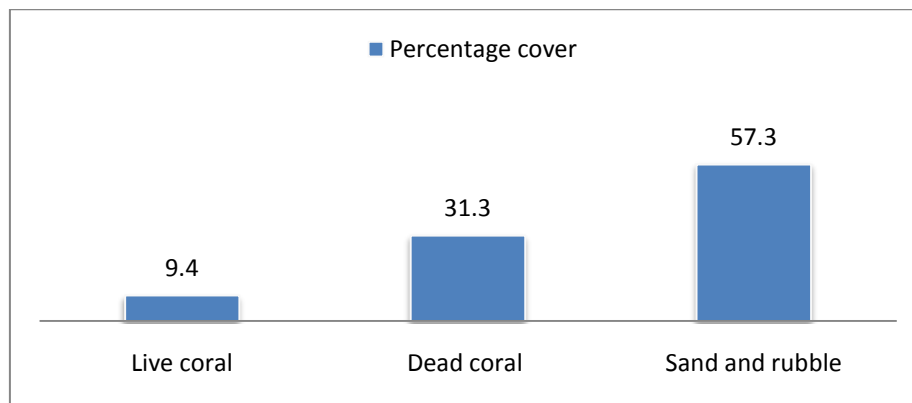
Figure 4.41 Reef benthic composition at transect 2

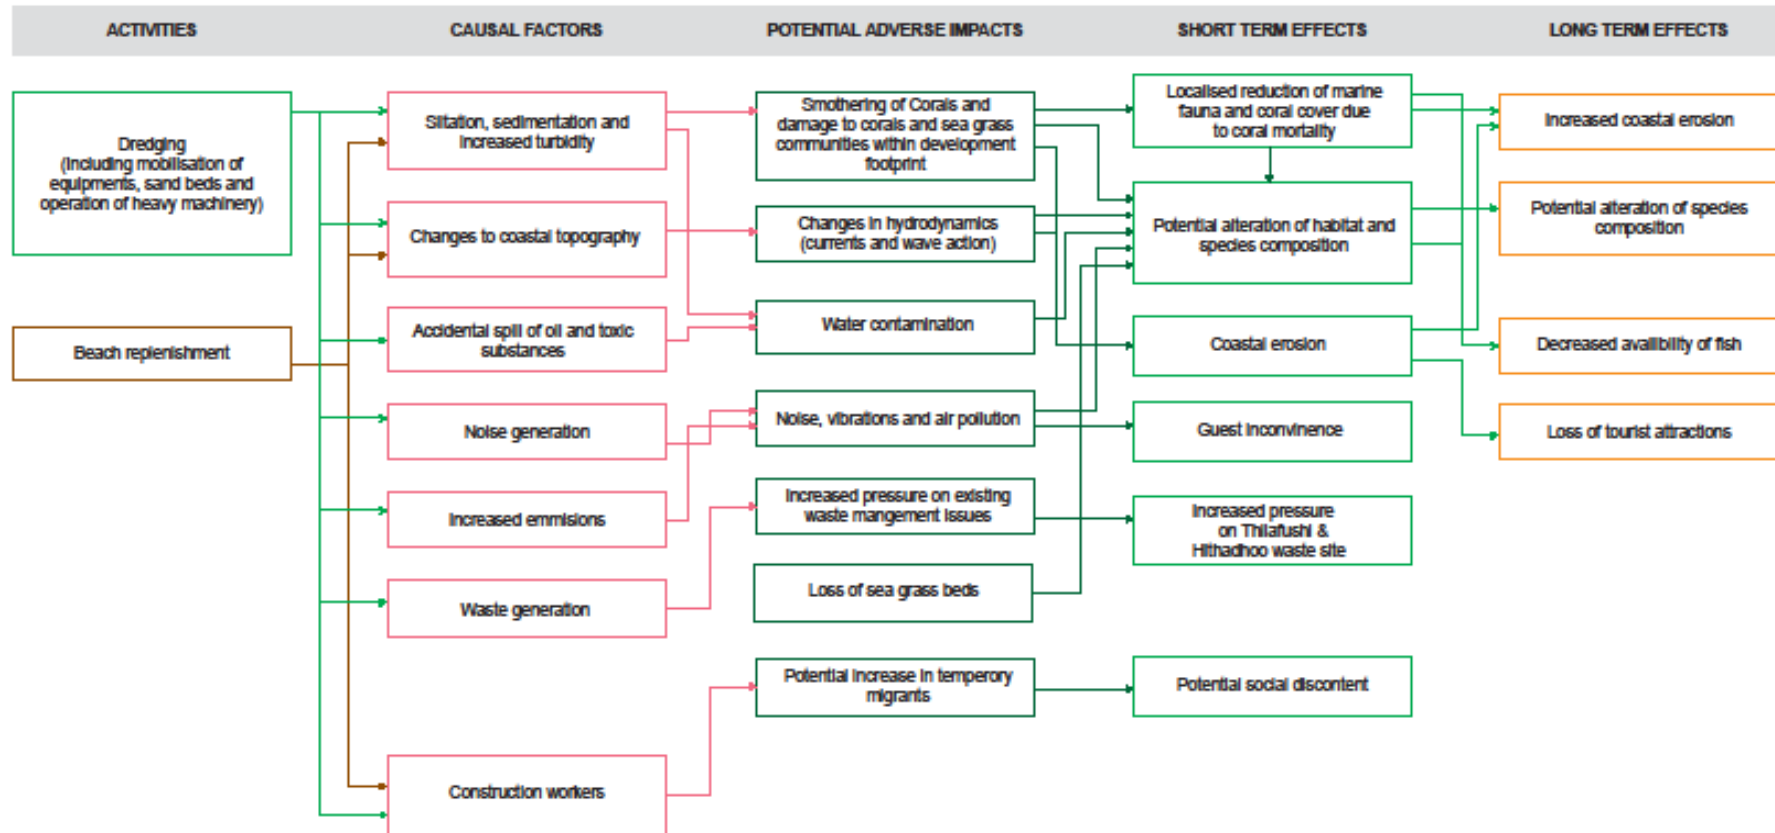
POTENTIAL NEGATIVE IMPACTS FROM SEA GRASS REMOVAL AND BEACH REPLENISHMENT

A summary of the potential negative and positive impacts during construction and operation stage of the report is provided in the diagrams in the next four pages. Details of the key impacts provided in the following subsections.
