# Environmental and Social Impact Assessment Report

**Upgrading of infrastructure at Regional Waste  
Management Facility Zone II, Raa, Vandhoo**

Ministry of Environment

January 2019

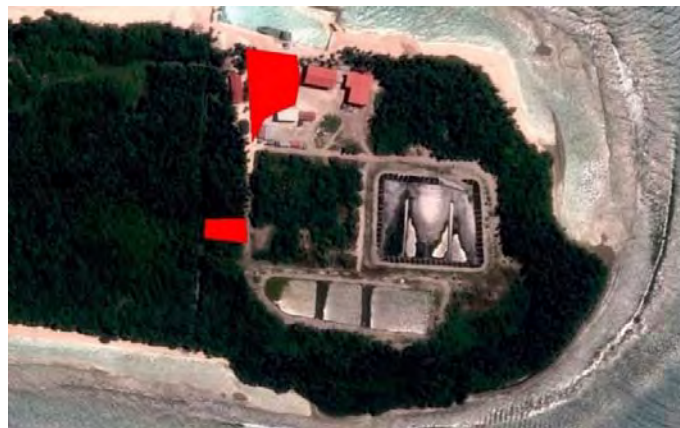
**Figure 6. Recommended areas for temporary material storage**

Construction material for the project, such as building material, galvanized iron pipes and nets will be brought to the island on bigger vessels. Materials will be unloaded to the island at the existing harbor. Construction materials will be temporarily stored at the areas indicated on Figure 6 below as these areas are currently barren. Vegetation clearance for temporary storage is not recommended. Once the land gets cleared for building plots, some material can be moved about to those areas as well.

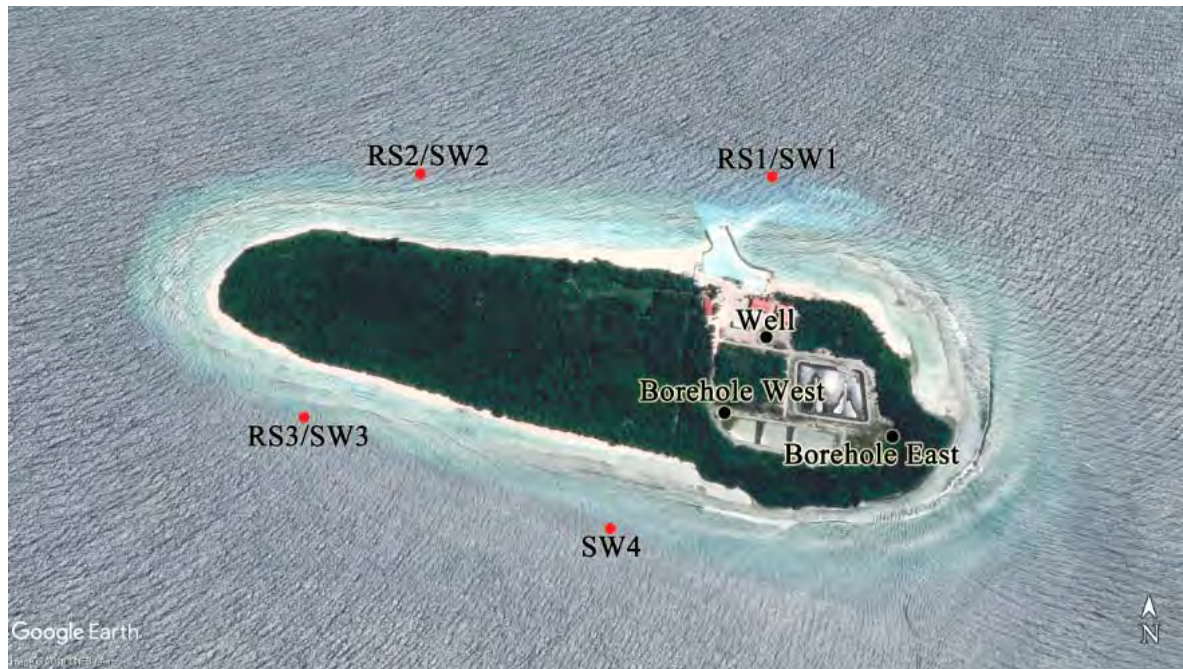
**Figure 14. Reef survey and water sampling sites at Vandhoo**

Reef fish abundance and diversity was assessed along the same belt the reef survey was done, at a depth of 2-3m. The assessment was generally made at the family level, with the focus on estimating the presence of major fish groups and predominant species.

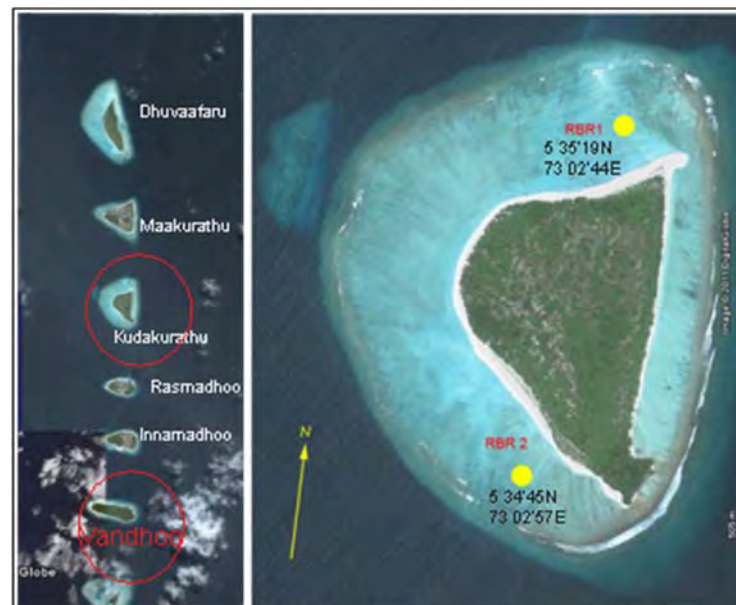
**Figure 20. Location of Kudakurathu with respect to Vandhoo and location of wave gauges**

Since site specific wave data is not available for Vandhoo; data collected at a nearby island (located at the eastern periphery as Vandhoo) was used to understand the wave climate of the area. The island of Kudakurathu is proposed for resort development and as part of Environmental data collection; LaMer Pvt Ltd has collected wave and tide data from this island. The island of Kudakurathu is approximately 4.7 km north of Vandhoo (Figure 20 shows location of Kudakurathu and wave gauge). RBR model TWR 2050 was used to collect wave data at 30 min interval burst.

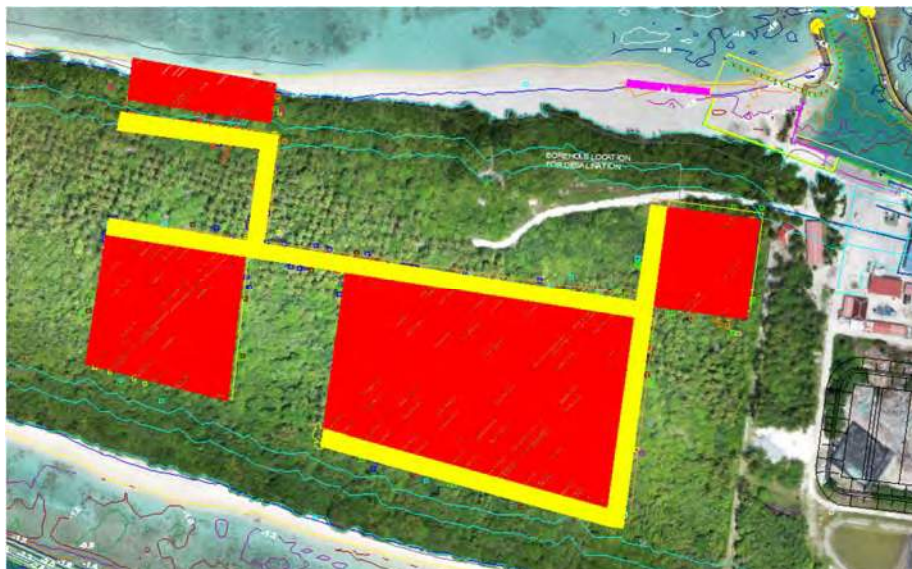
**Figure 33. Areas which require vegetation clearance to develop the plots (red) and roads (yellow) as per the proposed master plan**

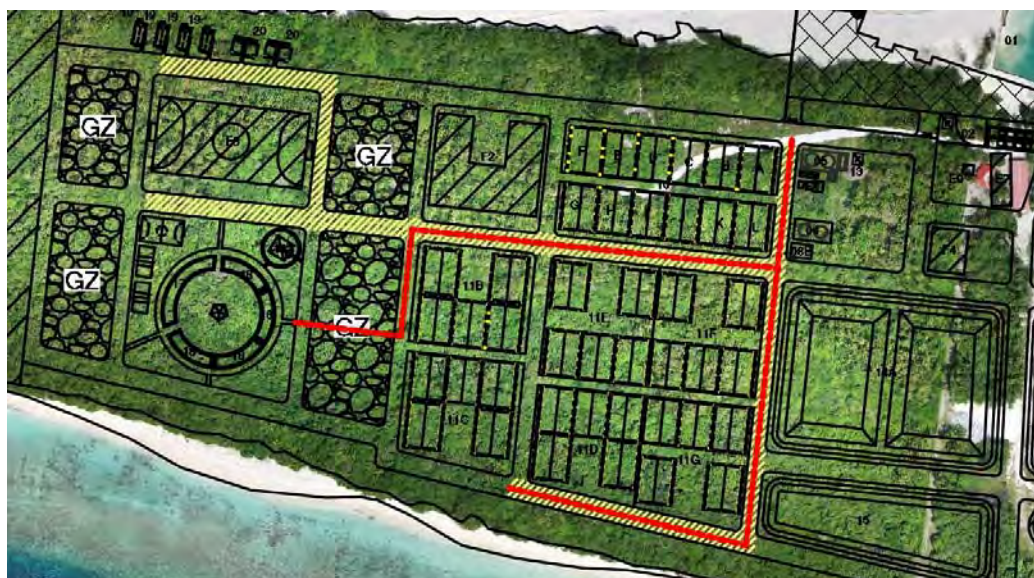
**Figure 43. Proposed road network (yellow highlight) and alternate road network (red) for RWMF at Vandhoo**
