Environmental Impact Assessment Notes for Sh. Bilehfahi Harbor Construction Project

Bilehfahi, Miladhunmadulu Uthuruburi, Maldives

January 2008

Ibrahim Naeem (M Env Mgt) – EIA Consultant Number: EIA 13/2007.

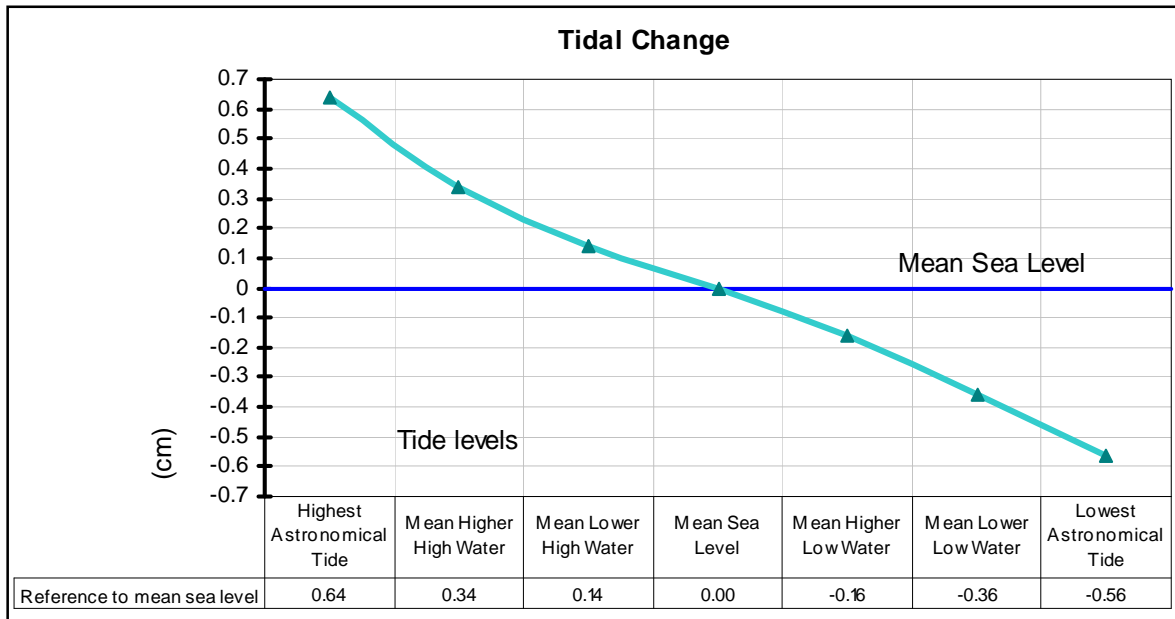
Figure 6: Astronomical tidal variation in Maldives, (Environment Maldives SoE Maldives 2002)

Maldives experiences mixed semi-diurnal and diurnal tides with a strong diurnal inequality. Tide records at K. Hulhule, and HDh. Hanimaadhoo which can be applied for estimating tide levels at Bilehfahi with reasonable accuracy, shows that, the maximum tidal range to be about 1.20m (see Figure 6). The highest astronomical tide level is +0.64m (Mean Sea Level) and the lowest astronomical tide level is -0.56m (MSL).

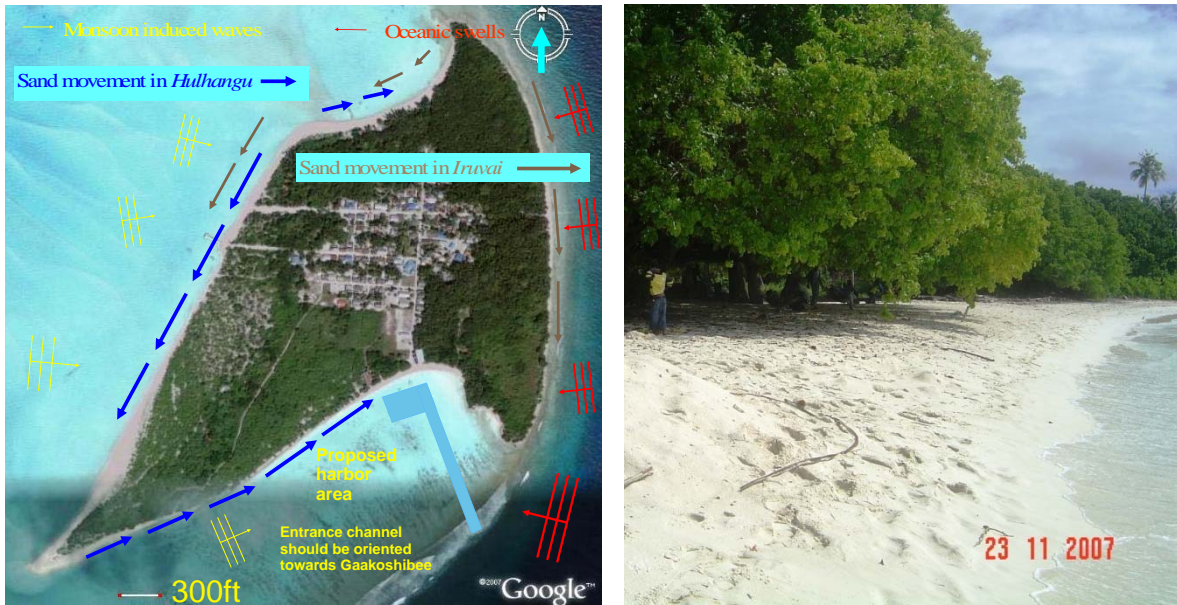
Figure 7: Wave and sand movement around Bilehahi during the two monsoons (left). Fine grained sand at the proposed harbor area (right).

The coastal dynamics such as accretion and erosion of islands depends on wave energy. The type of beach and the beach materials also depends largely on the strength of wave energy. Bilehfahi is exposed to waves generated by swells on the eastern side of the Island. On the southern and western side, short wind generated waves from the atoll lagoon are felt (Figure 7).

The beach and nearshore environments of Maldivian islands are composed of coralline and skeletal remnants derived from the reef. The sediments in this environment are mostly coral fragments, calcareous algae and foraminiferans. It has been determined that the major forces which produce sediment on the reefs, are storm waves and waves driven by monsoon winds Figure 7.

Tides and wave driven currents play a very important role in the transport of sediment around the islands. The sediment movement around Bilehfahi was crudely presented in the Figure 7.

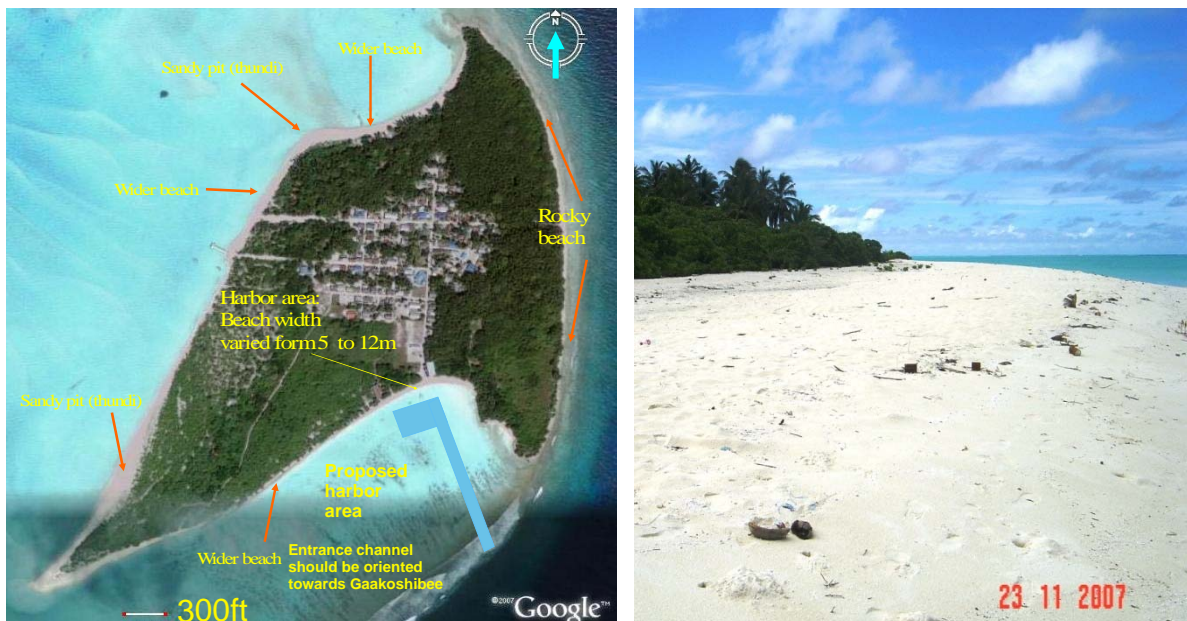
Figure 8: Beach widths of Bilehahi (left). Wider beach was found at the northern side of harbor (right)

Beach is normally defined as the white sandy area between the vegetation line and the lowest astronomical tide. Width of the beach varies with the tidal fluctuations. The beach has a narrow width along much of the length of the east coast of Bilehahi (see Figure 8). The west coast beach is relatively wider. Two large sand pits (*thundi*) were on the north-western corner and south-western side of the island.

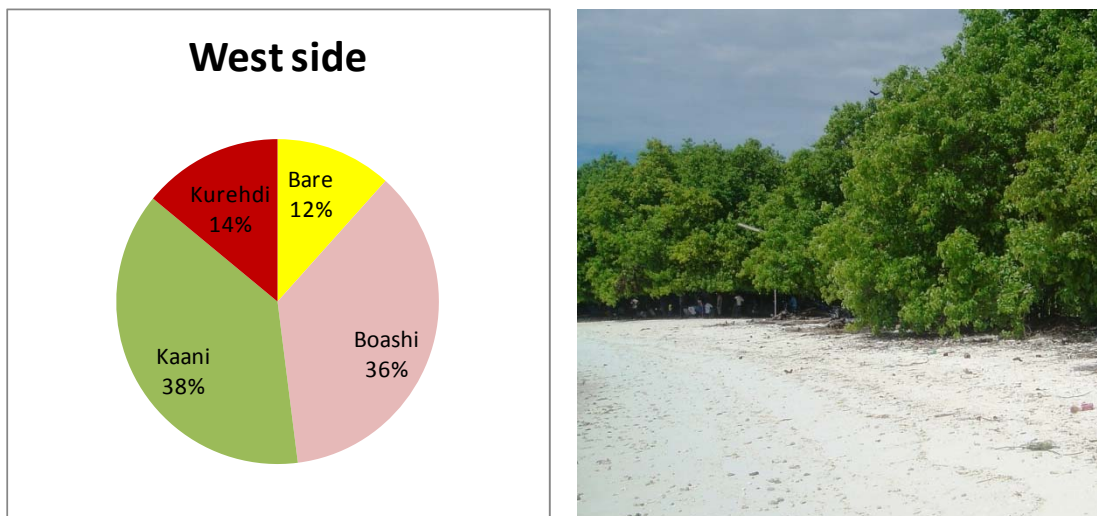
Figure 9: Coastal vegetation at western side of the proposed harbor area (left), dominant vegetation was *kaani* at the site (right).

The result of the 3 transects (VT 1, VT 2 and VT 3 carried out at the western side of the harbour reveals that 38% of the beach vegetation cover was *kaani*. Other species encountered included *boashi* and *kuredhi*. About 12% of the surveyed area was observed to be bare (see Figure 9).

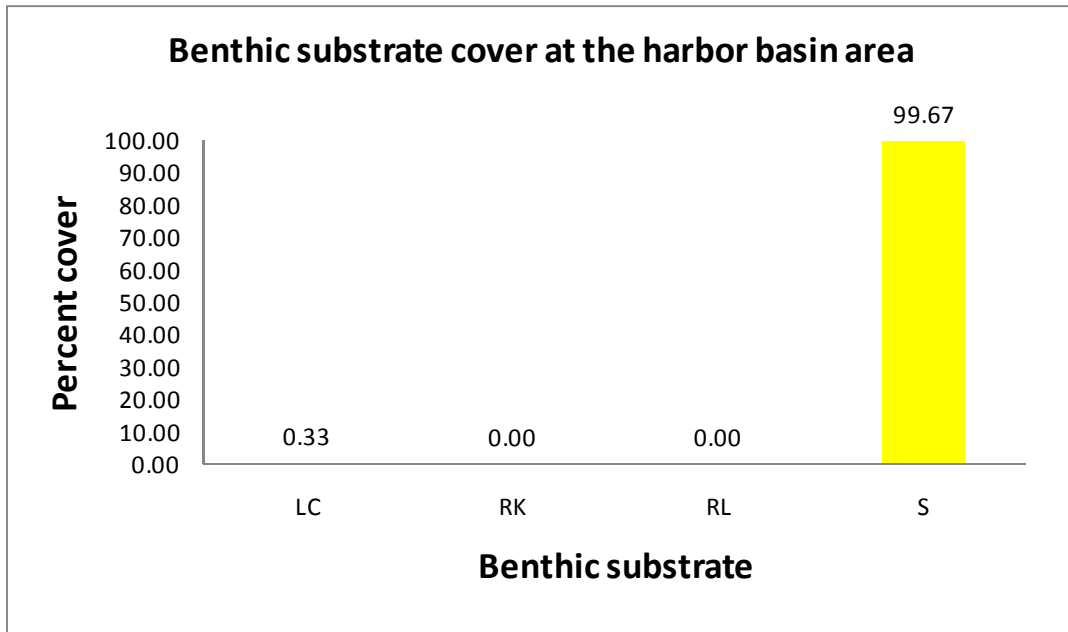
Figure 11: Percentage cover of benthic substrate present at the proposed harbor site’s reef-flat. The dominant form of benthic cover is coral rubble. Massive forms of *Porites* spp. predominates the live benthic cover. Branching type corals namely *Acropora* spp. (staghorn), other massive types *Favites* spp., *Favia* sp. and encrusting types were also present. The benthic covers are given in percentages of the bottom area surveyed. LC = live coral, RK = rock, RL = rubble, and S = sand.

The reef-flat around the proposed harbor area is poorly developed with less 1% live coral cover (see Figure 11). The bottom of the reef-flat was dominated by sand. The reef slope at this side forms a steep slope to the atoll basin. The reef condition near the crest and edge was better than the reef-flat near the island in terms of coral cover, fish and other marine life.

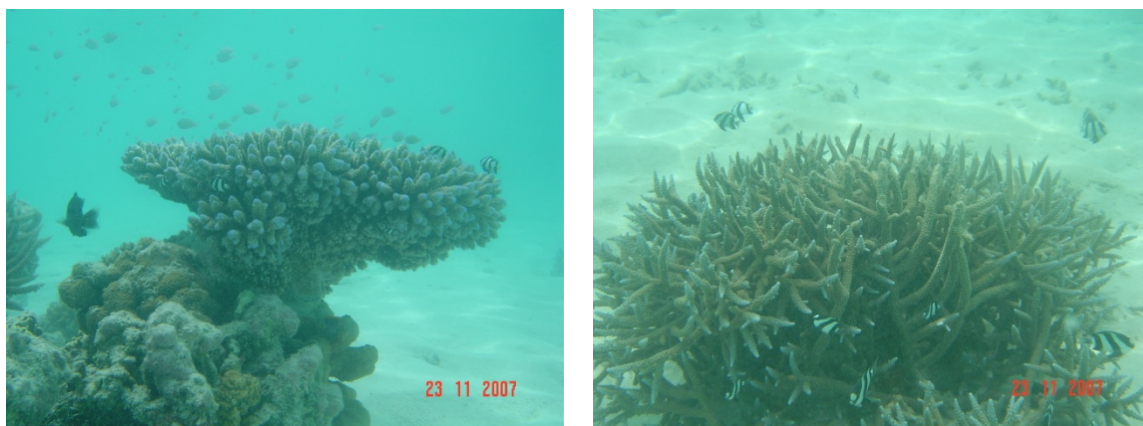
Figure 14: Benthic cover at entrance channel area. Branching *Acropora* (left); mostly sandy with *Acropora* (right).

More hard substrate is seen here. The fish life is also richer here. The depth remained rather similar with 1 to 1.2m at MSL. The benthic substrate at the entrance channel area is presented below (Figure 14).

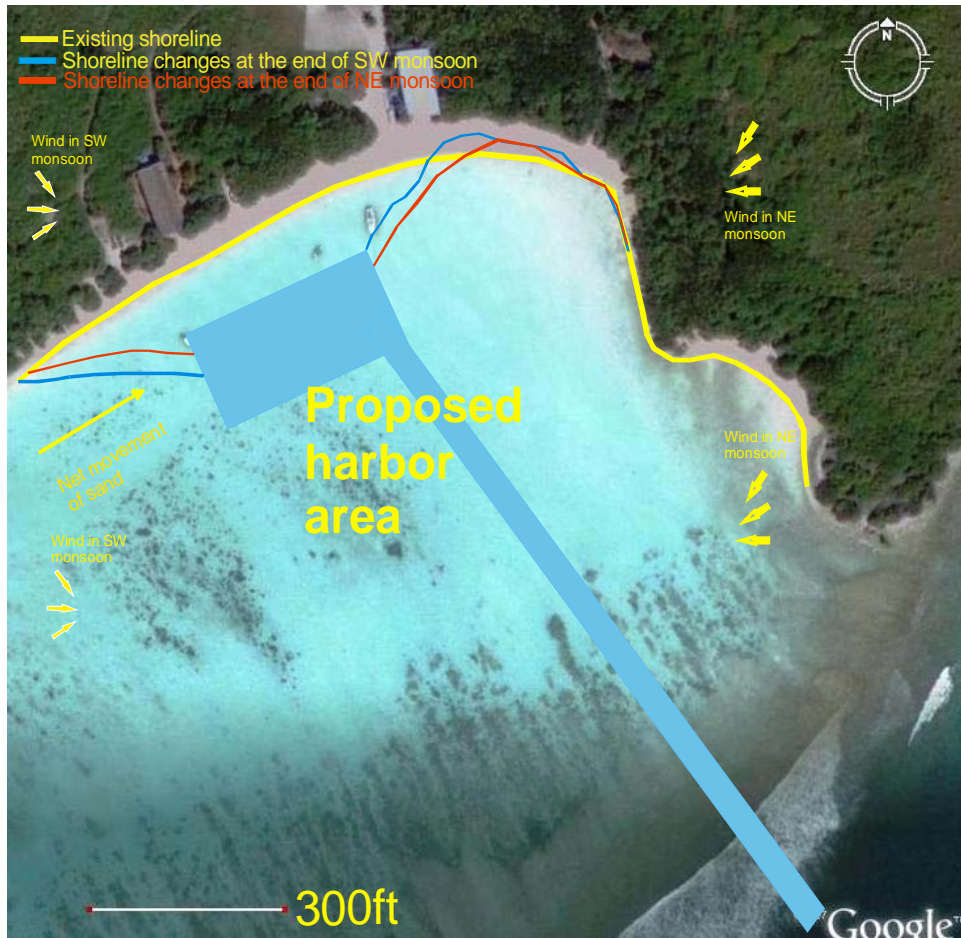
Figure 15: Possible alteration of shoreline as a result of harbor construction

- Change in near-shore hydrodynamics (see Figure 15).
- Erosion and loss of vegetation at the low energy areas during either monsoons.
- Sedimentation and turbidity resulting poor water quality which negatively impacts vitality of marine organisms.
- Alteration of bottom substrate.
- Degradation of sea water quality due to turbidity.

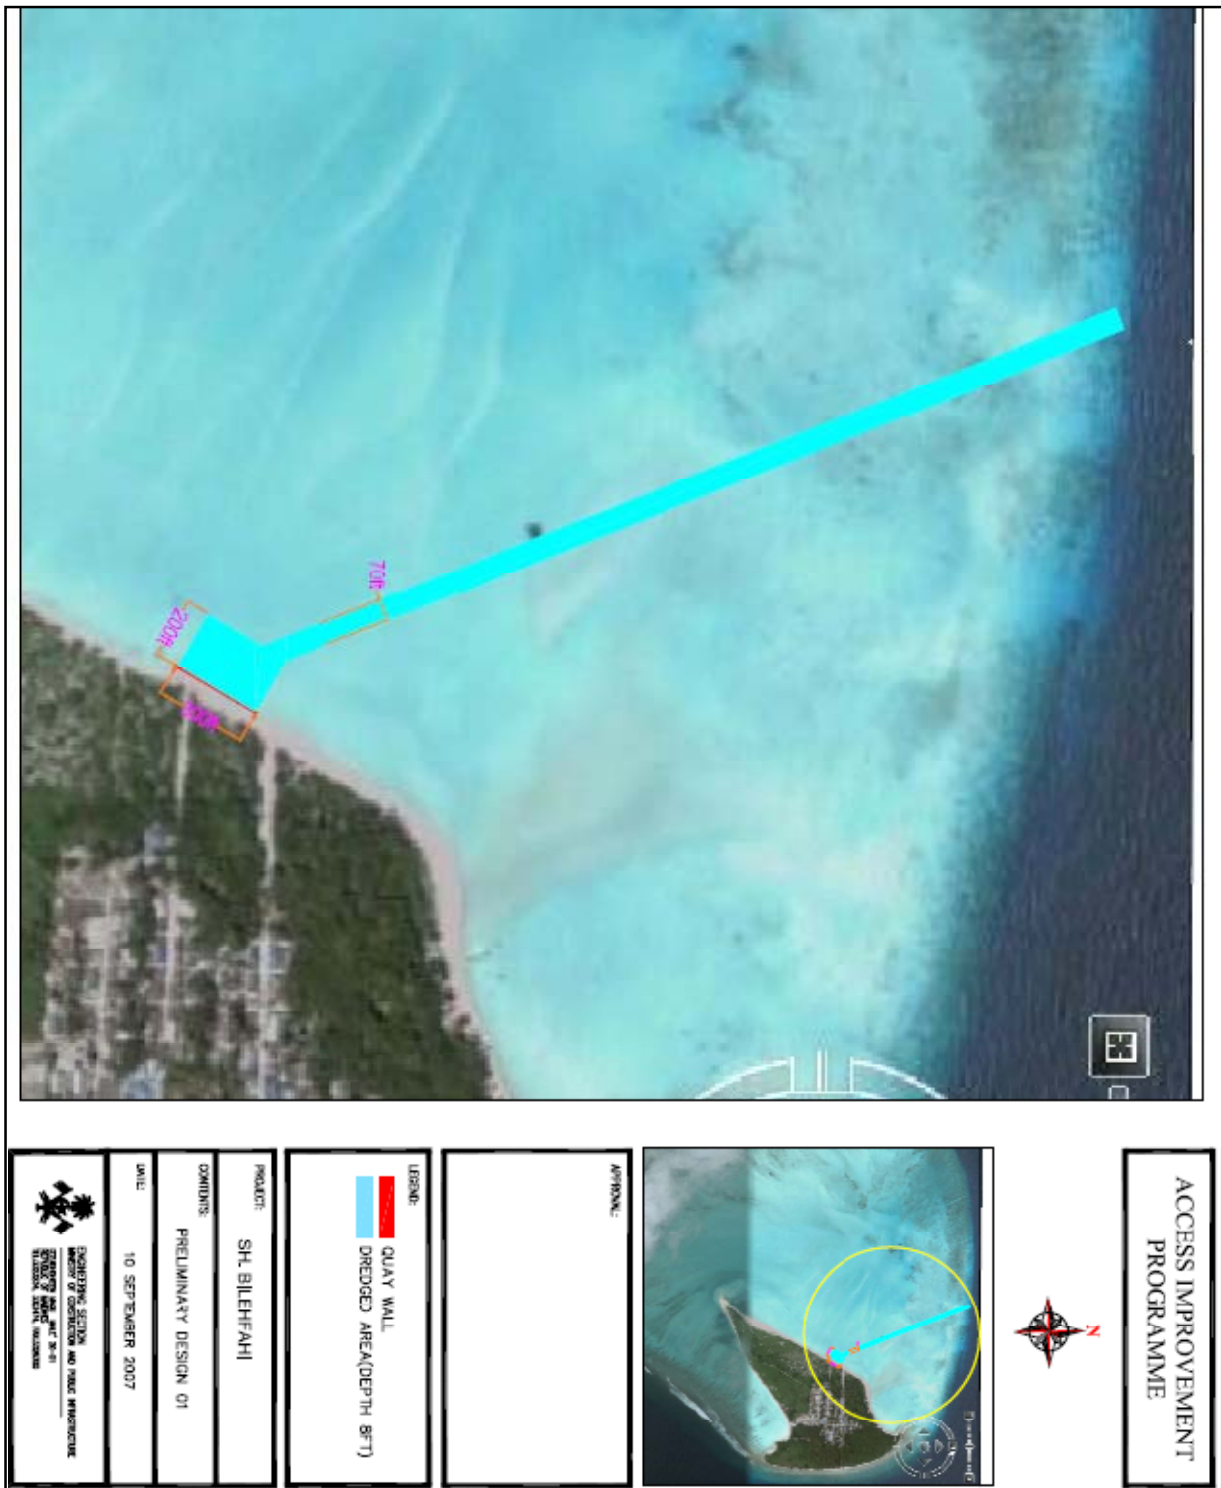
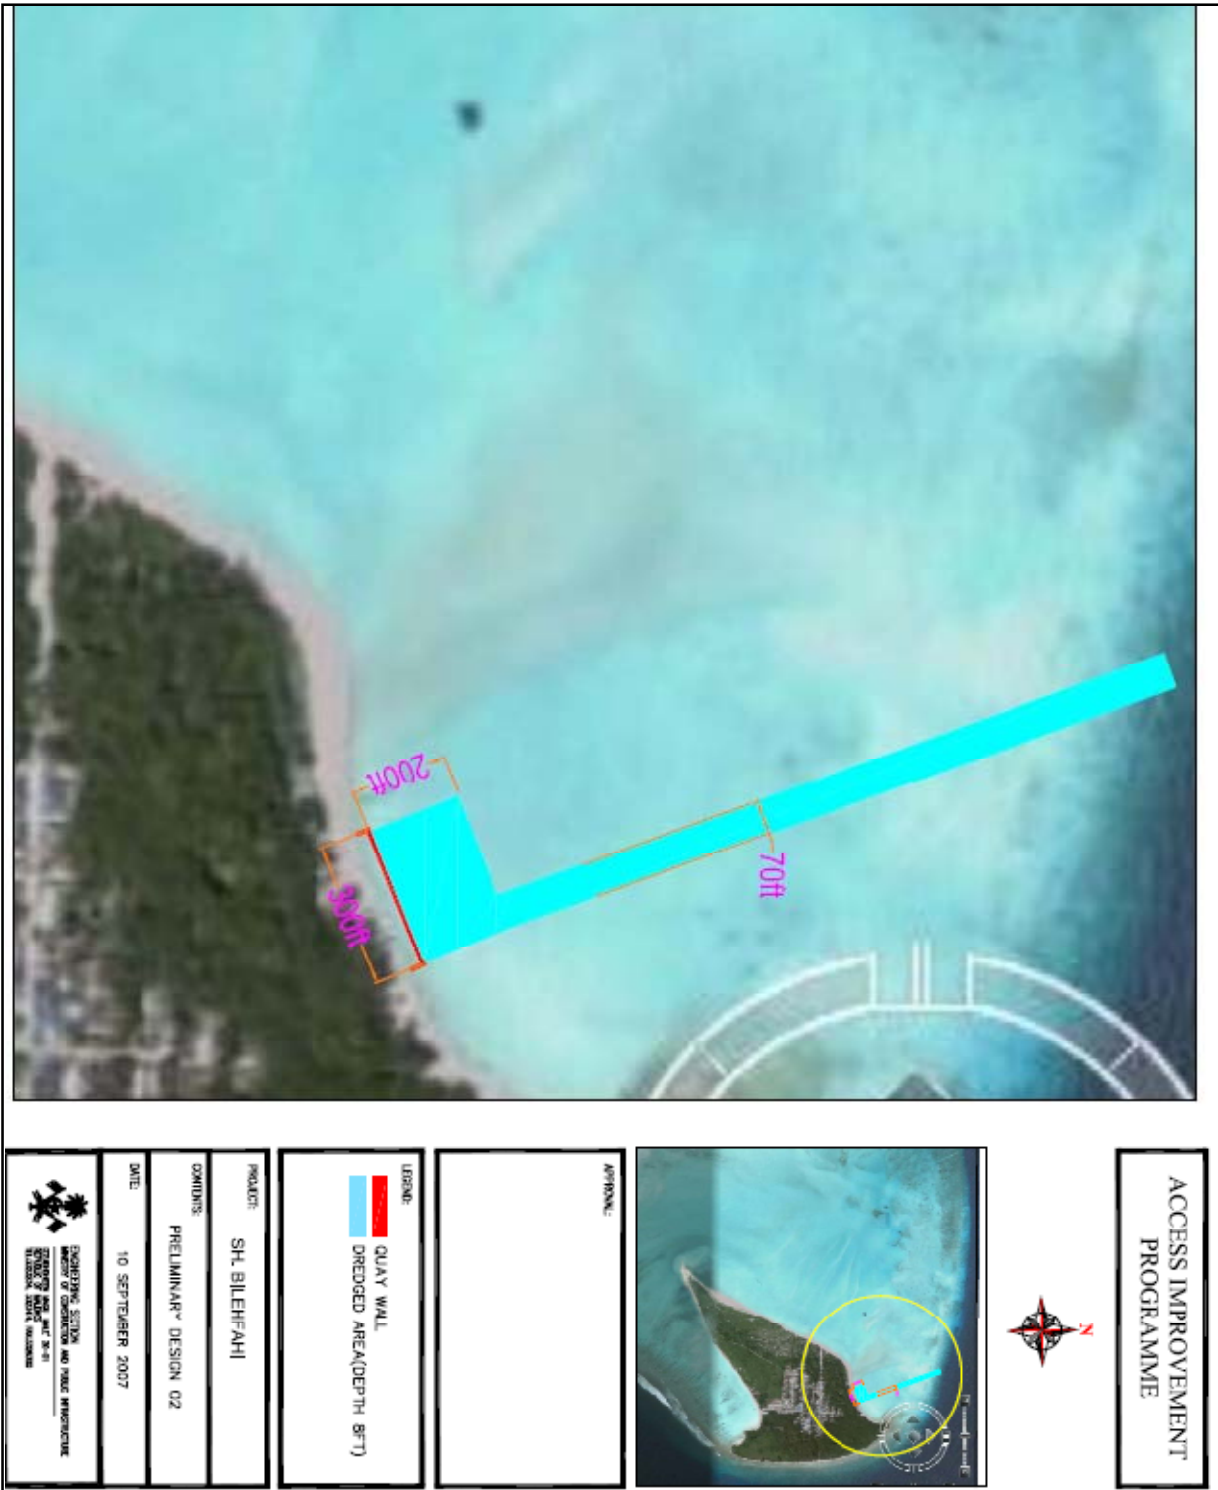
10 Annex 1: Proposed harbor concept drawings

Note: The locations proposed in these two Designs were not approved by the Island Authorities. Instead the harbor's agreed location was the southern side of the Island. The dimensions of the harbor basin remain the same.

- Dredging the harbor basin of 300ft length and 200ft width to a depth of 8ft in mean low tide
- Building a quay-wall of 300ft along land-ward side
- Building of breakwaters along other sides of the harbor
- Dredging of a 70ft wide, entrance channel to the harbor
